Inspection Report

From: Jason P. Ball, PE, SE
Ball Maritime Group, LLC

Date: May 14, 2024

Project: PN 23-1035: Coronado Ferry Landing Level 1 Inspection
Coronado, California

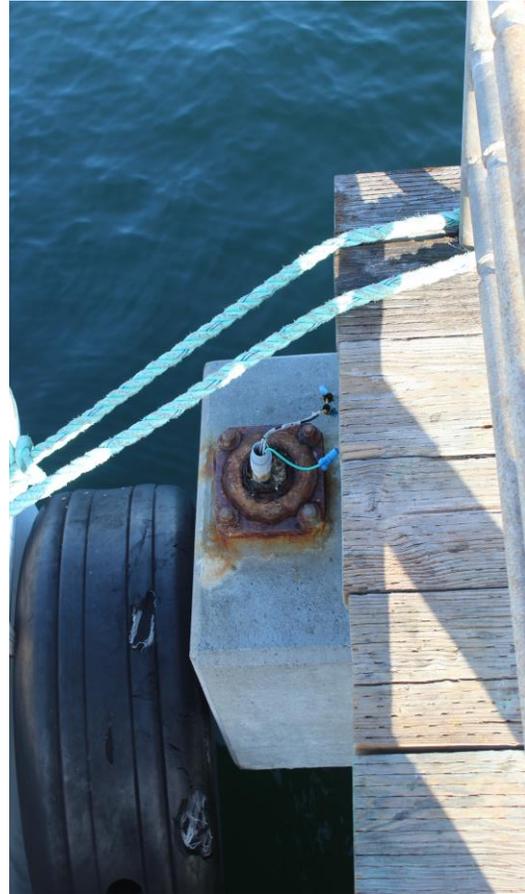
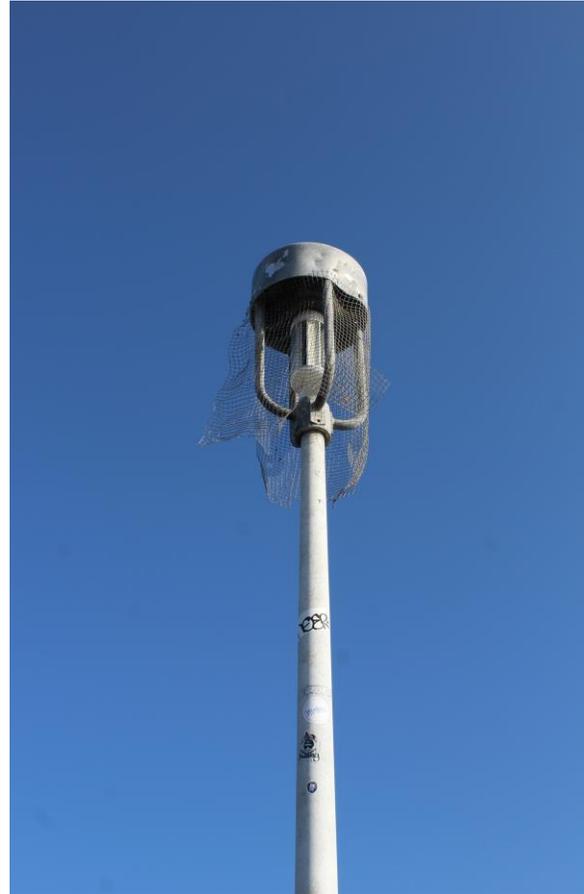
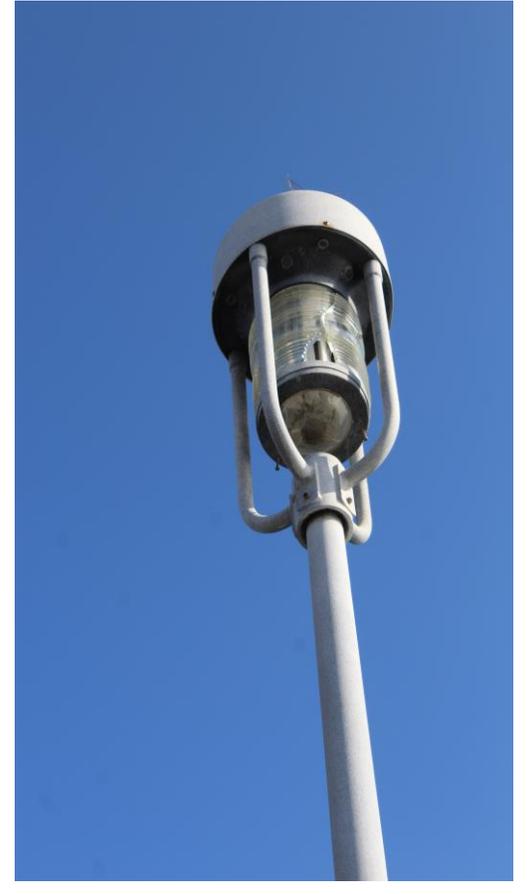
Light poles are missing and damaged, and missing ones are left with the wires exposed.
(photos 7248, 7252, 7265, 7289, 7310)

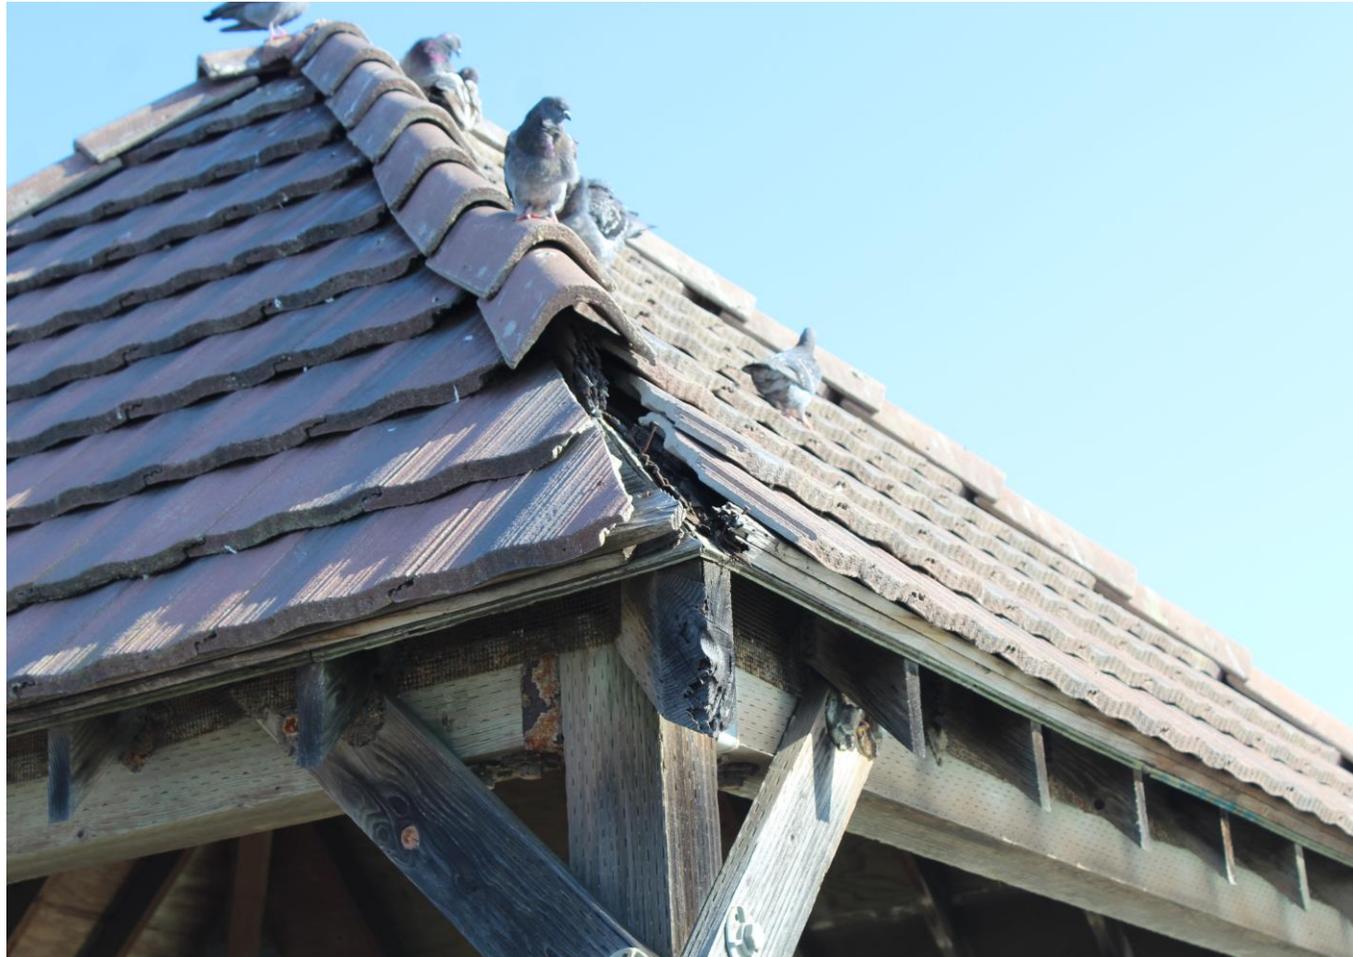
Gazebo is missing roof ridge tiles, and the roof sheathing is rotting.

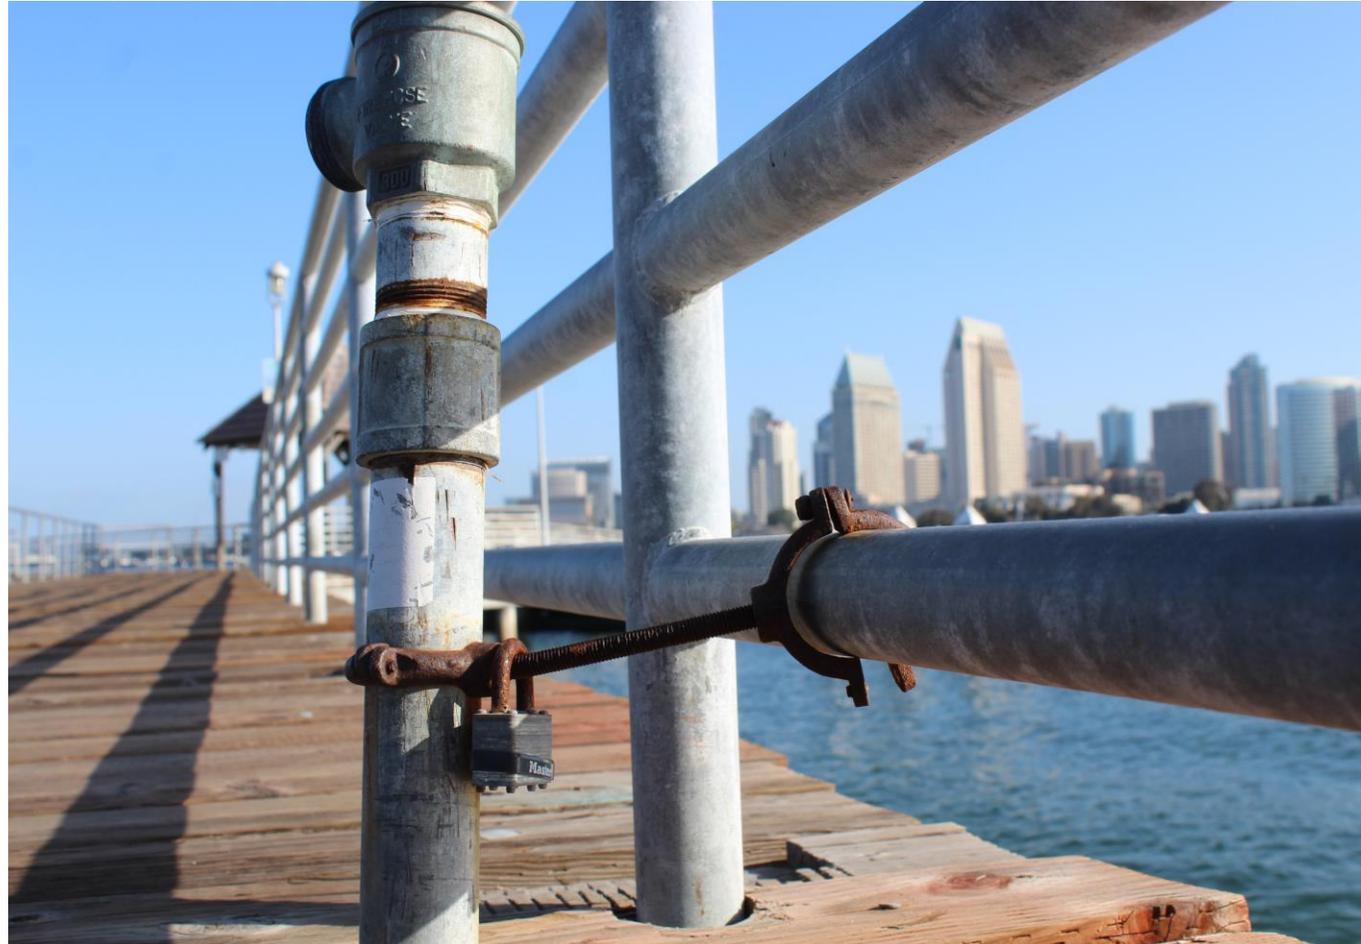
The fire standpipe support connection is broken.

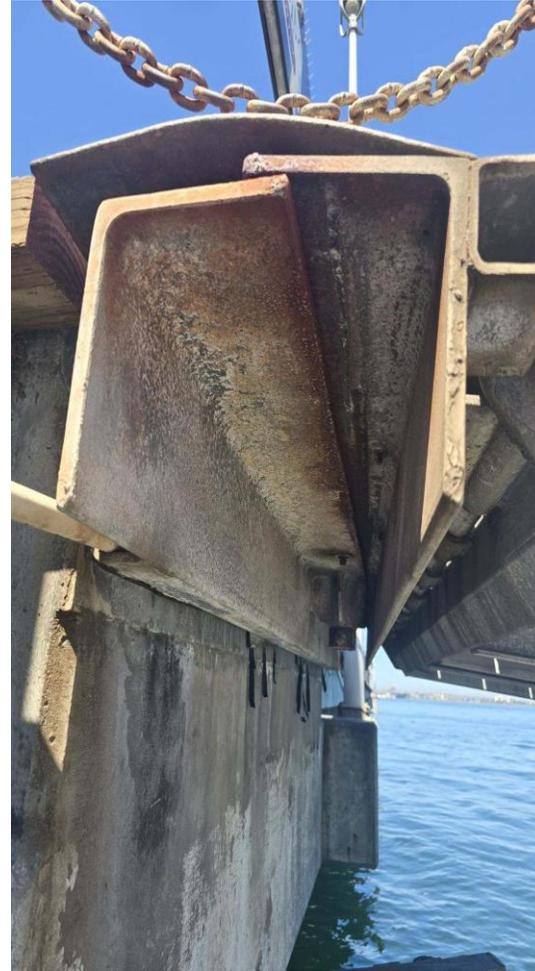
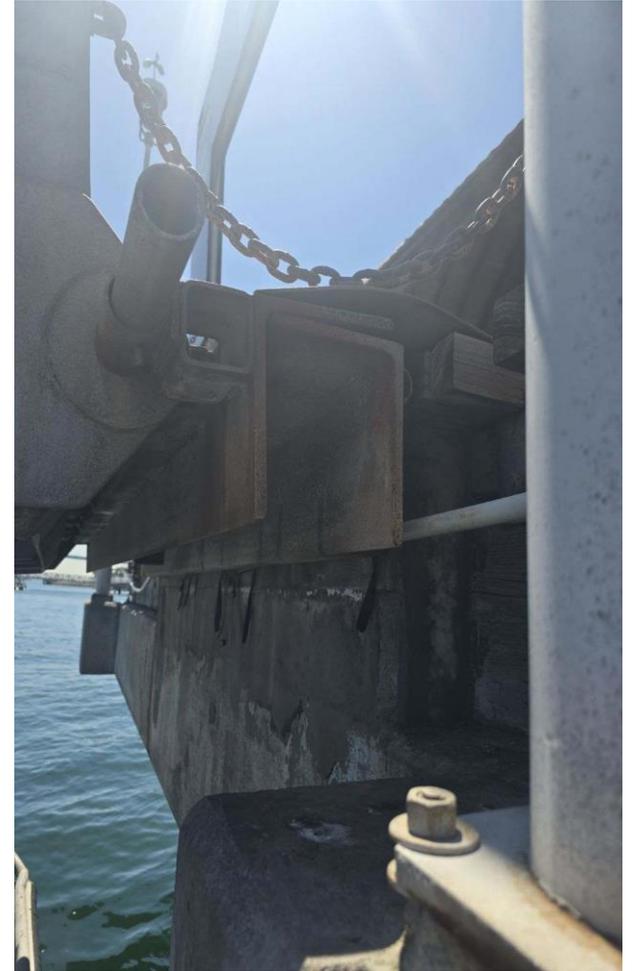
The floating dock ramp has an unfamiliar designed connection that is not on any of the plan sets. (photos 1000007044, 7045, 7046, 7047, 7048)

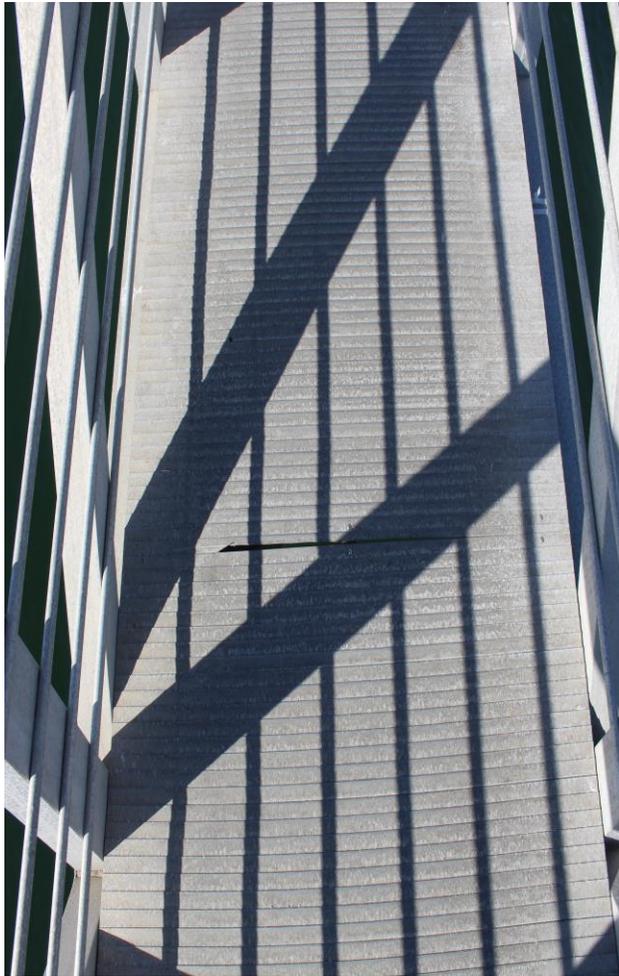
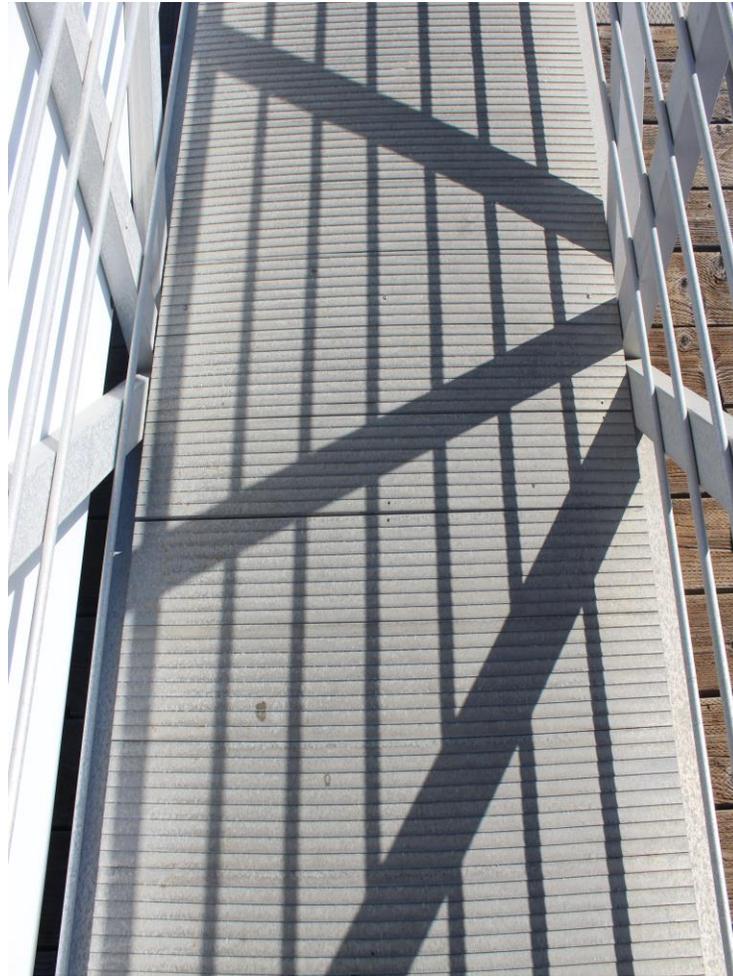
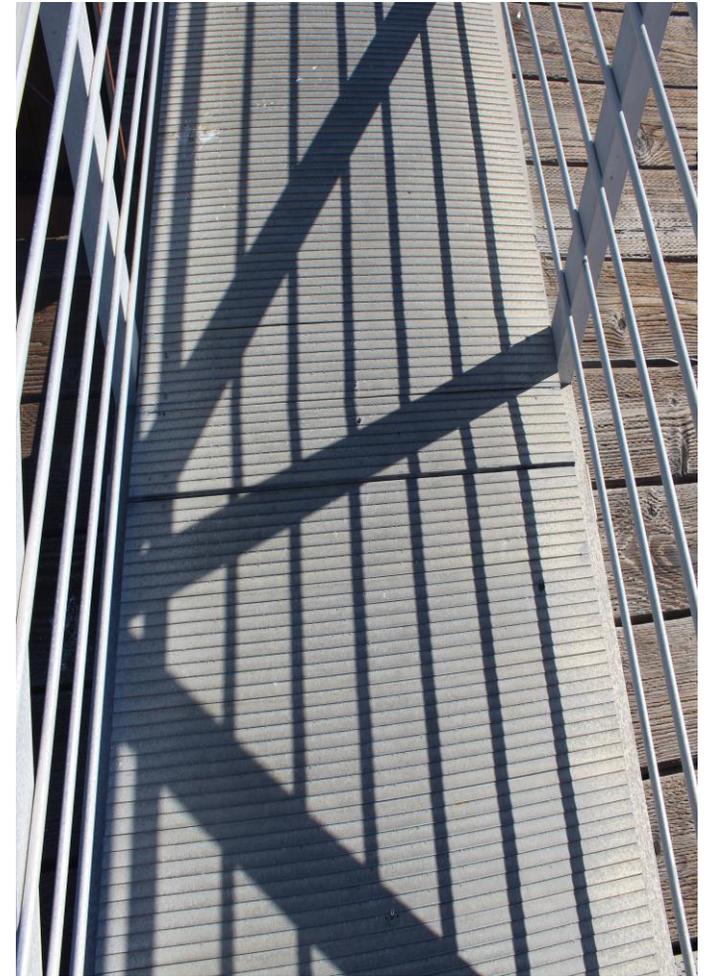
Ramp decking loose in multiple places

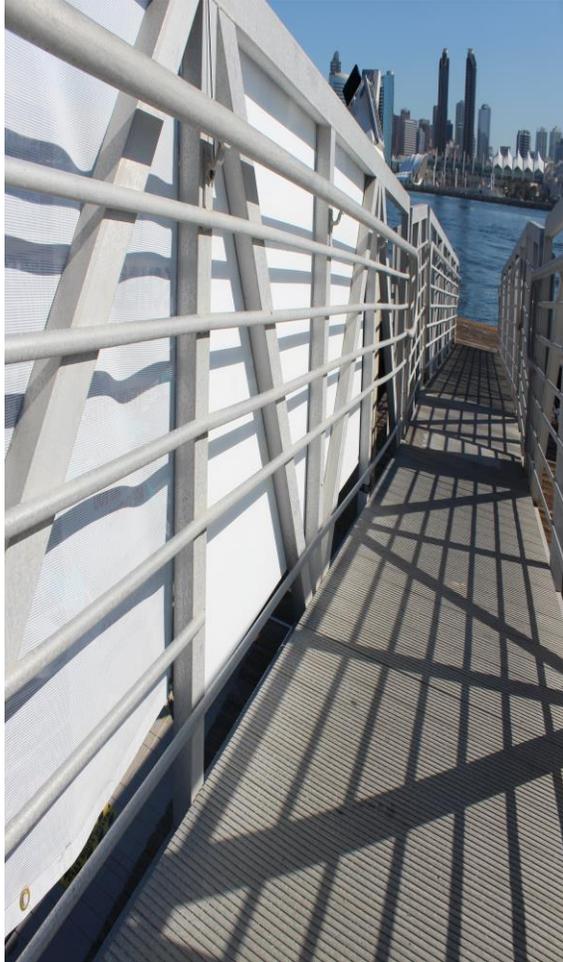
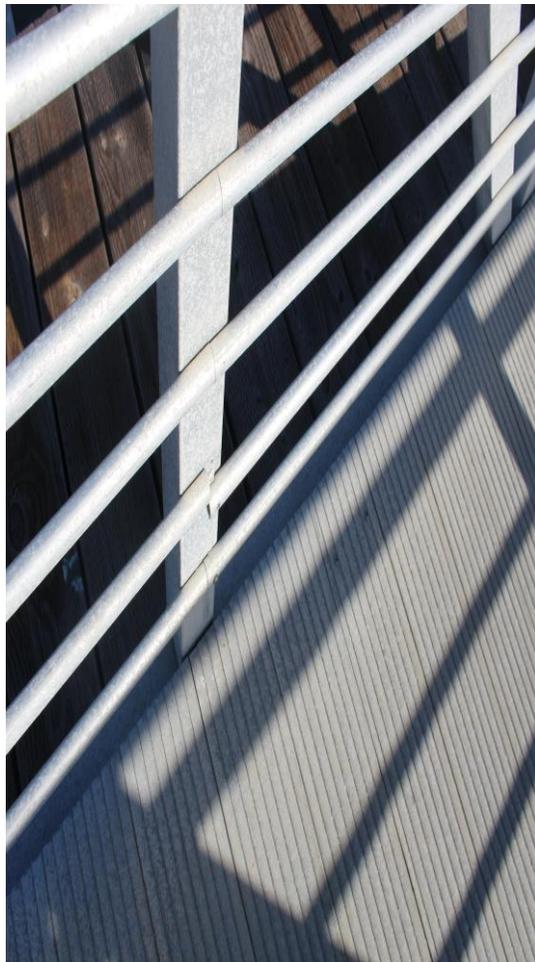
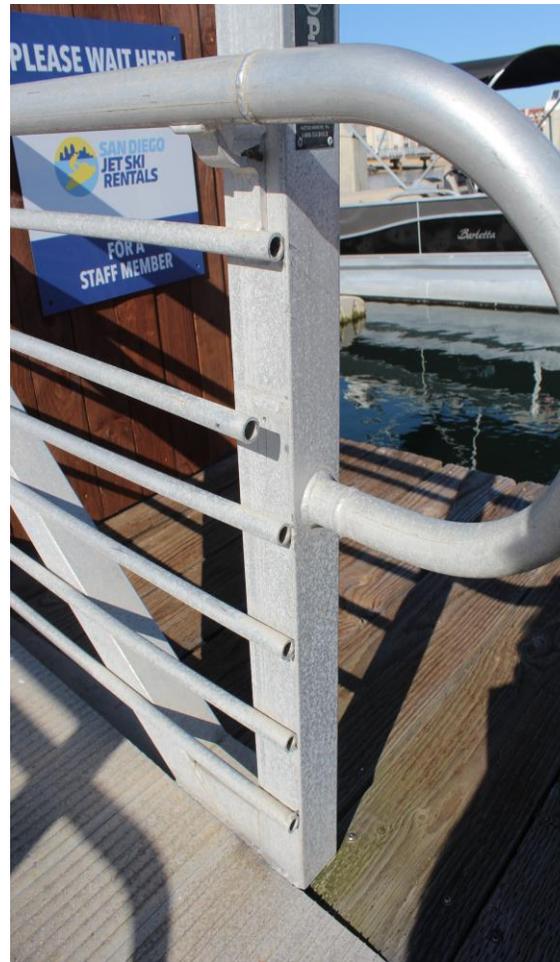
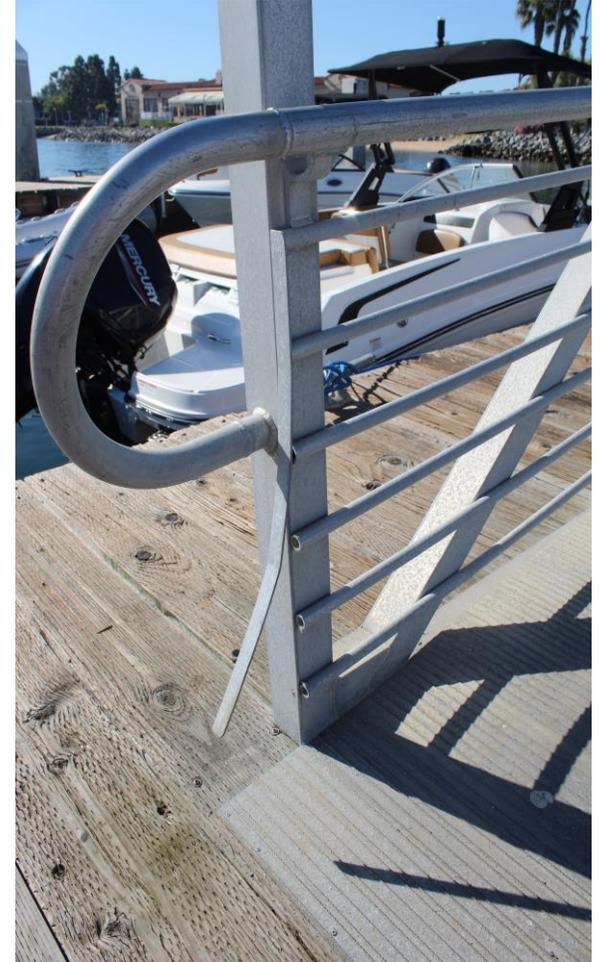
Multiple areas on the handrails are loose or missing altogether. The end of the floating dock has a finishing bar that is bent off, and the other side is missing.

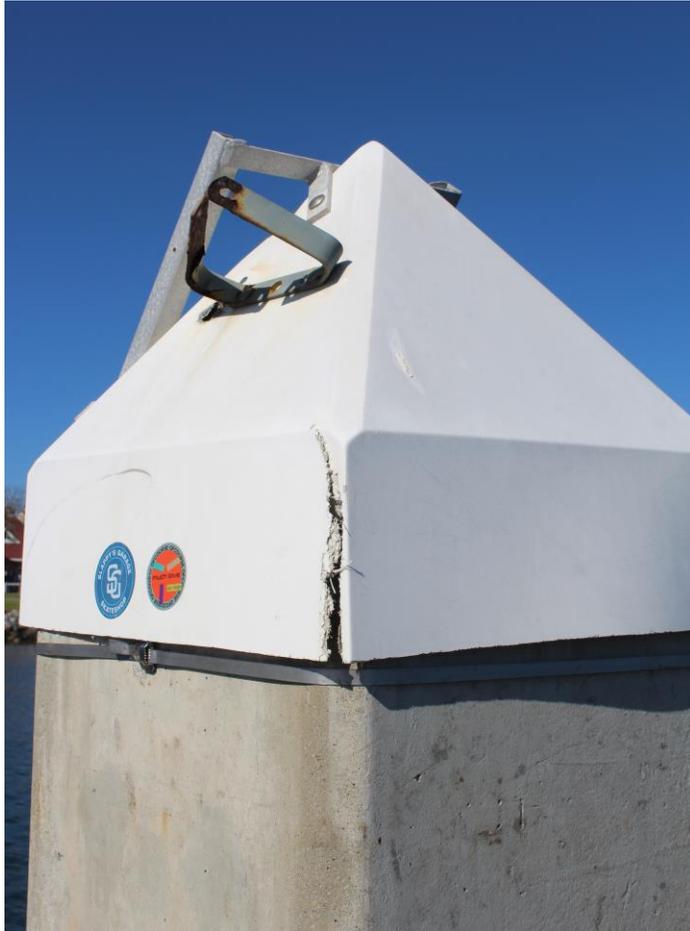
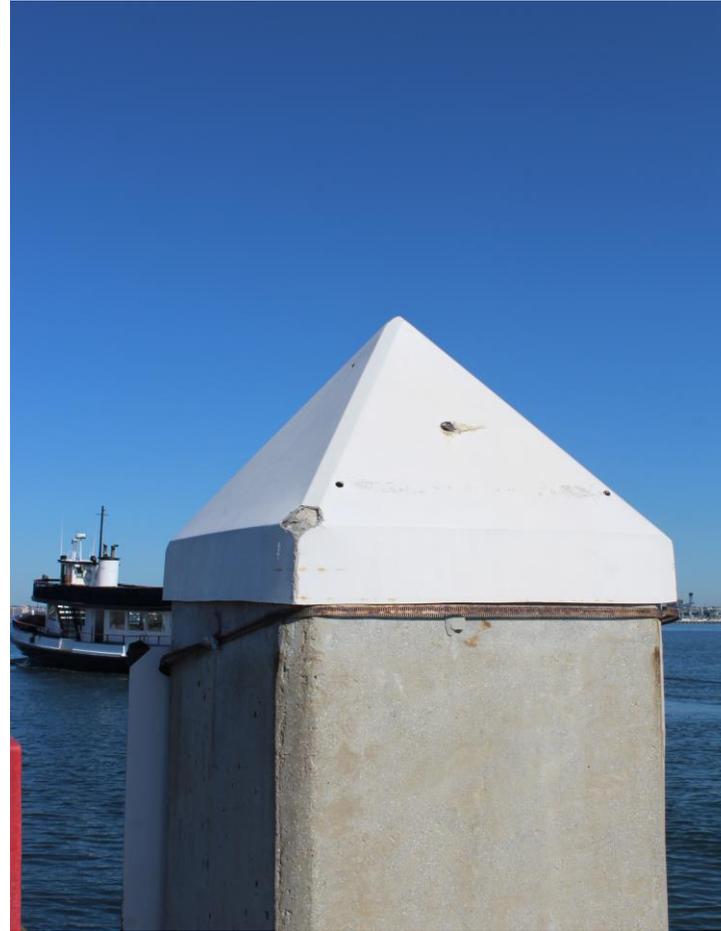
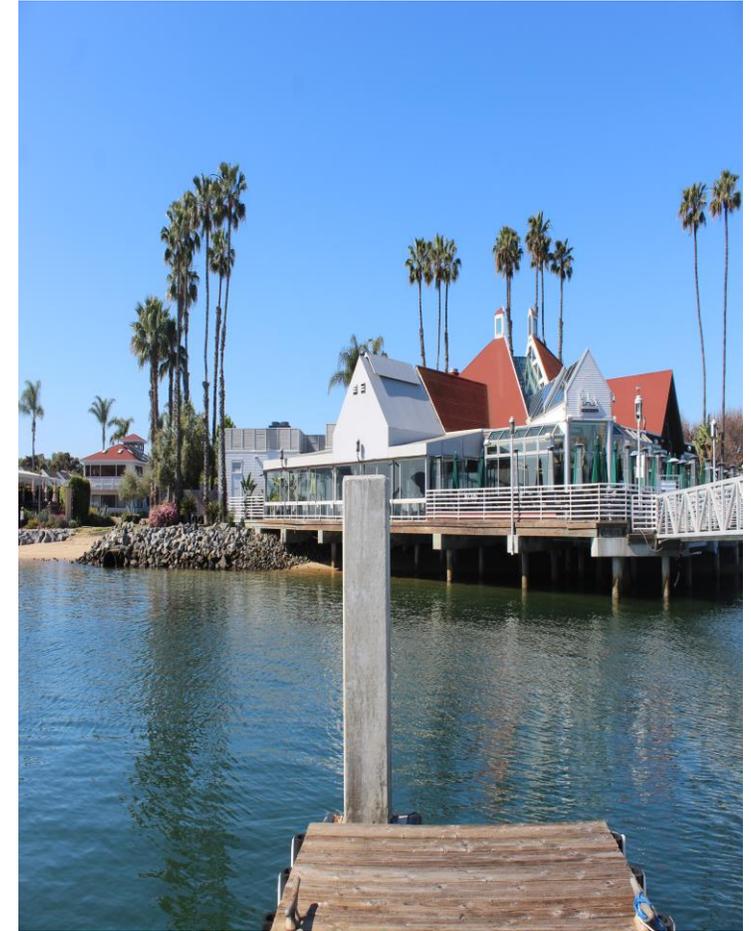
Pile caps (covers) damaged or missing

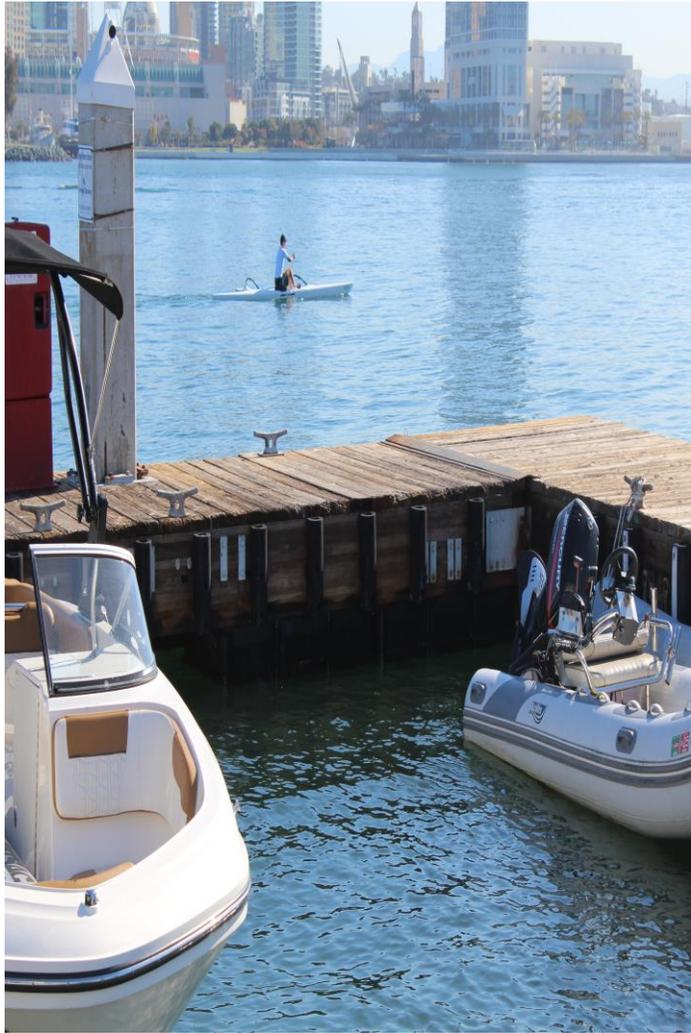
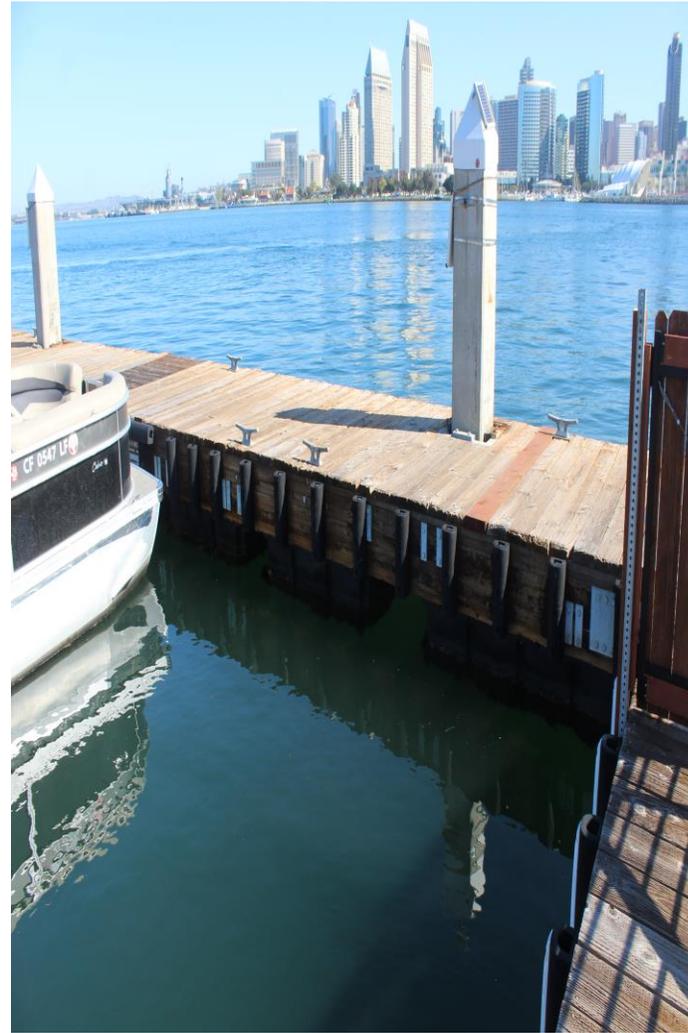
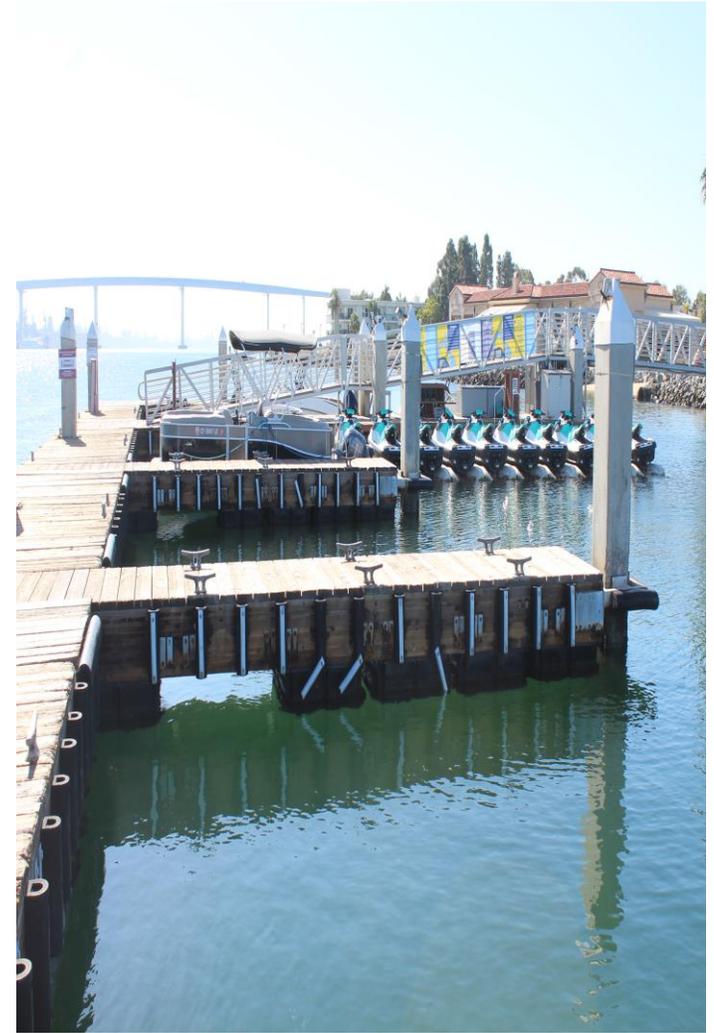
Rubber fenders are missing/damaged, and the UHMW sliders are missing.

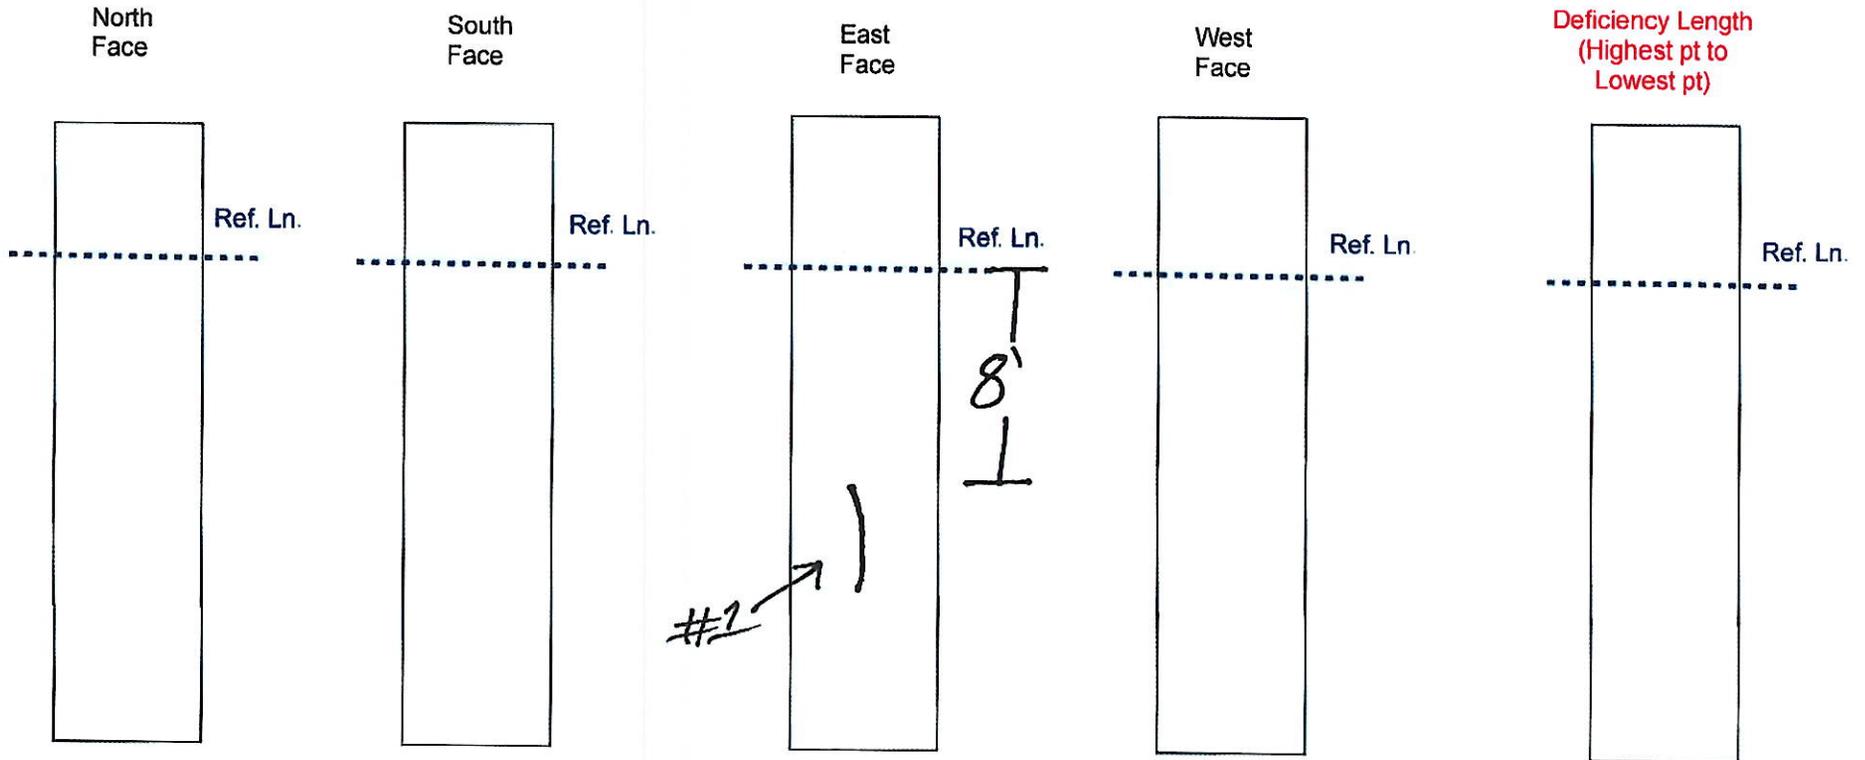
Location #	Type	Distance from Ref. Line	Vert. Length	Width	Depth
1	Crack	96"	5"	1.5"	1/16" - 1/8"
2					*Below 3" COVER
3					
4					
5					
6					
7					
8					
9					
10

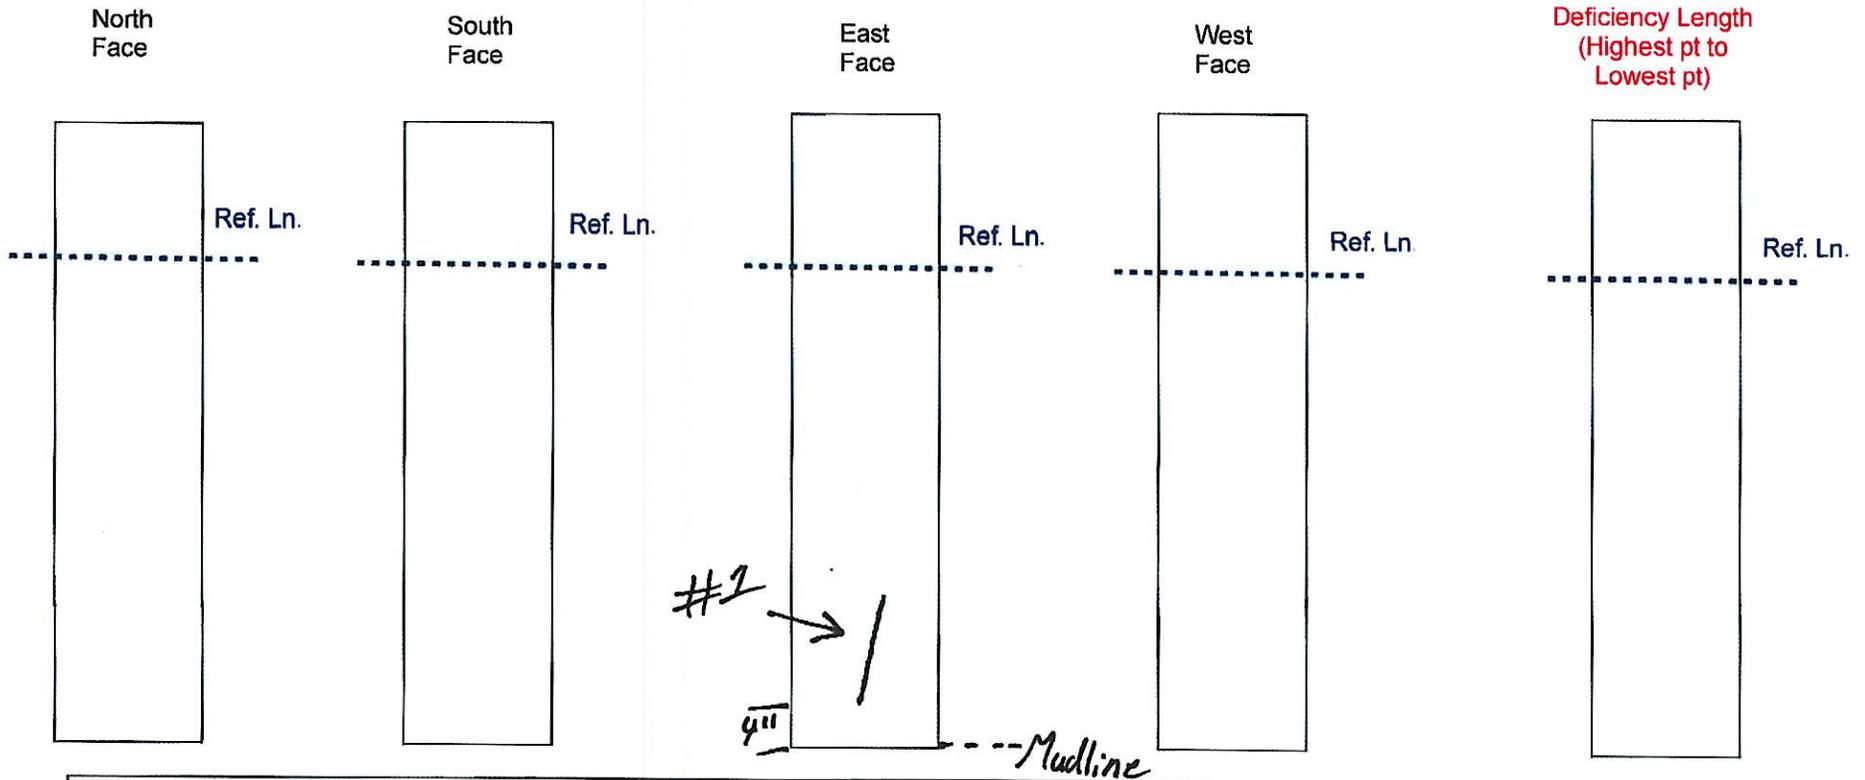
Location #	Type	Distance from Ref. Line	Vert. Length	Width	Depth
1	Crack		9"	1"	1/16" - 3/4"
2					< 3"
3					
4					
5					
6					
7					
8					
9					
10

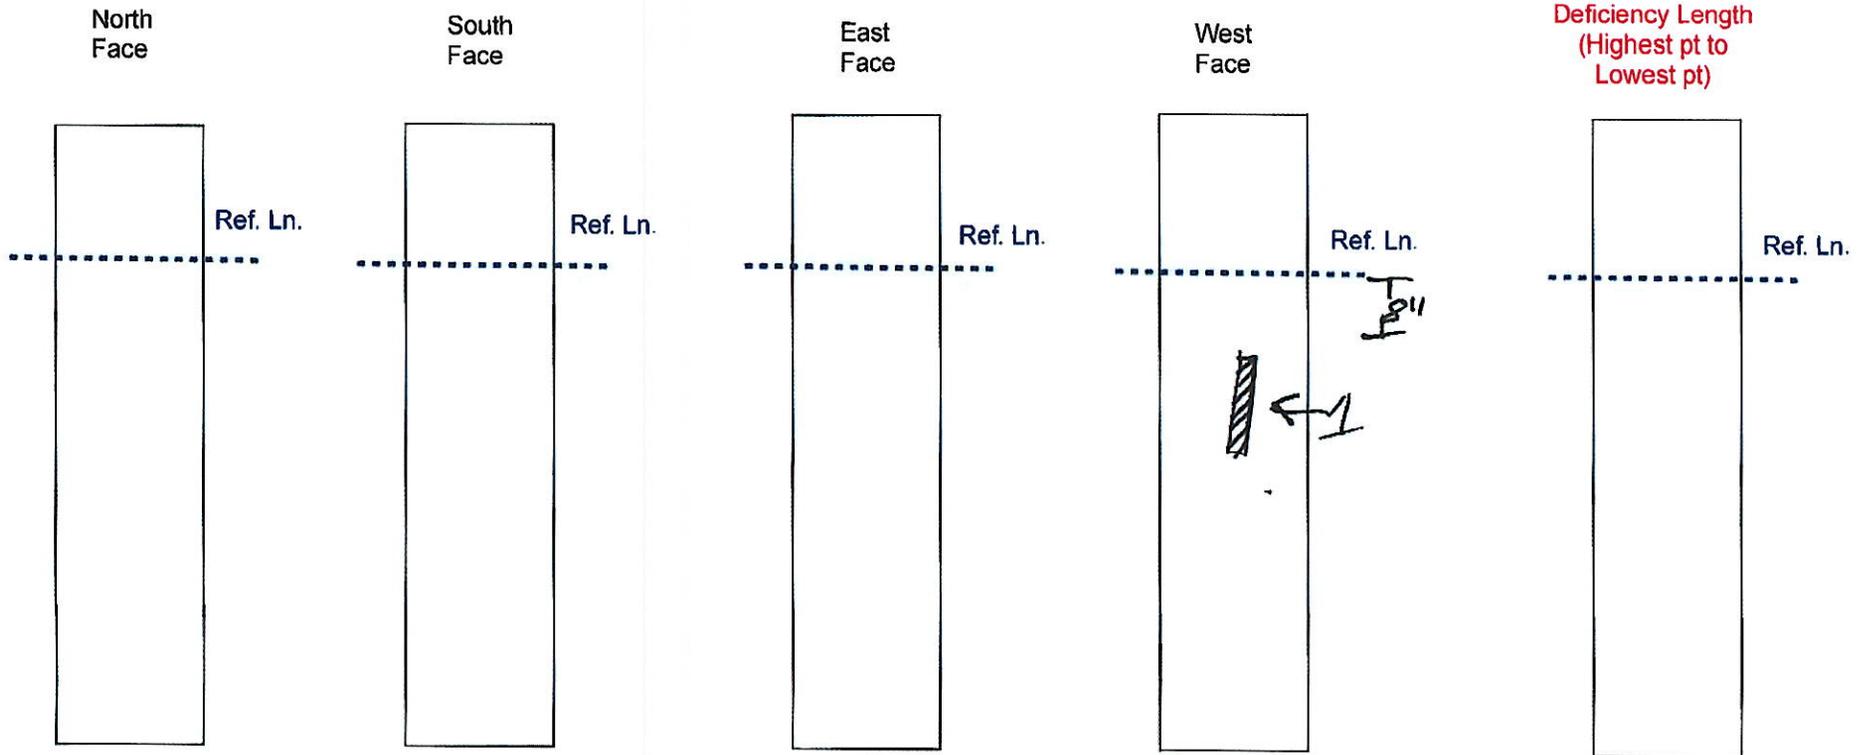
Location #	Type	Distance from Ref. Line	Vert. Length	Width	Depth
1	Rusting	8"	18"	1"	N/A
2	↳ INDICATES CONCRETE COVER IS COMPROMISED, TYPICAL OF SERVICE LIFE				
3					
4					
5					
6					
7					
8					
9					
10

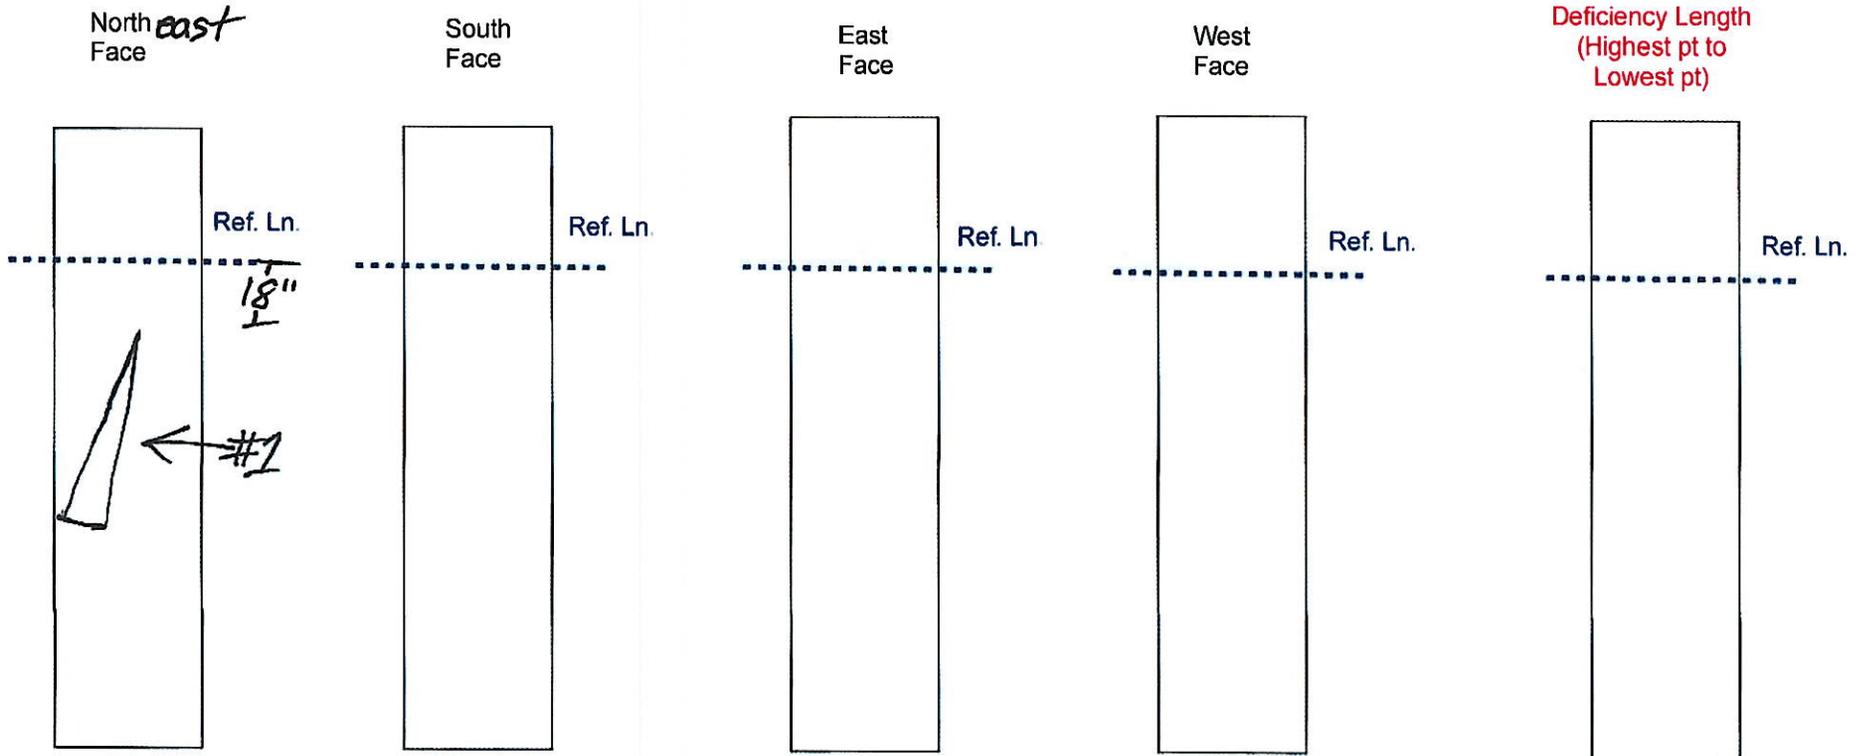
Location #	Type	Distance from Ref. Line	Vert. Length	Width	Depth
1	Spall	18"	42"	3"	1/16" - 1/4"
2					< 3"
3					
4					
5					
6					
7					
8					
9					
10

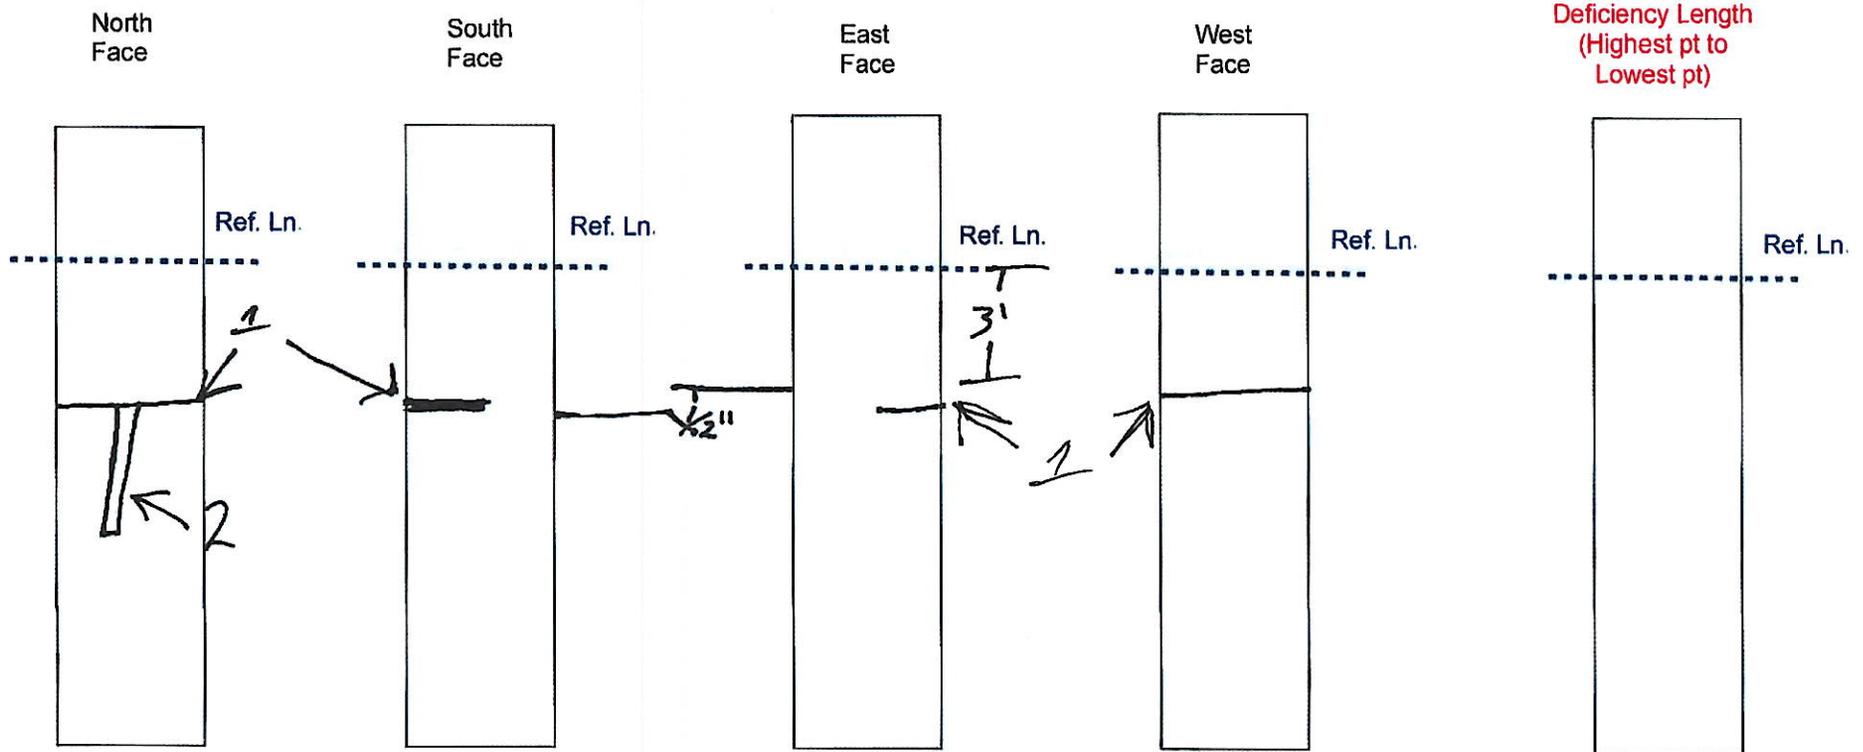
Location #	Type	Distance from Ref. Line	Vert. Length	Width	Depth
1	Crack	36"	1/16" - 1/8"	42"	1/4"
2	Spall	36"	12"	3/4"	1/16" - 1/8"
3					
4					
5					
6					
7					
8					
9					
10

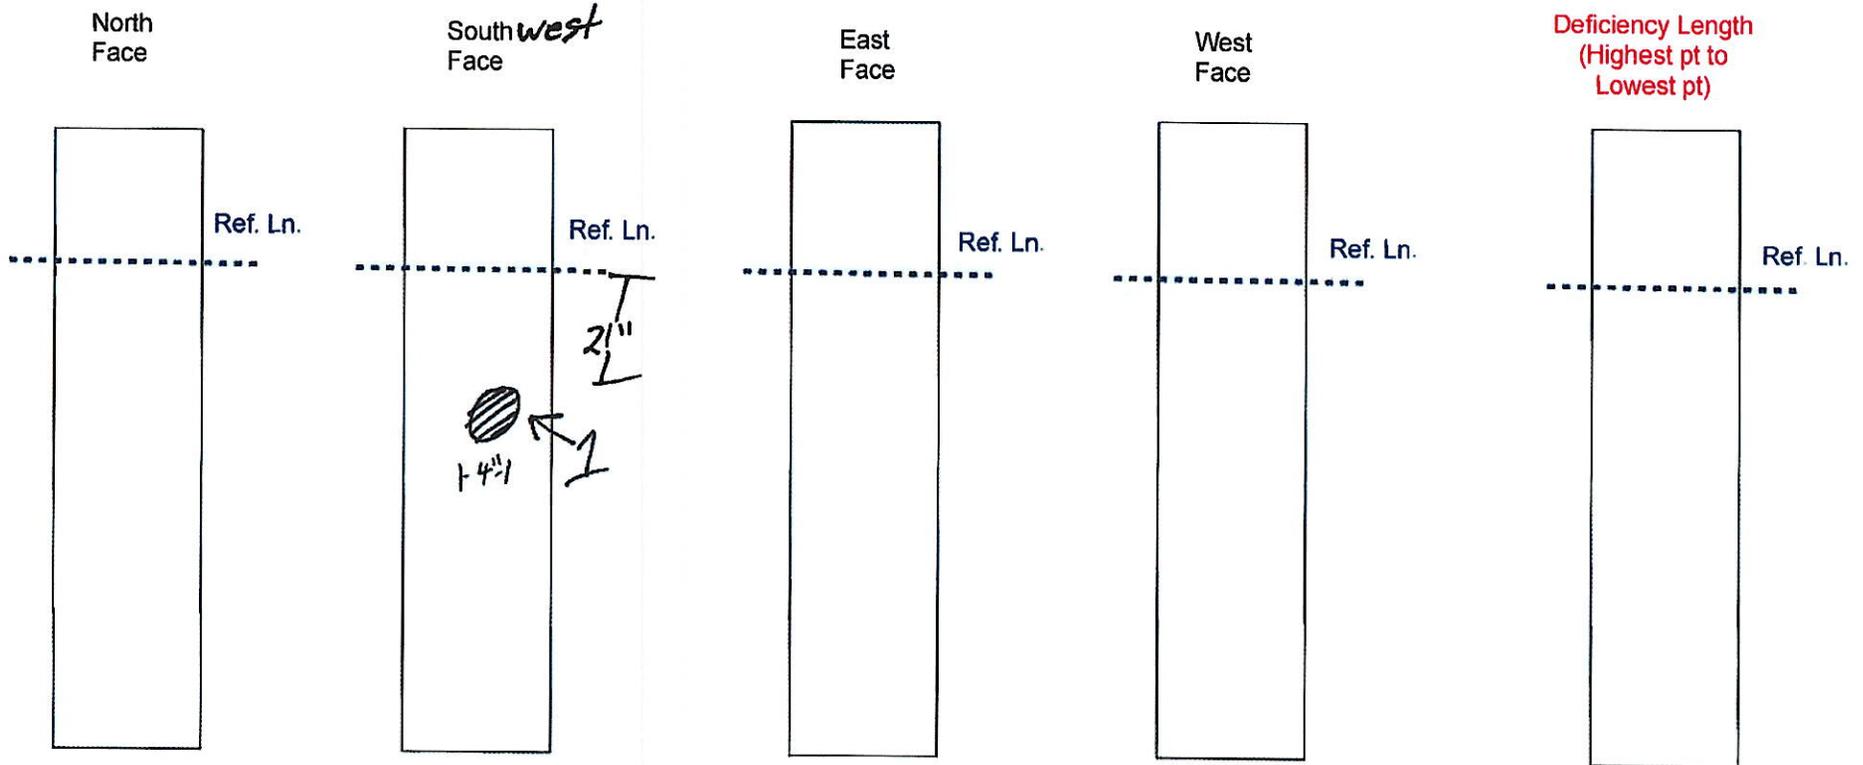
Location #	Type	Distance from Ref. Line	Vert. Length	Width	Depth
1	Bleeding	21"	4"	4"	N/A
2					
3					
4					
5					
6					
7					
8					
9					
10
