Inspection Report

From: Jason P. Ball, PE, SE
Ball Maritime Group, LLC

Date: May 14, 2024

Project: PN 23-1035: Coronado Ferry Landing Level 1 Inspection
Coronado, California

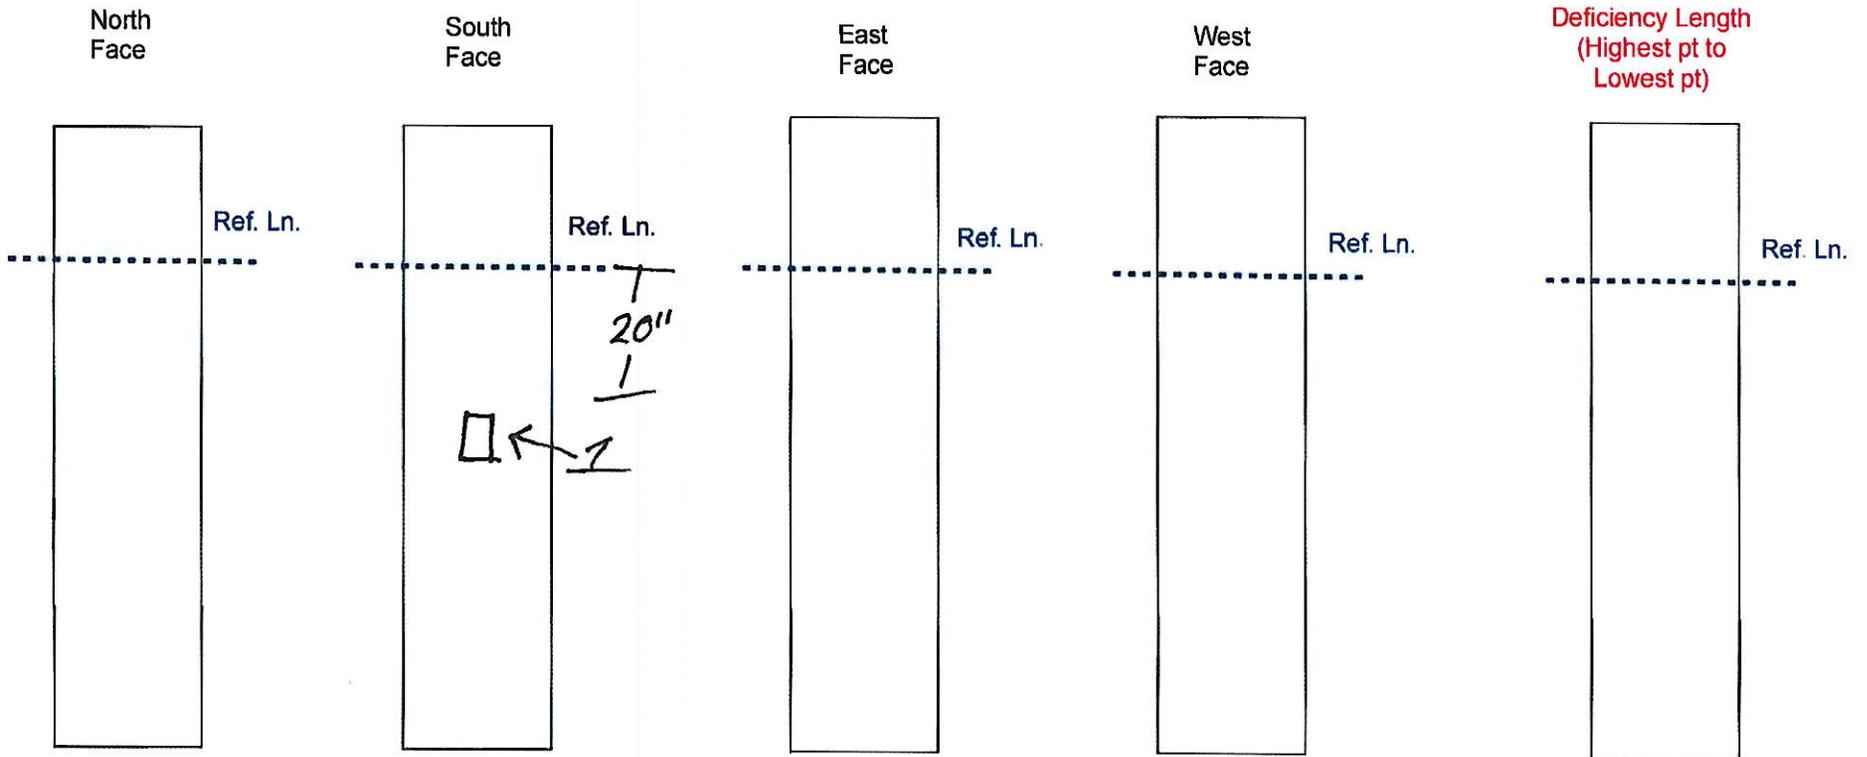
Location #	Type	Distance from Ref. Line	Vert. Length	Width	Depth
1	Bleeding	20"	2"	3"	N/A
2					
3					
4					
5					
6					
7					
8					
9					
10

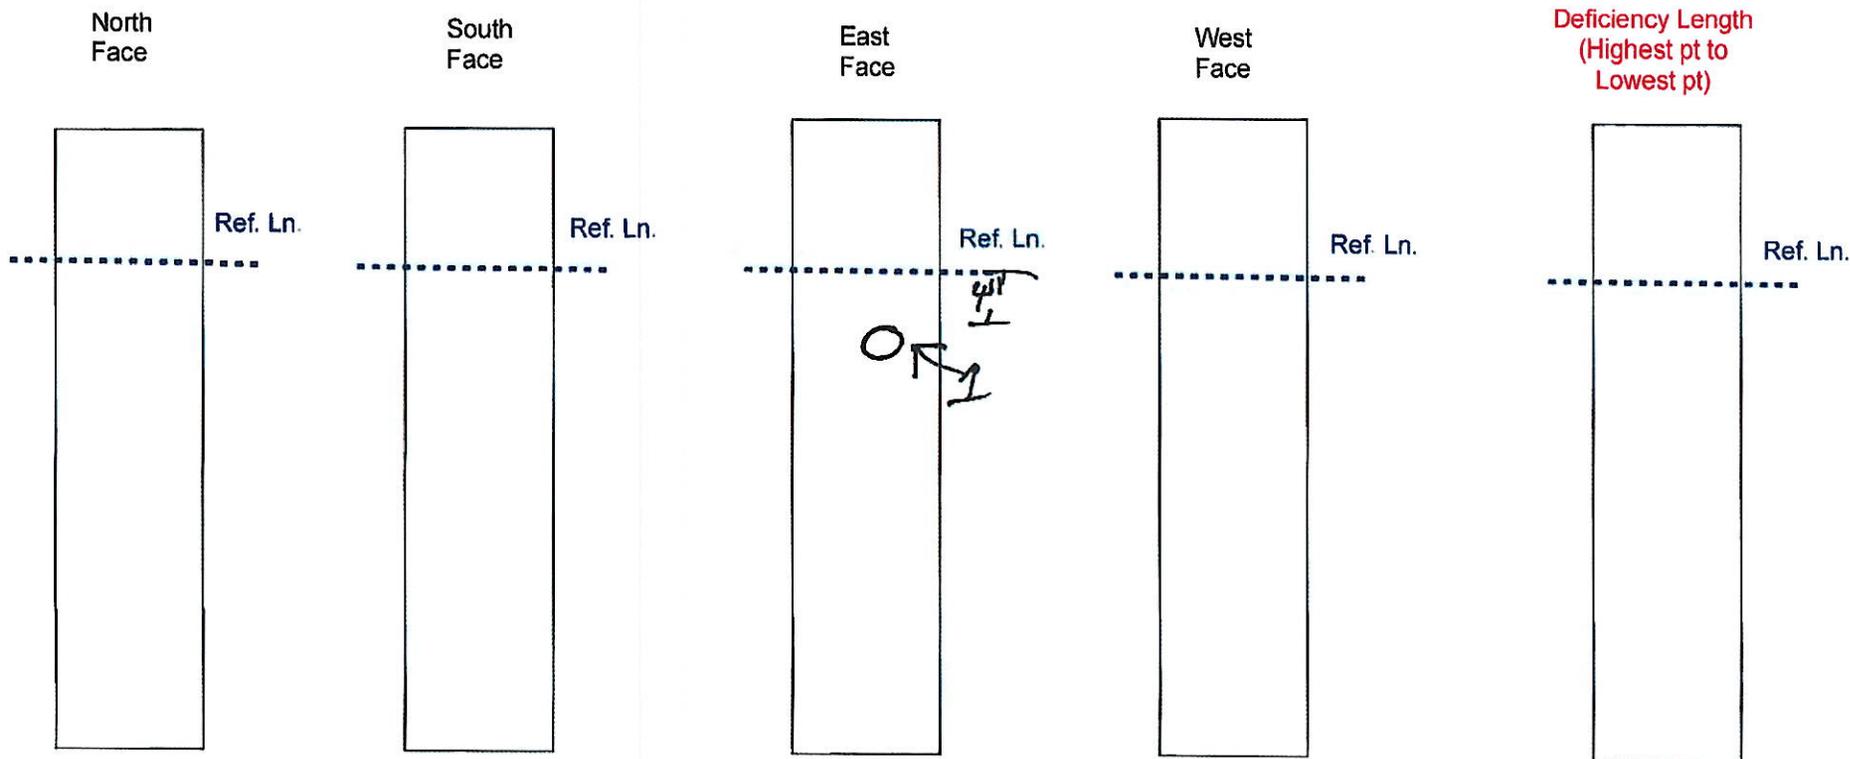
Location #	Type	Distance from Ref. Line	Vert. Length	Width	Depth
1	Bleeding	4"	2"	2"	N/A
2					
3					
4					
5					
6					
7					
8					
9					
10

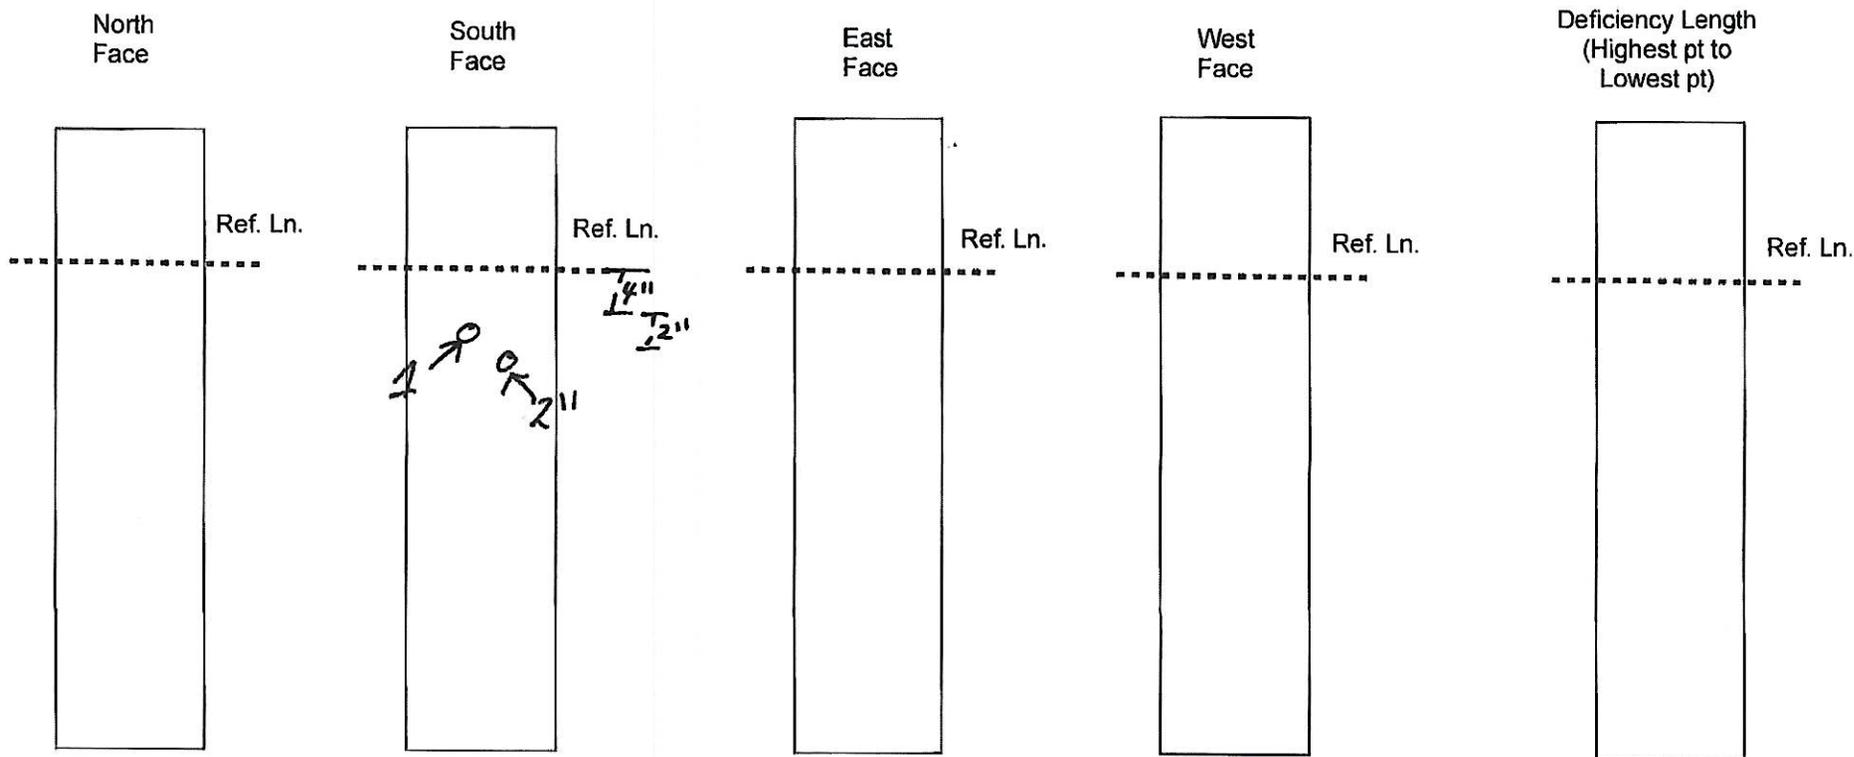
Location #	Type	Distance from Ref. Line	Vert. Length	Width	Depth
1	Bleeding	4"	3/4"	3/4"	N/A
2	Bleeding	6"	3/4"	3/4"	N/A
3					
4					
5					
6					
7					
8					
9					
10

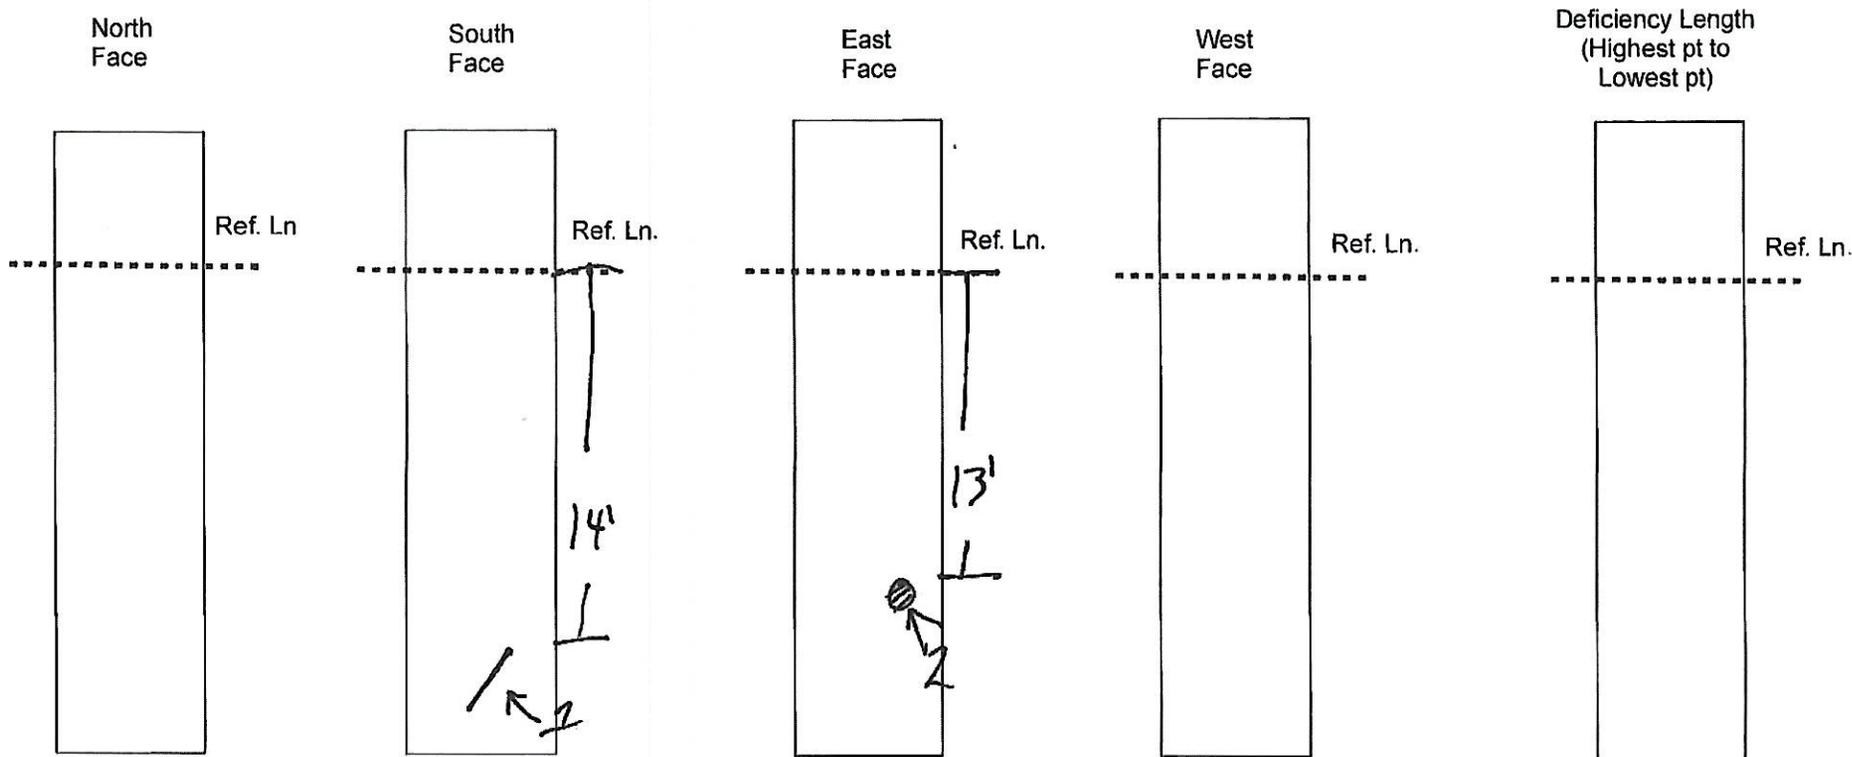
Spall & Crack - Dimensions and locations Table (all measurements in inches)					
Location #	Type	Distance from Ref. Line	Vert. Length	Width	Depth
1	Crack	168"	10"	1/16" - 3/16"	1/4"
2	Bleeding	156"	2"	2"	N/A
3					
4					
5					
6					
7					
8					
9					
10

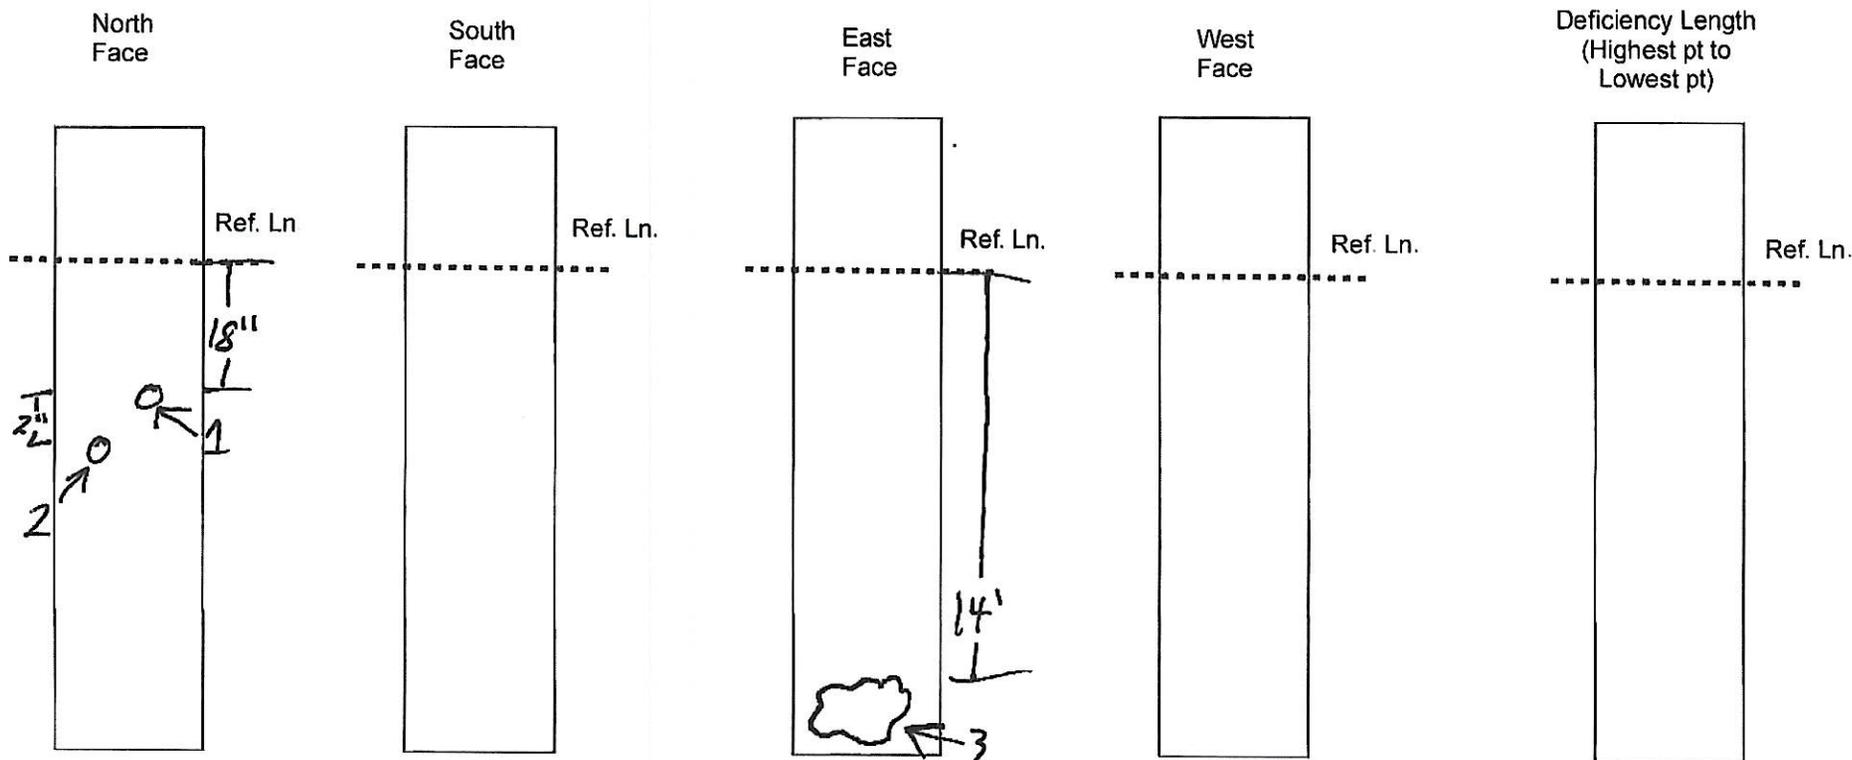
Spall & Crack - Dimensions and locations Table (all measurements in inches)					
Location #	Type	Distance from Ref. Line	Vert. Length	Width	Depth
1	Bleeding	18"	3/4"	3/4"	N/A
2	Bleeding	20"	3/4"	3/4"	N/A
3	Spall	168"	12"	8"	1/4" - 1/8"
4					
5					
6					
7					
8					
9					
10

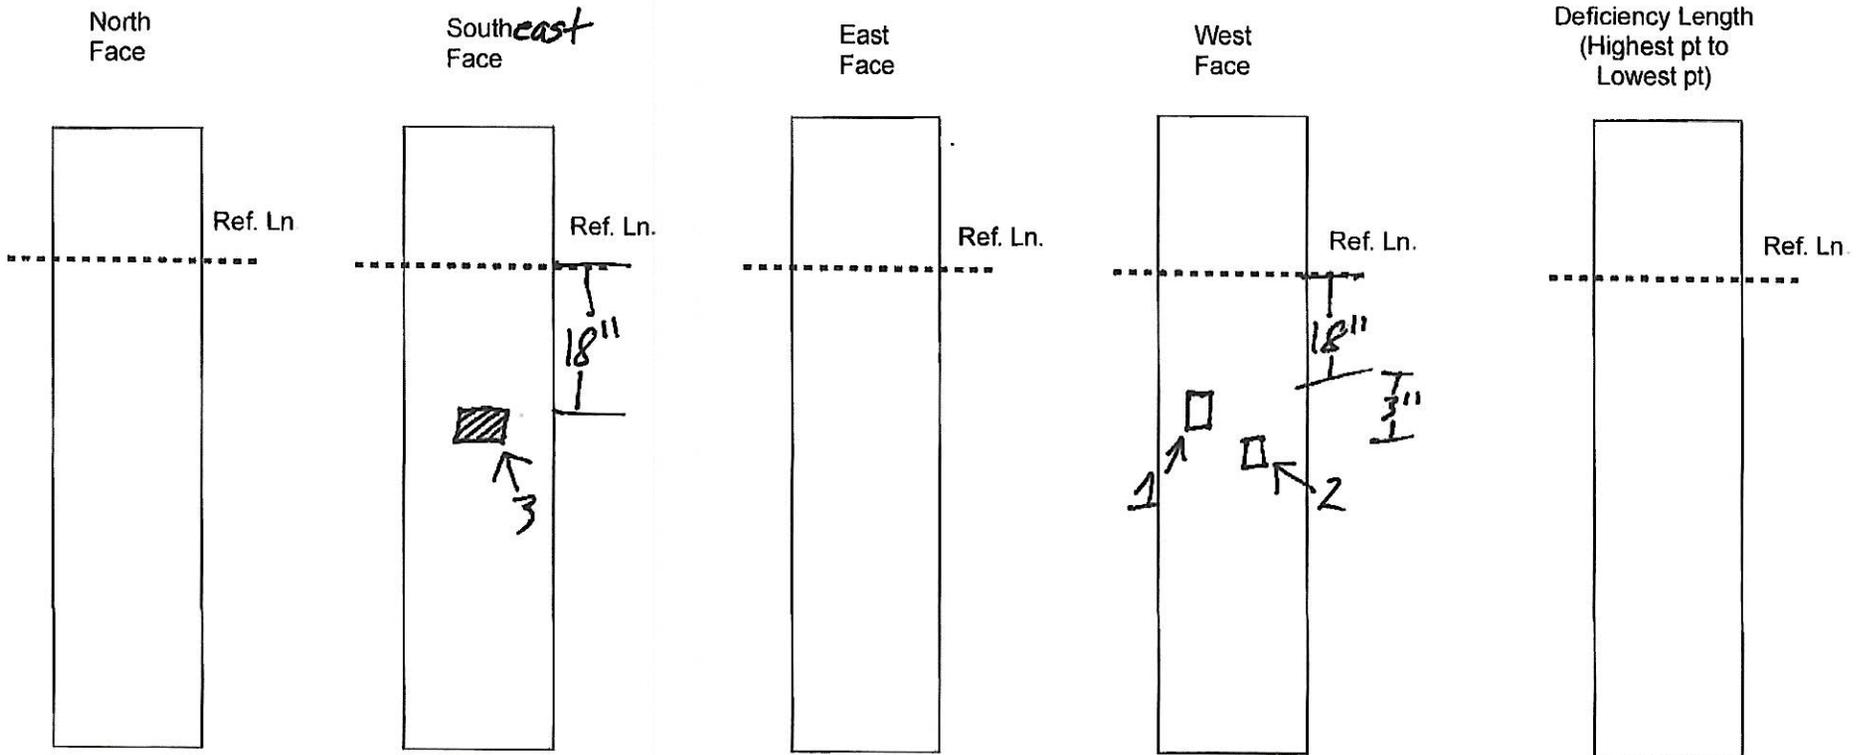
Location #	Type	Distance from Ref. Line	Vert. Length	Width	Depth
1	Spall	18"	1/2"	2"	1/16" - 1/8"
2	Spall	21"	3/4"	3"	1/16" - 1/8"
3	Bleeding	18"	2"	3"	N/A
4					
5					
6					
7					
8					
9					
10

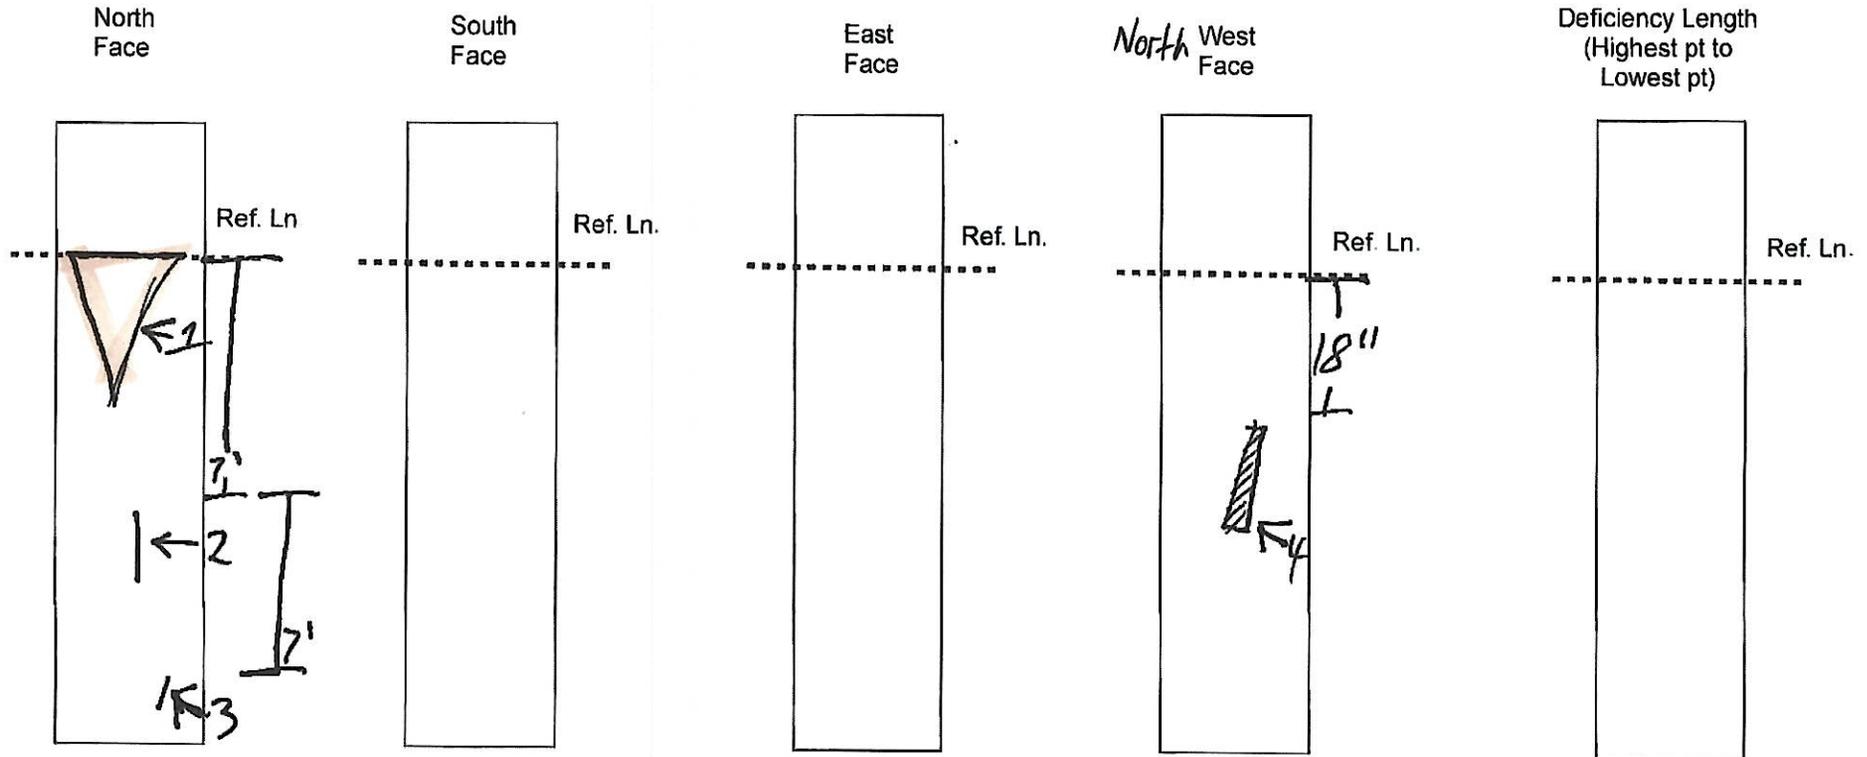
Location #	Type	Distance from Ref. Line	Vert. Length	Width	Depth
1	Delam.	0"	30"	9"	+1"
2	Crack	84"	12"	1"	1/16" - 3/8"
3	Crack	168"	4"	1/2"	1/16" - 3/8"
4	Bleeding	18"	18"	1"	N/A
5					
6					
7					
8					
9					
10

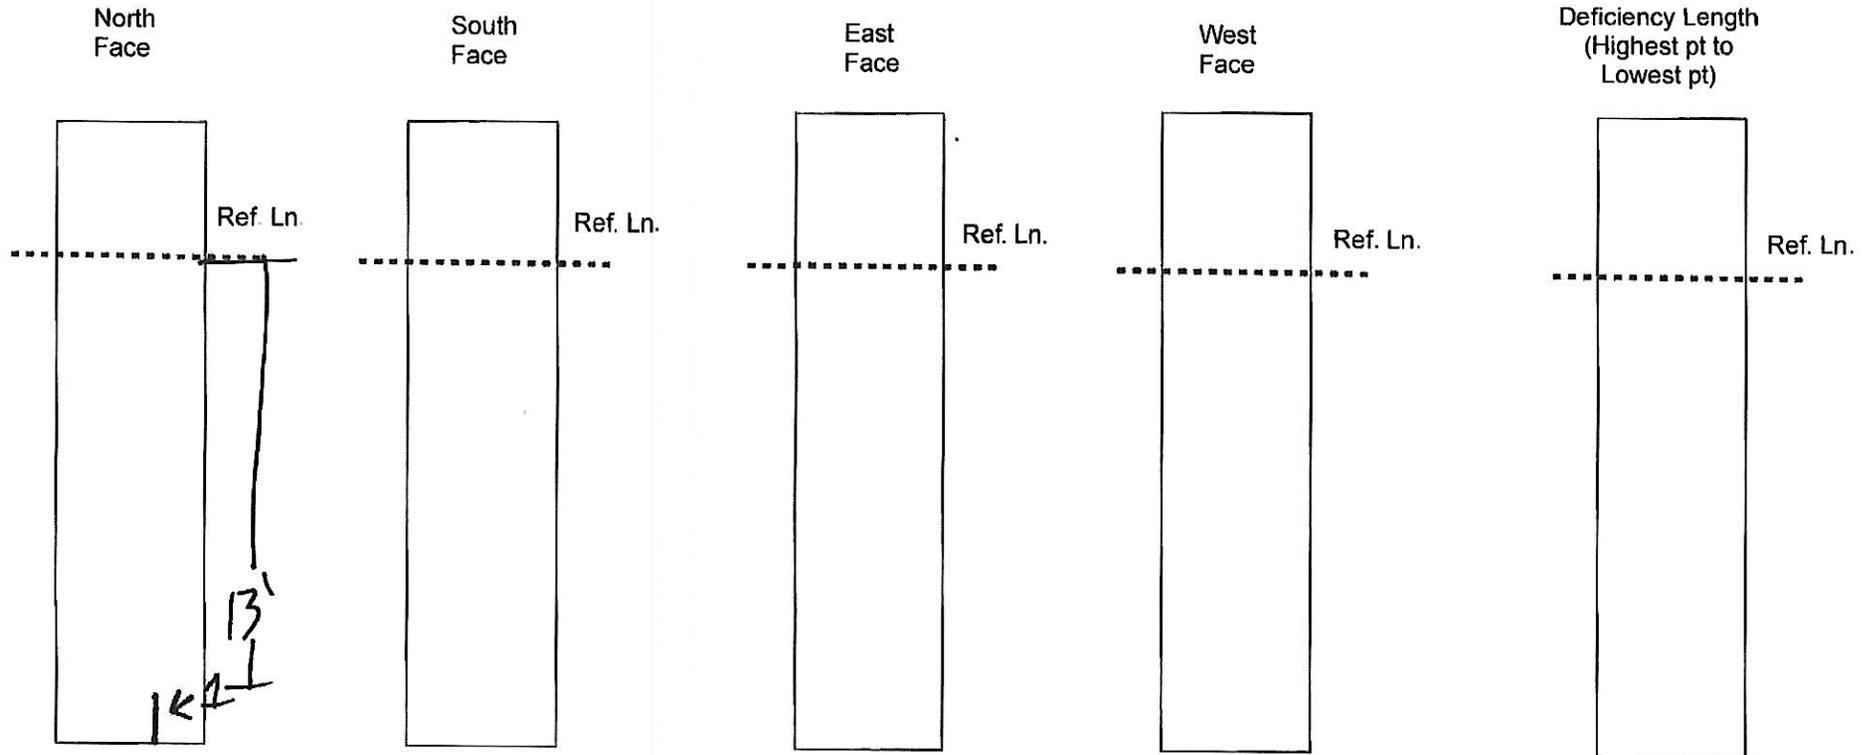
Location #	Type	Distance from Ref. Line	Vert. Length	Width	Depth
1	Crack	13'	12"	1"	1/16" - 1/4"
2					
3					
4					
5					
6					
7					
8					
9					
10

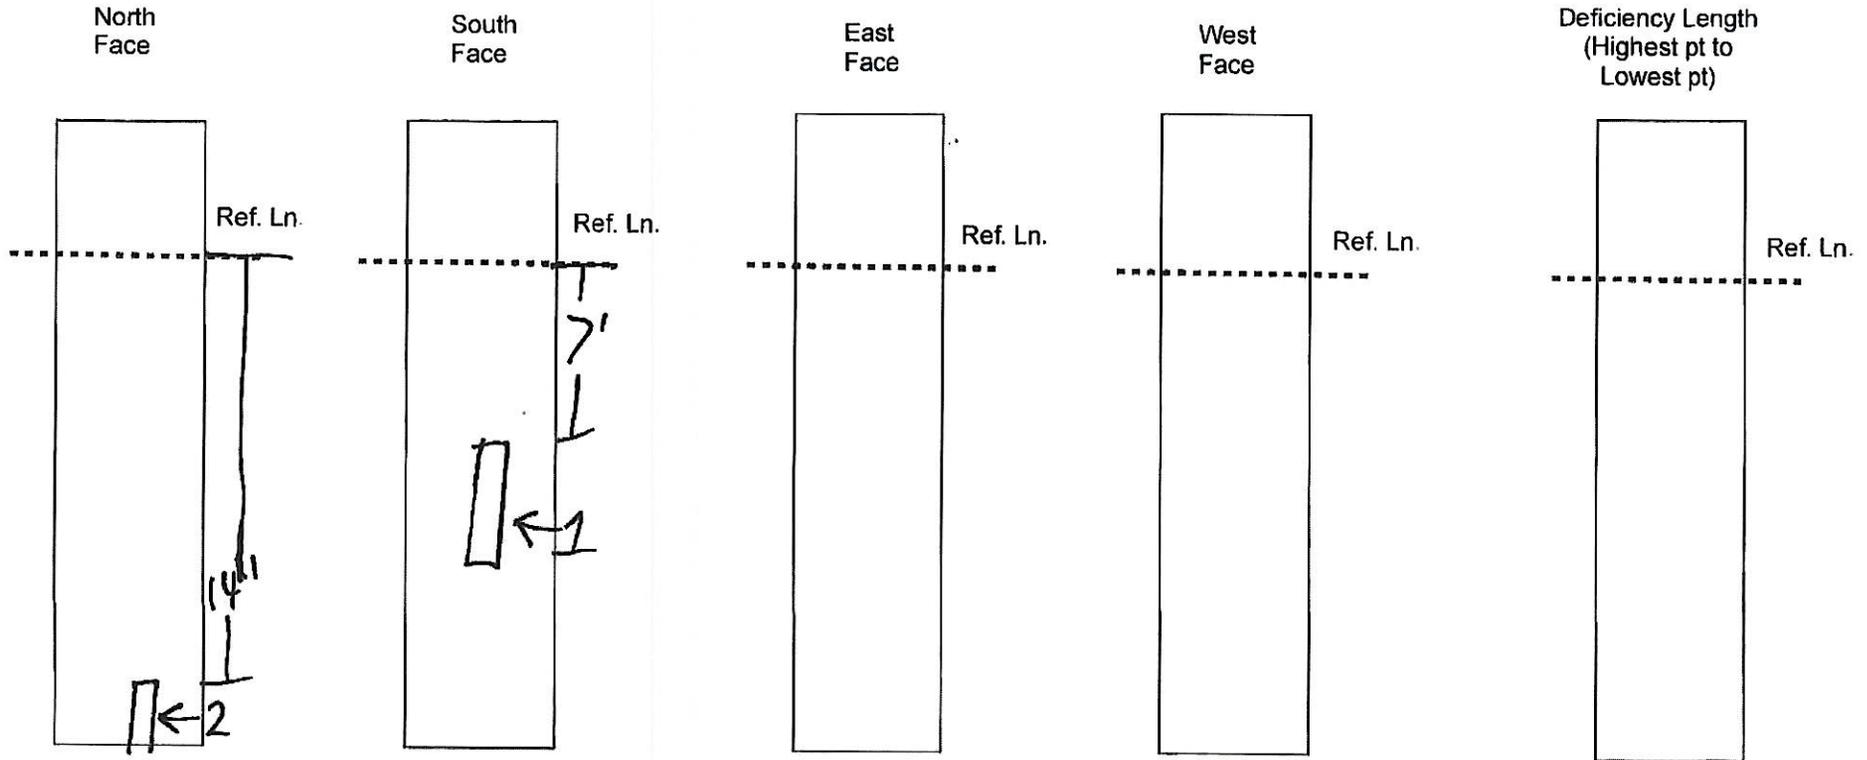
Spall & Crack - Dimensions and locations Table (all measurements in inches)					
Location #	Type	Distance from Ref. Line	Vert. Length	Width	Depth
1	Spall	84"	12"	3/4"	1/6" - 1/4"
2	Spall	168"	12"	1/2"	1/6" - 1/2"
3					
4					
5					
6					
7					
8					
9					
10

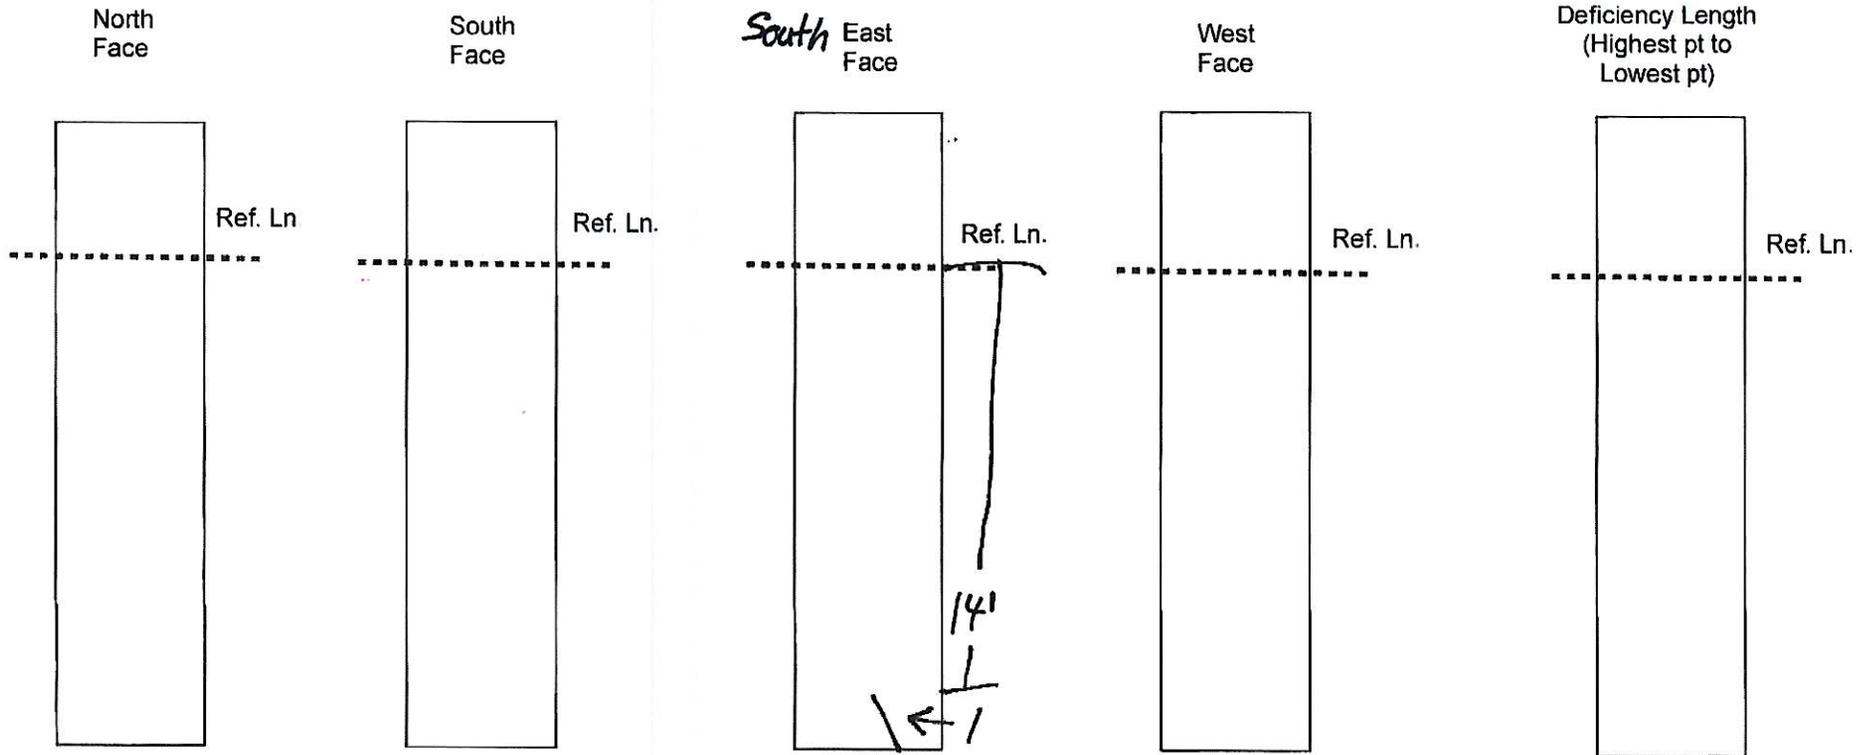
Spall & Crack - Dimensions and locations Table (all measurements in inches)					
Location #	Type	Distance from Ref. Line	Vert. Length	Width	Depth
1	Cracks	168"	11"	3/4"	1/6" - 1/2"
2					
3					
4					
5					
6					
7					
8					
9					
10

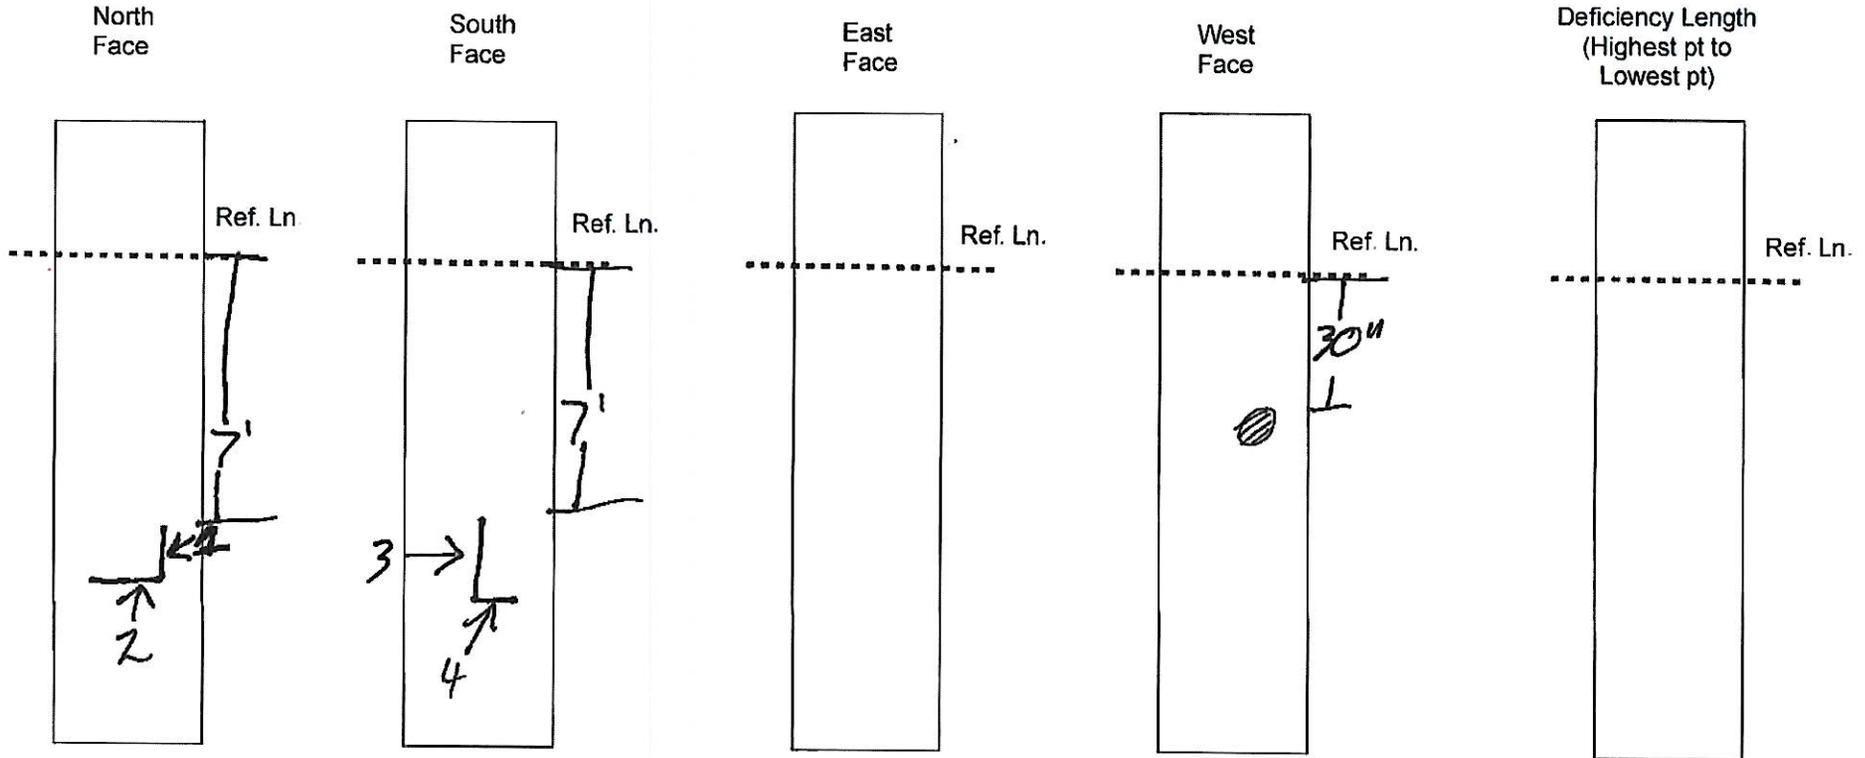
Spall & Crack - Dimensions and locations Table (all measurements in inches)					
Location #	Type	Distance from Ref. Line	Vert. Length	Width	Depth
1	Crack	84"	4"	12 1/2"	1/2"
2	Crack	84"	6"	1/8"	1/8"
3	Crack	84"	12"	3/4"	1/4"
4	Crack	84"	5"	1/8"	1/16"
5					
6					
7					
8					
9					
10

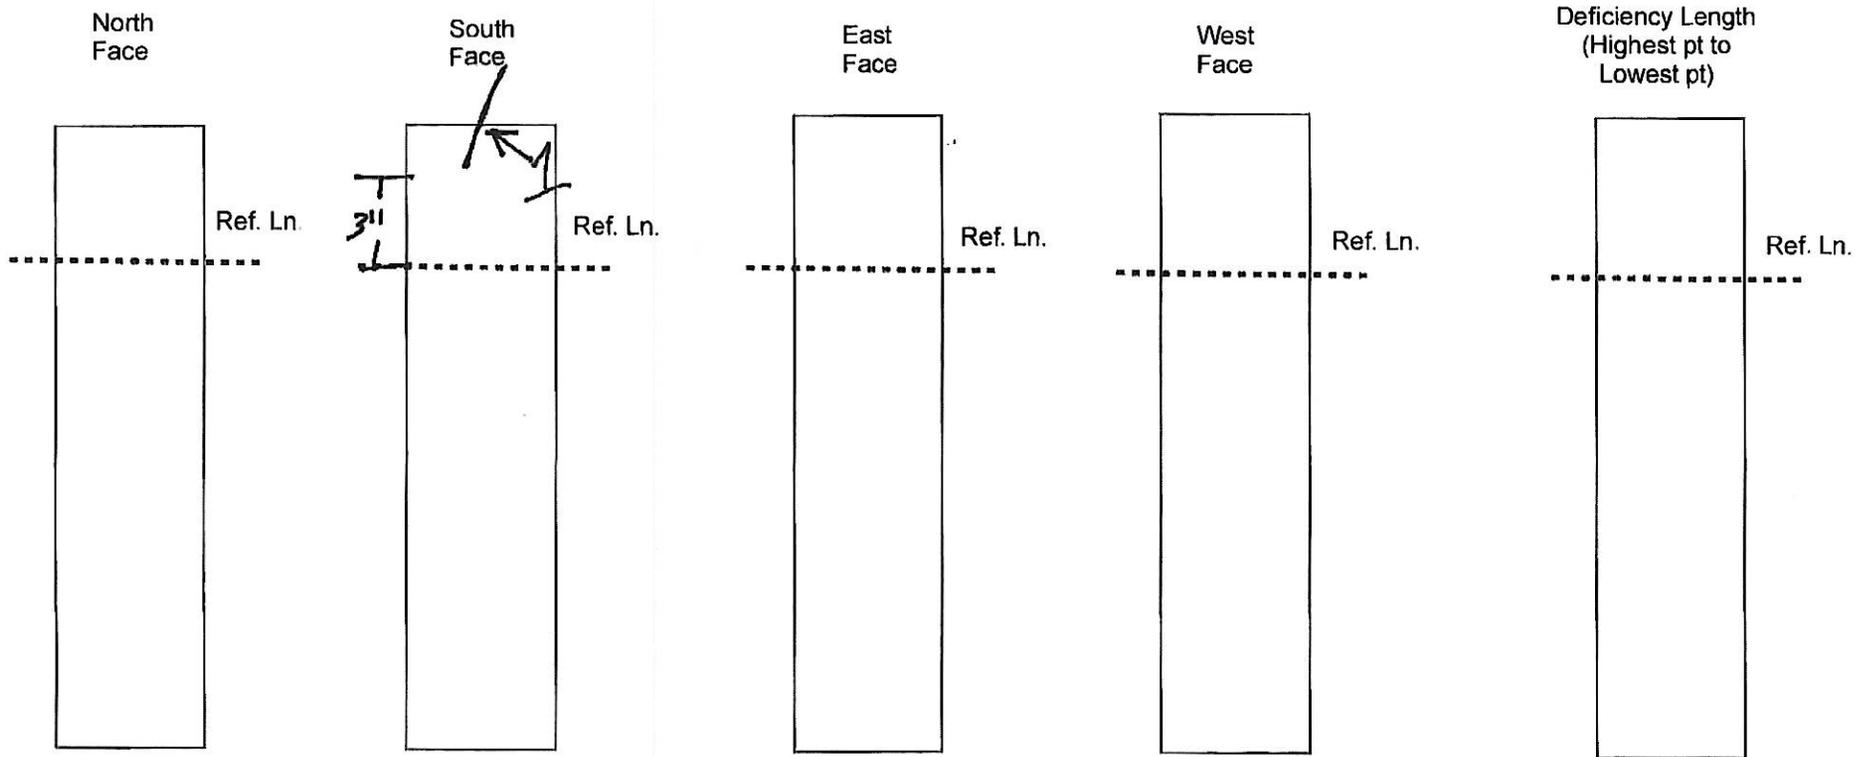
Location #	Type	Distance from Ref. Line	Vert. Length	Width	Depth
1	Crack	3"	12"	1/2"	1/16" - 1/8"
2					
3					
4					
5					
6					
7					
8					
9					
10

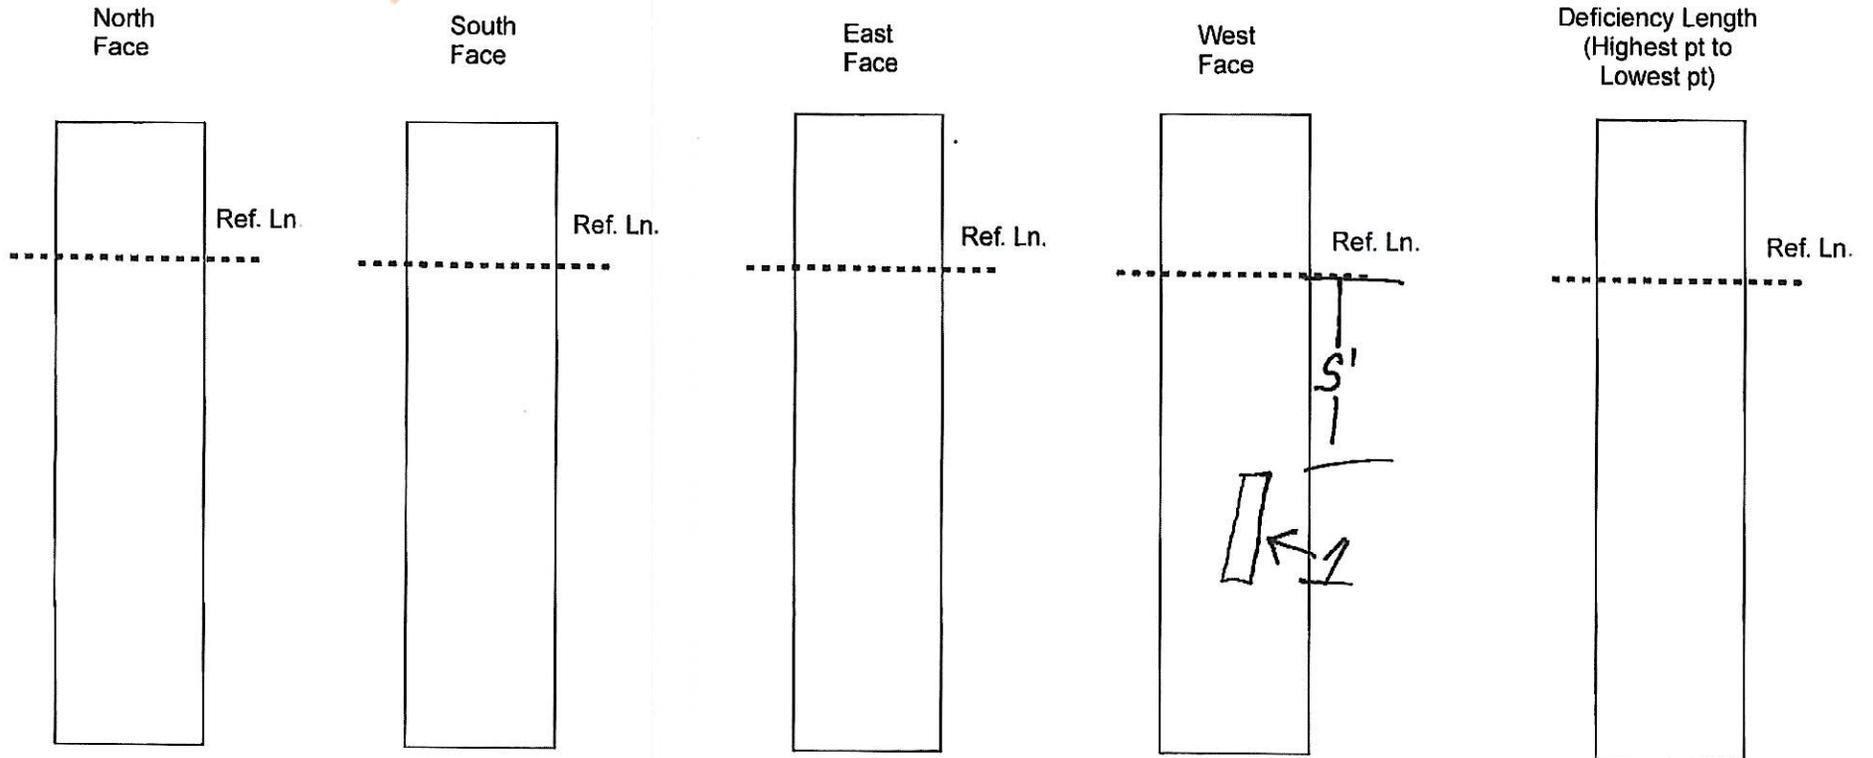
Spall & Crack - Dimensions and locations Table (all measurements in inches)					
Location #	Type	Distance from Ref. Line	Vert. Length	Width	Depth
1	Spall	60"	12"	1/2"	1/16" - 1/8"
2					
3					
4					
5					
6					
7					
8					
9					
10

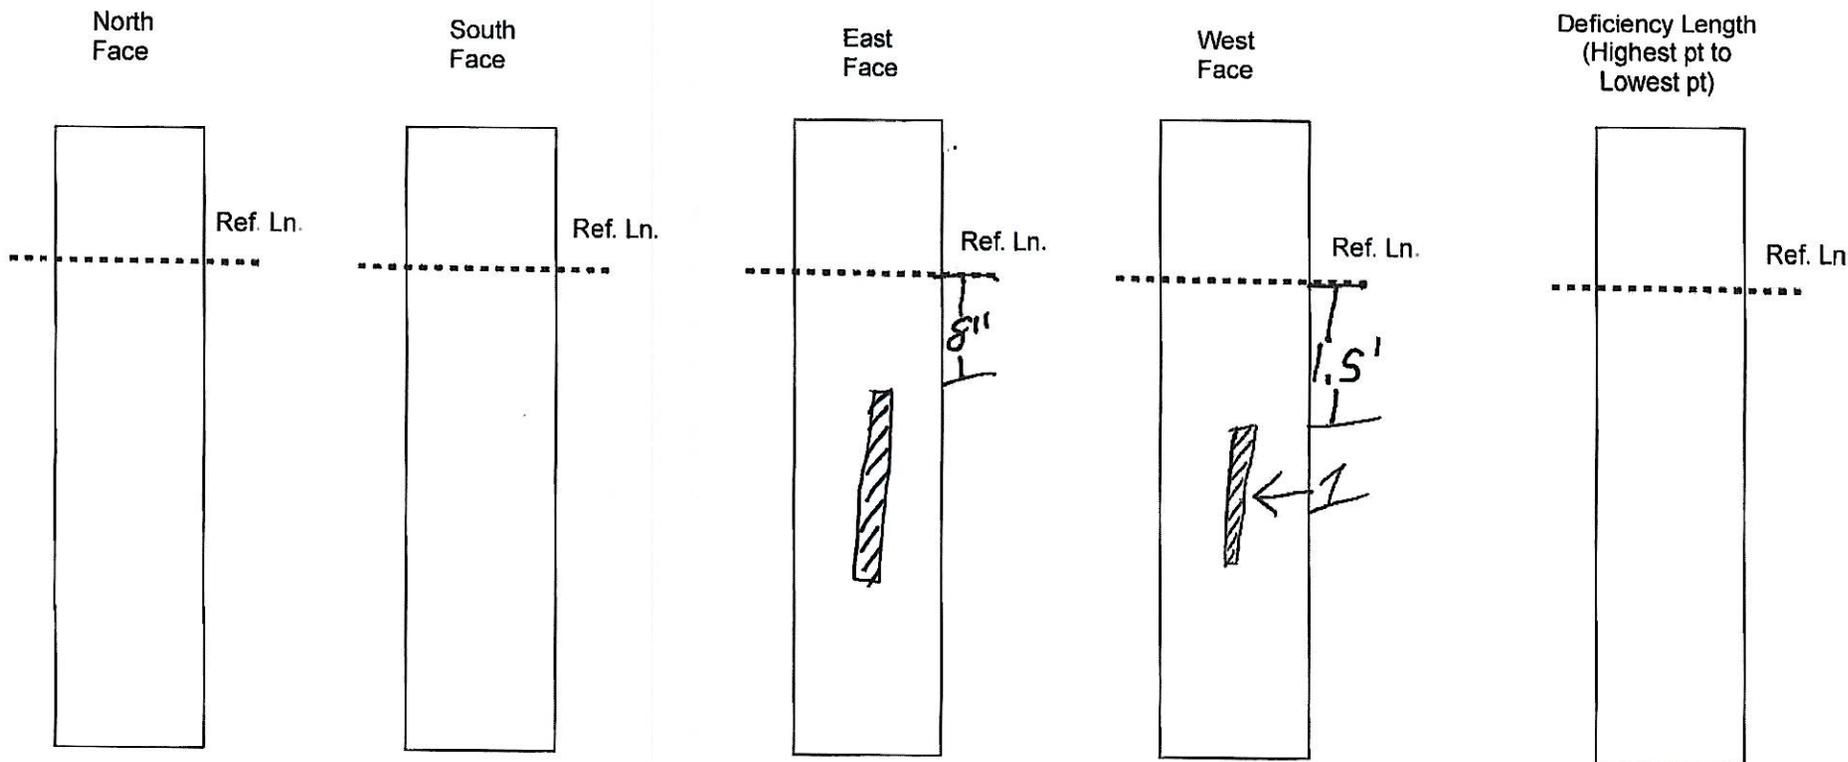
Location #	Type	Distance from Ref. Line	Vert. Length	Width	Depth
1	Bleeding	18"	16"	1"	N/A
2	Bleeding	8"	36"	1"	N/A
3					
4					
5					
6					
7					
8					
9					
10

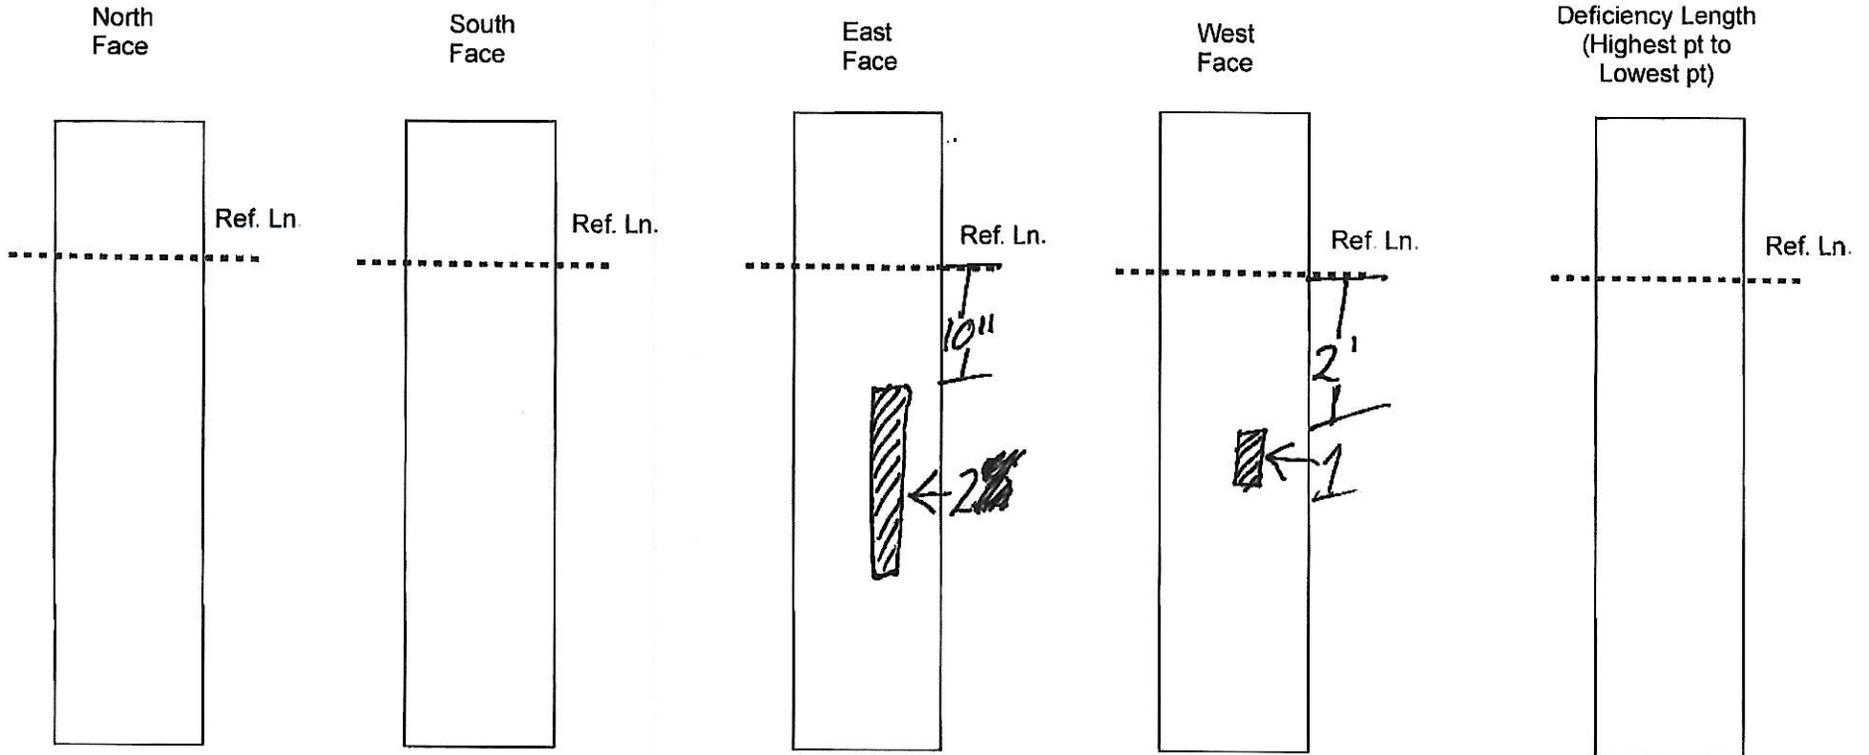
Spall & Crack - Dimensions and locations Table (all measurements in inches)					
Location #	Type	Distance from Ref. Line	Vert. Length	Width	Depth
1	Bleeding	24"	3"	1"	N/A
2	Bleeding	10"	30"	1"	N/A
3					
4					
5					
6					
7					
8					
9					
10
