Inspection Report

From: Jason P. Ball, PE, SE
Ball Maritime Group, LLC

Date: May 14, 2024

Project: PN 23-1035: Coronado Ferry Landing Level 1 Inspection
Coronado, California

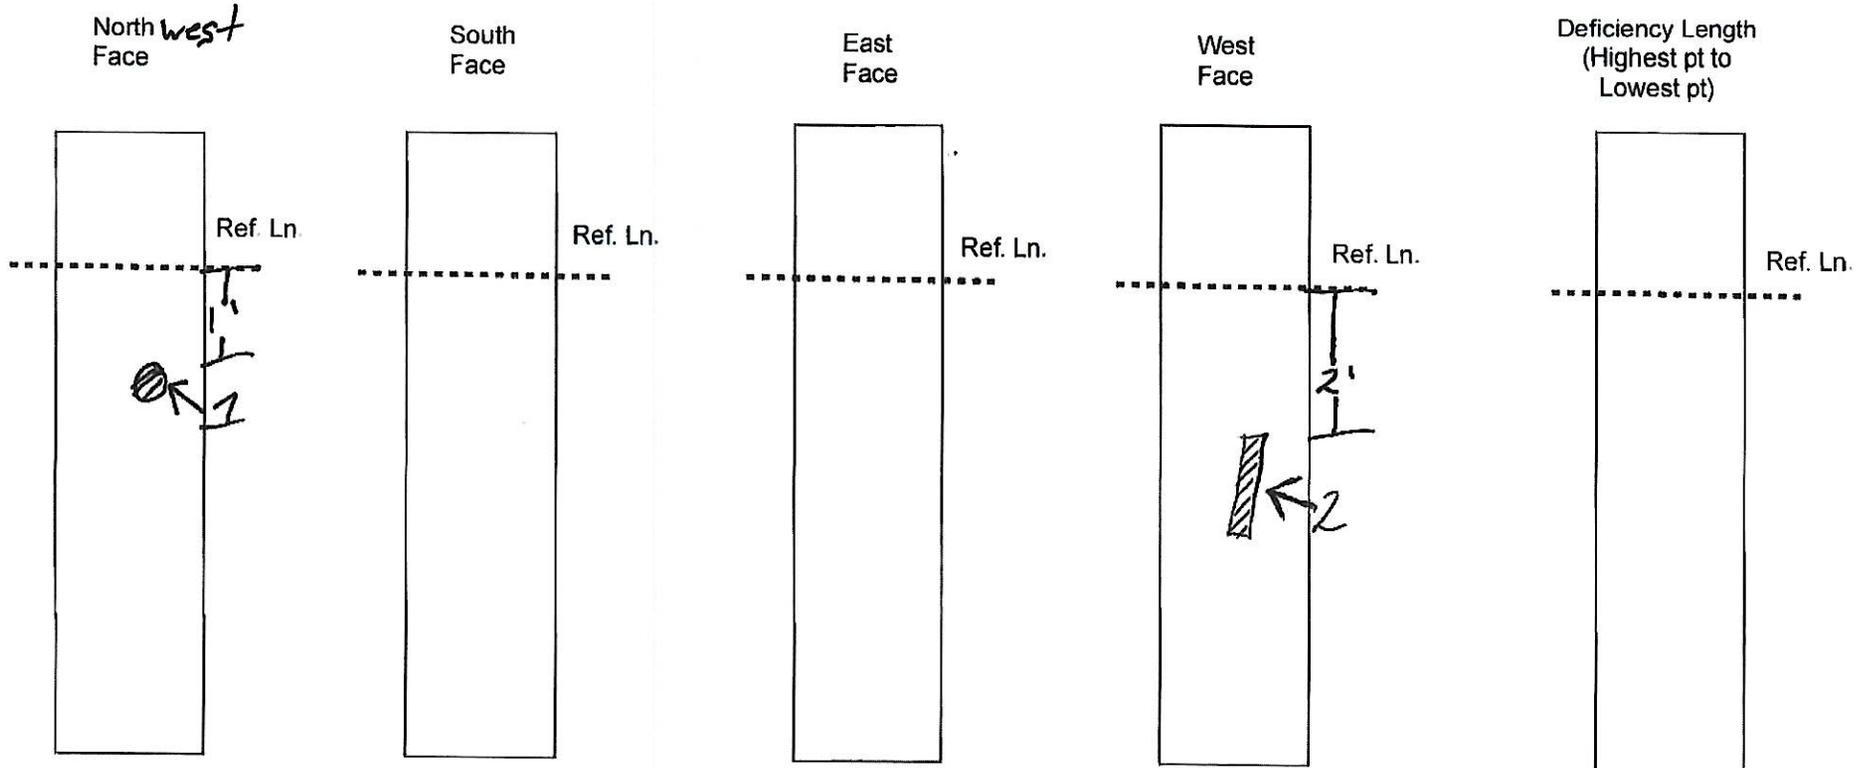
Spall & Crack - Dimensions and locations Table (all measurements in inches)					
Location #	Type	Distance from Ref. Line	Vert. Length	Width	Depth
1	Metal	12"	2"	2"	N/A
2	Bleeding	24"	12"	1"	N/A
3					
4					
5					
6					
7					
8					
9					
10

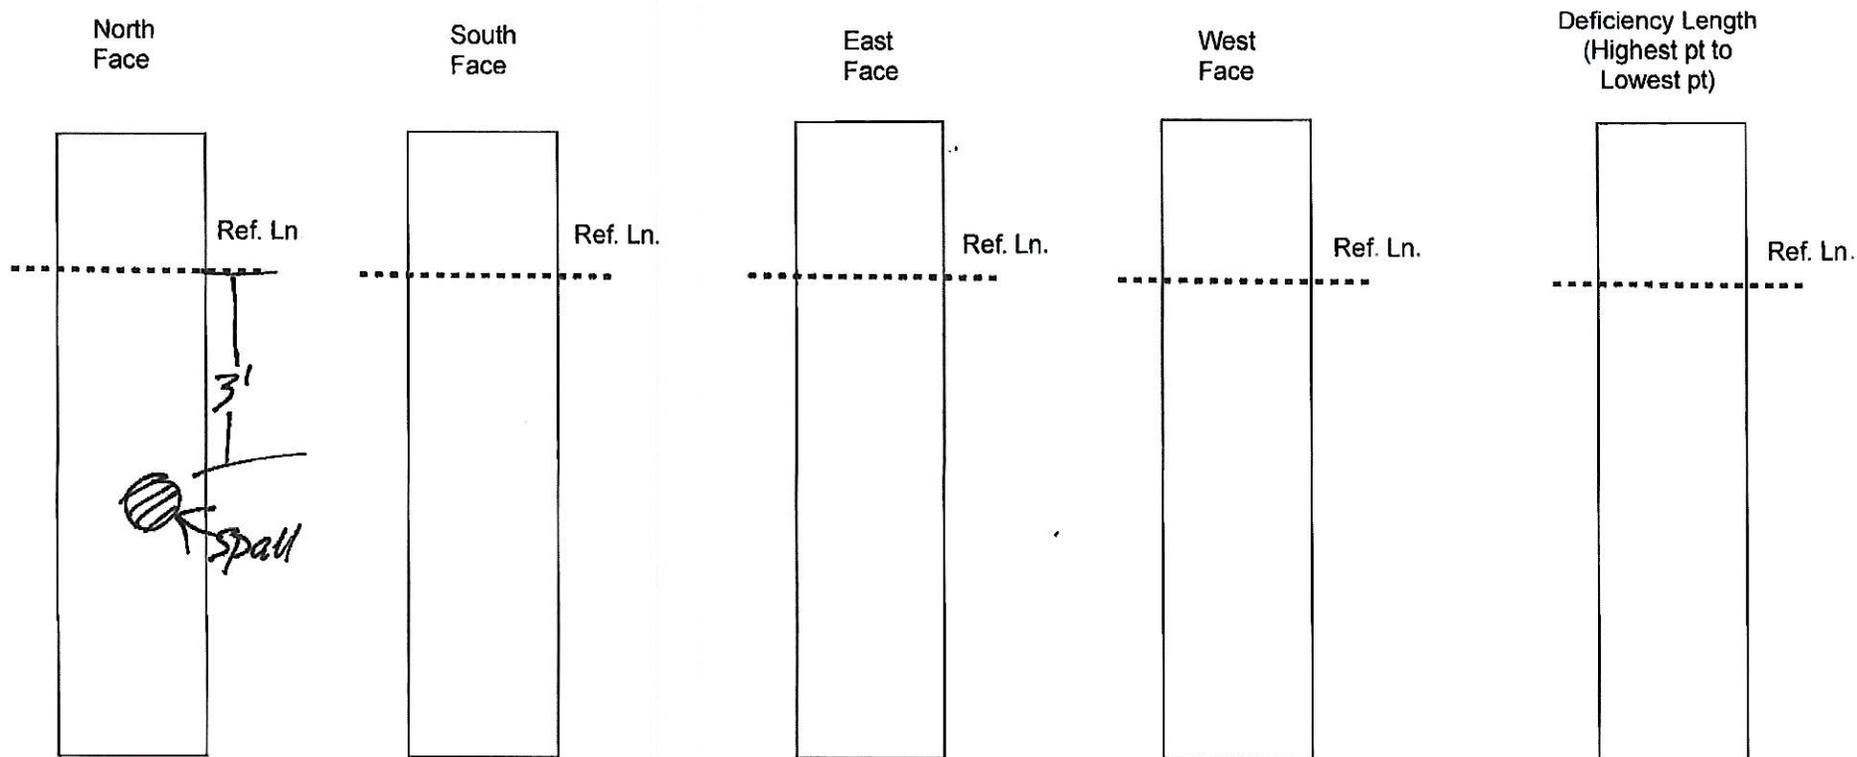
Bent #	15
Pile #	6

Spall & Crack - Dimensions and locations Table (all measurements in inches)					
Location #	Type	Distance from Ref. Line	Vert. Length	Width	Depth
1	Spall	36"	4"	4"	1/16" - 1/8"
2					
3					
4					
5					
6					
7					
8					
9					
10

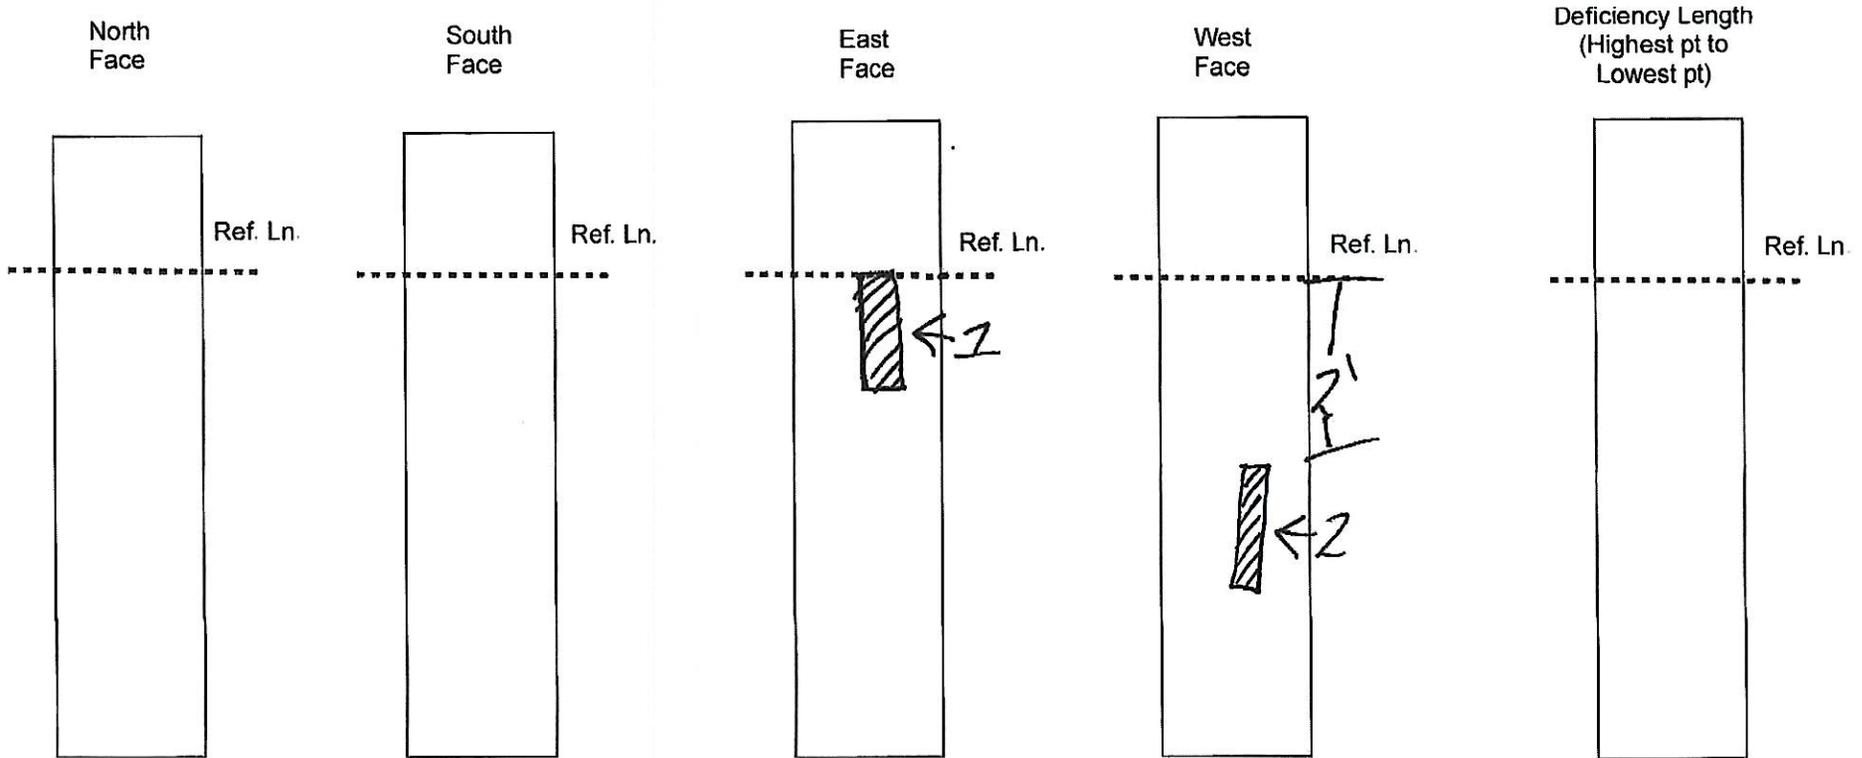
Location #	Type	Distance from Ref. Line	Vert. Length	Width	Depth
1	Bleeding	0"	18"	3"	N/A
2	Bleeding	24"	15"	1"	N/A
3					
4					
5					
6					
7					
8					
9					
10

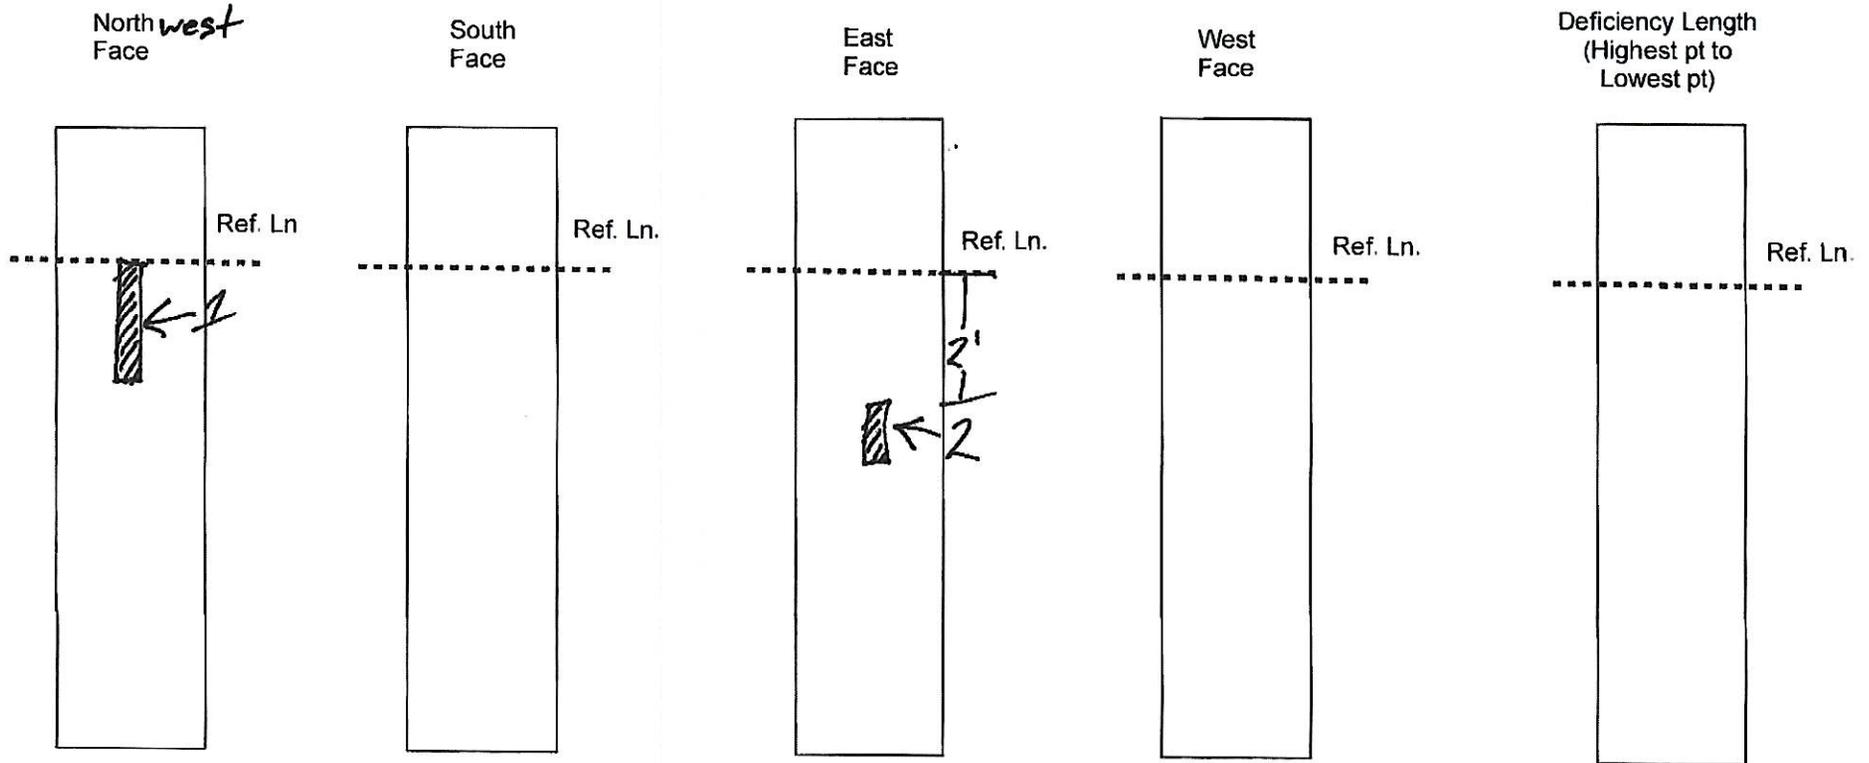
Location #	Type	Distance from Ref. Line	Vert. Length	Width	Depth
1	Bleeding	0"	24"	1/2"	N/A
2	Bleeding	24"	4"	1"	N/A
3					
4					
5					
6					
7					
8					
9					
10

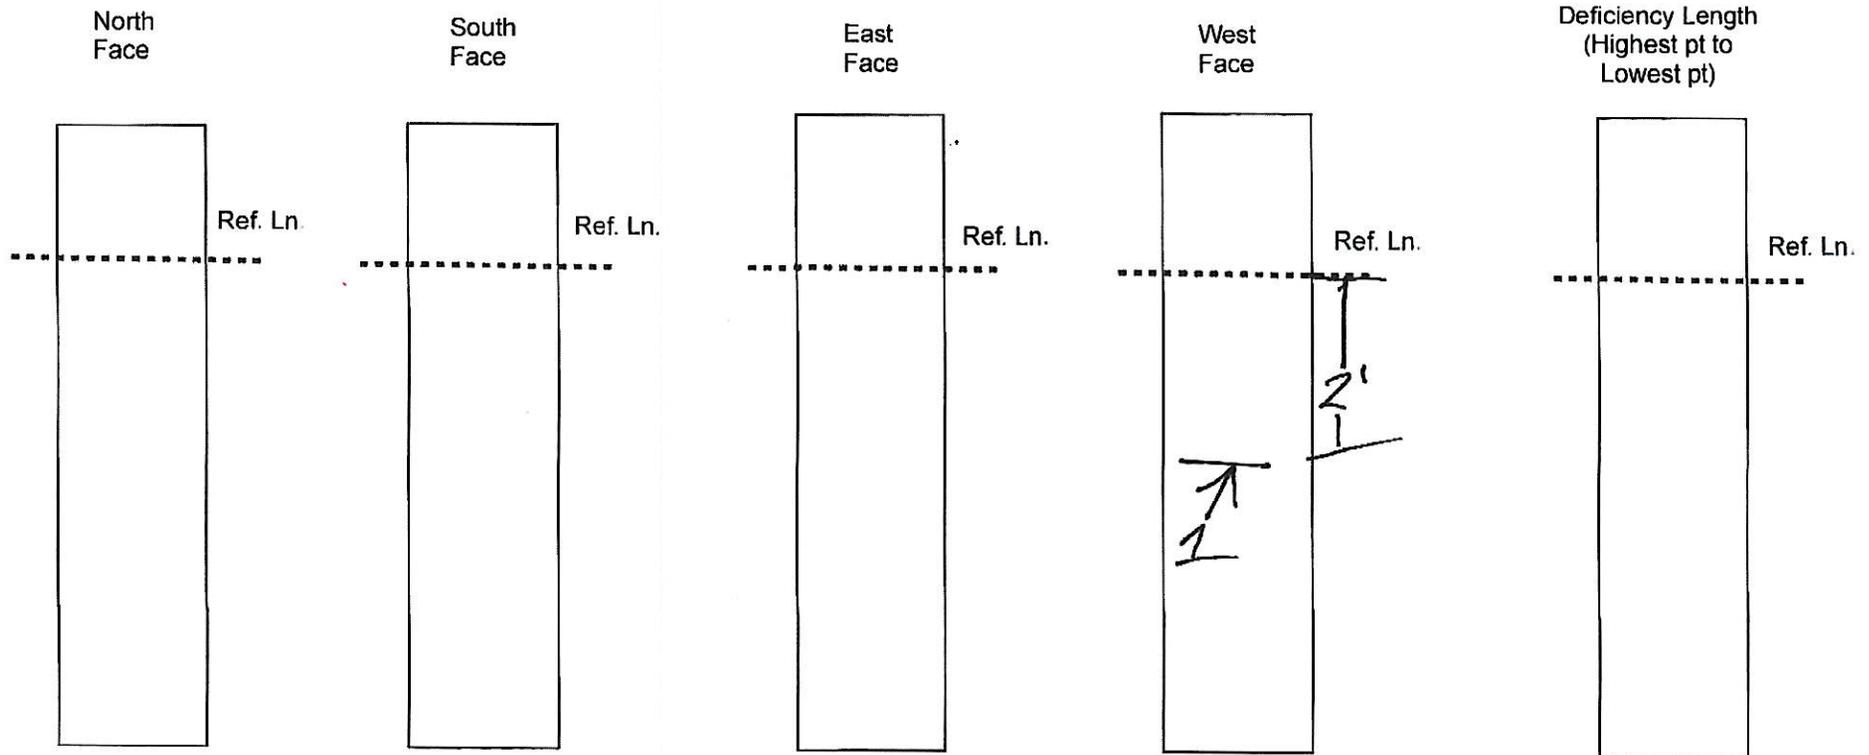
Spall & Crack - Dimensions and locations Table (all measurements in inches)					
Location #	Type	Distance from Ref. Line	Vert. Length	Width	Depth
1	Crack	24"	1/2"	8"	1/16"
2					
3					
4					
5					
6					
7					
8					
9					
10

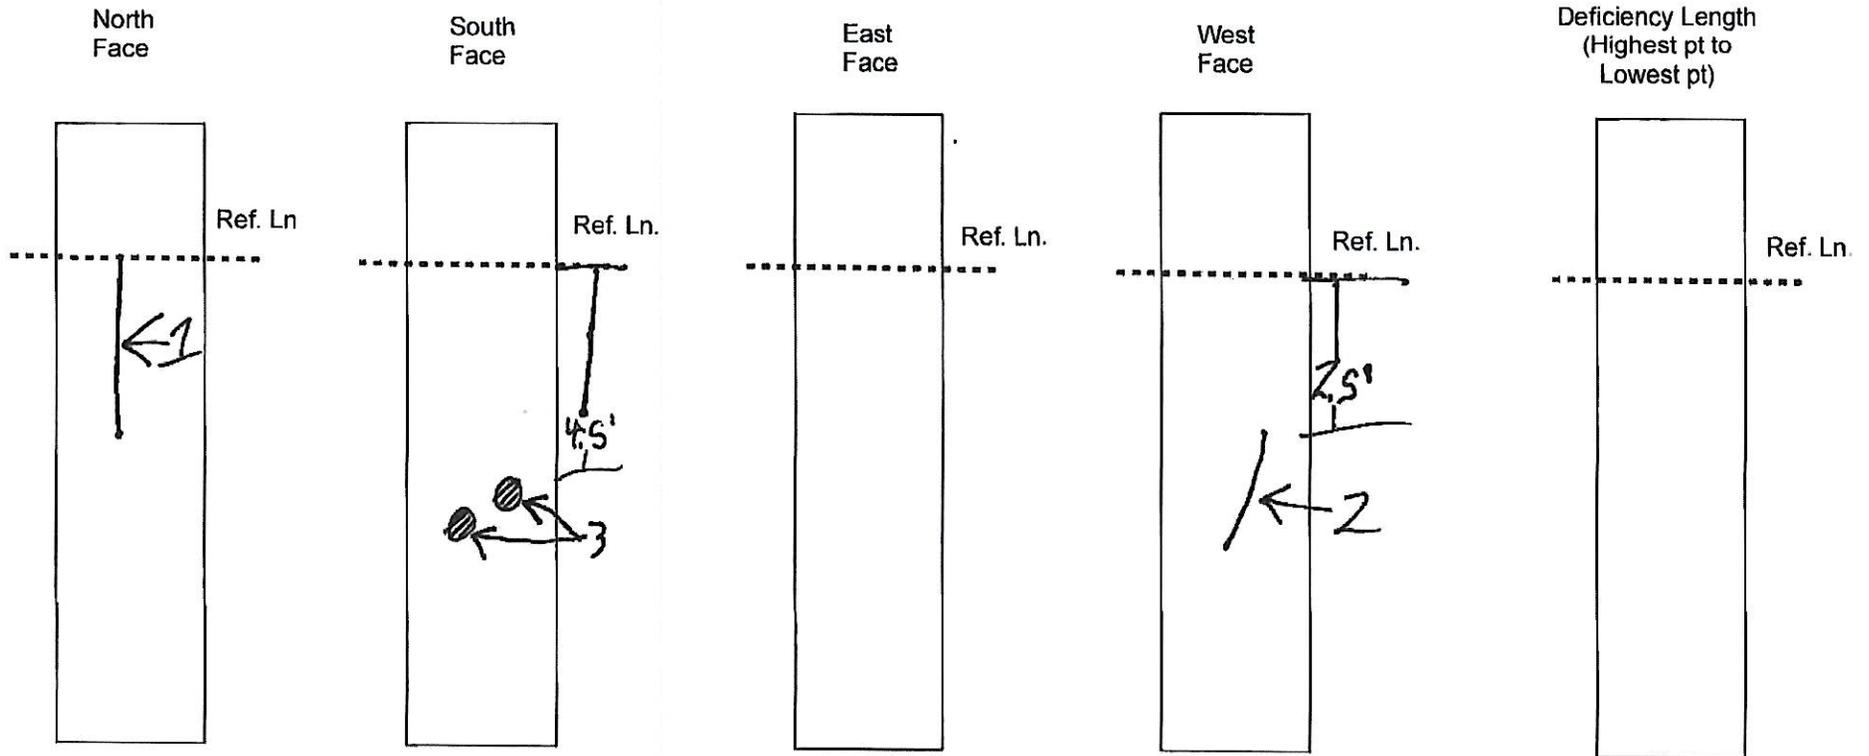
Location #	Type	Distance from Ref. Line	Vert. Length	Width	Depth
1	Crack	0"	48"	1/16"	1/16" - 1/8"
2	Crack	30"	30"	1/16"	1/16" - 1/8"
3	Bleeding	54"	1"	1"	N/A
4					
5					
6					
7					
8					
9					
10

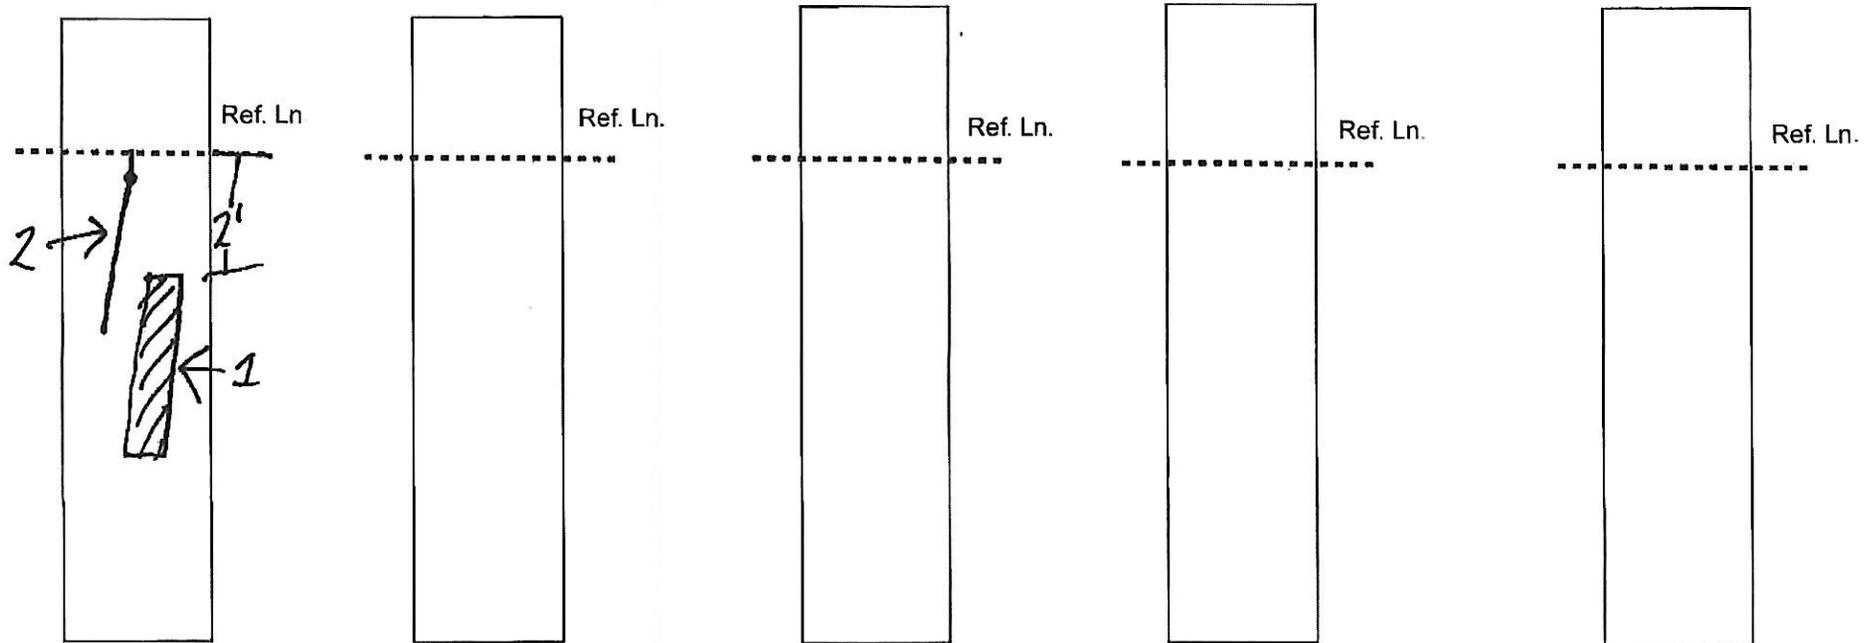
Location #	Type	Distance from Ref. Line	Vert. Length	Width	Depth
1	Bleeding	24"	30"	3"	N/A
2	Crack	0"	30"	1/6"	1/6" - 1/8"
3					
4					
5					
6					
7					
8					
9					
10

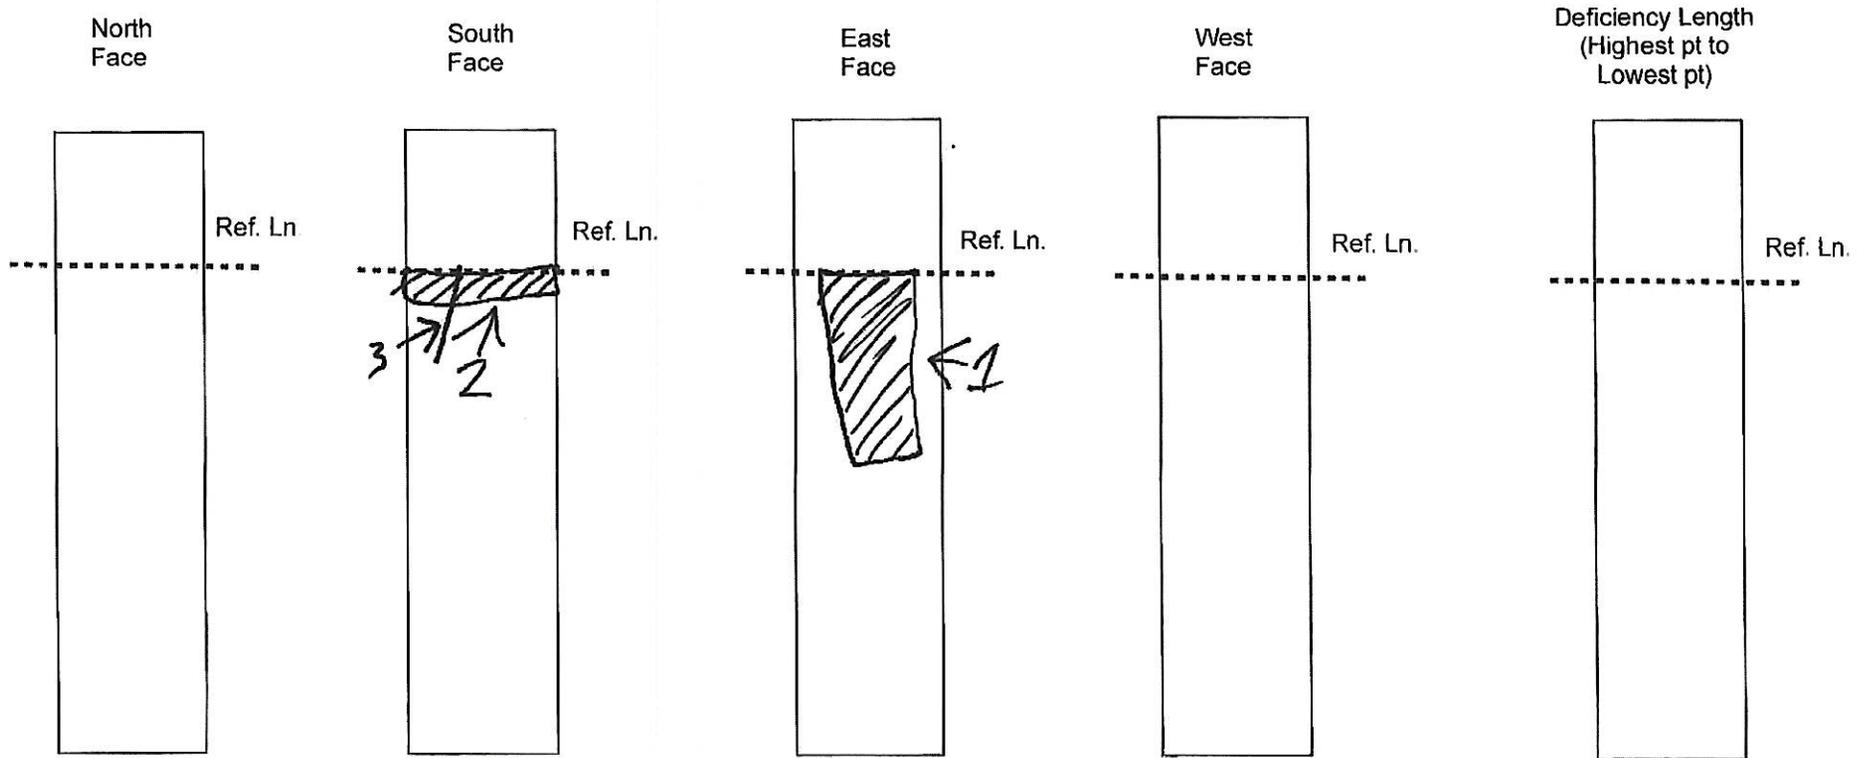
Spall & Crack - Dimensions and locations Table (all measurements in inches)					
Location #	Type	Distance from Ref. Line	Vert. Length	Width	Depth
1	Bleeding	0"	36"	12"	N/A
2	Bleeding	0"	3"	12"	N/A
3	Crack	0"	8"	1/6" - 1/8"	1/6" - 1/8" 1/4"
4					
5					
6					
7					
8					
9					
10

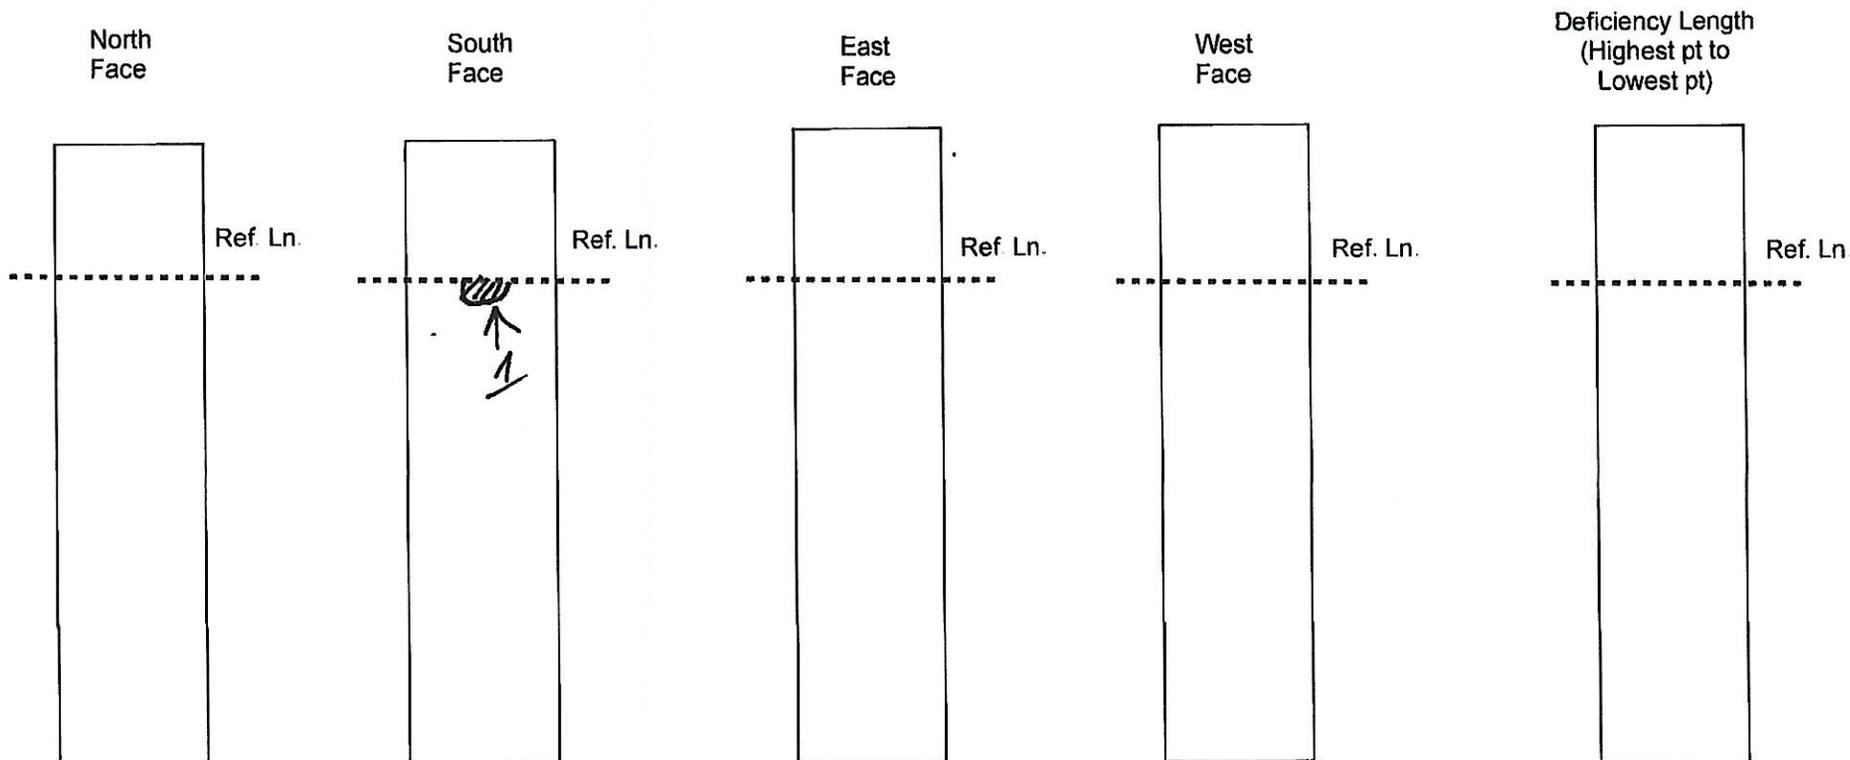
Location #	Type	Distance from Ref. Line	Vert. Length	Width	Depth
1	Bleeding	0"	1/2"	1/2"	N/A
2					
3					
4					
5					
6					
7					
8					
9					
10

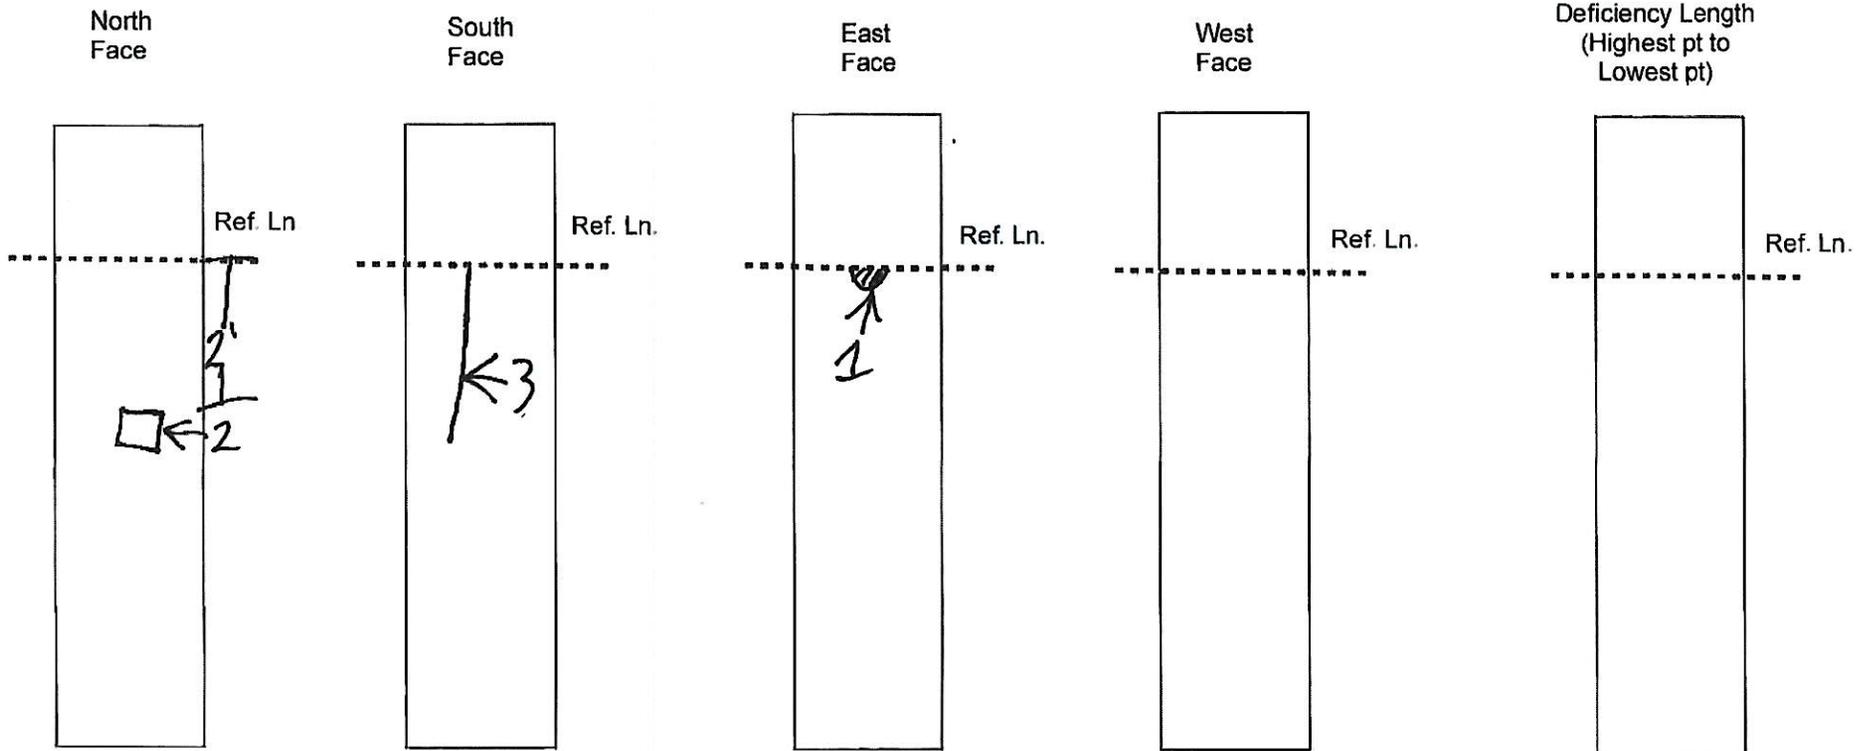
Location #	Type	Distance from Ref. Line	Vert. Length	Width	Depth
1	Bleeding	0"	1/2"	1/2"	N/A
2	Spall	24"	3"	2"	1/16" - 1/4"
3	Crack	0"	24"	1/16"	1/16" - 1/8"
4					
5					
6					
7					
8					
9					
10
