Inspection Report

From: Jason P. Ball, PE, SE
Ball Maritime Group, LLC

Date: May 14, 2024

Project: PN 23-1035: Coronado Ferry Landing Level 1 Inspection
Coronado, California

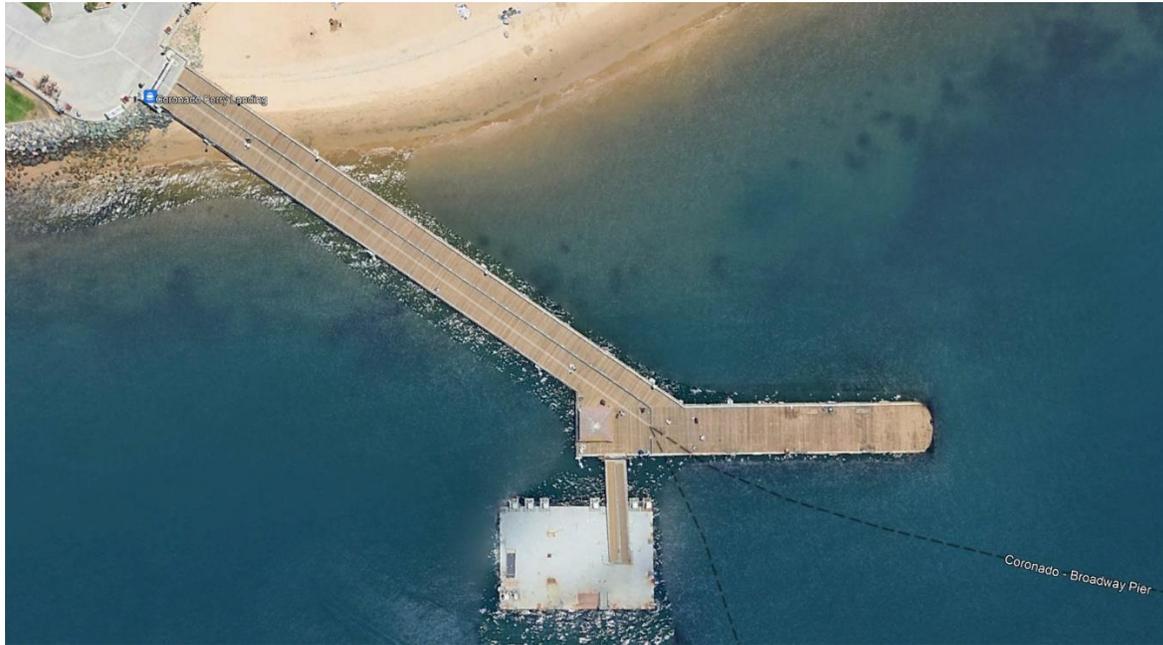
FIGURE 1 - Ferry and Fishing Pier

The Ferry and Fishing Pier comprises three elements – the access, the pierhead, and the floating dock (Figure 1). The access and pier head are approximately 37 years old, constructed

around 1987. The floating dock was replaced in 1994 and regularly accommodates ferries and other passenger vessels. The facility is fully operational and was used during the inspection.

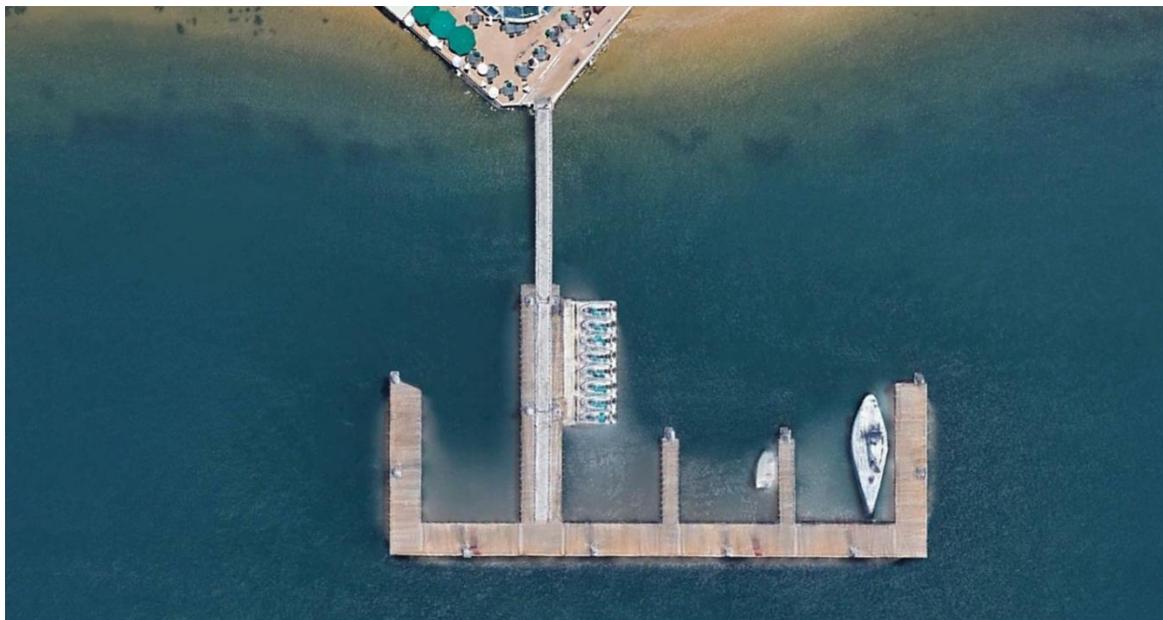
FIGURE 2 – Ferry Landing Docks

The Ferry Landing comprises three elements – the pierhead, the gangway, and the floating dock (Figure 2). The pierhead was not inspected. The floating docks appear to have been rebuilt in 2009. The docks accommodate small watercraft and personal watercraft. The facility is fully operational and was used during the inspection.

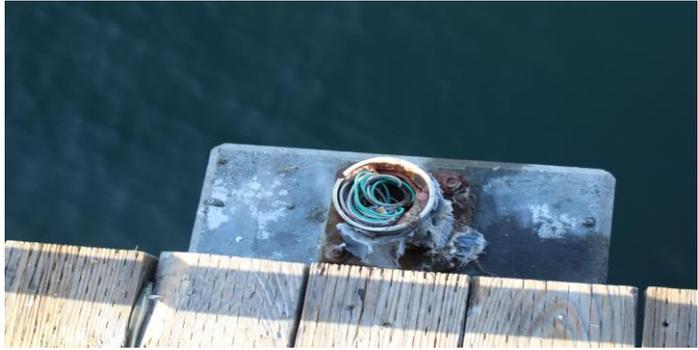
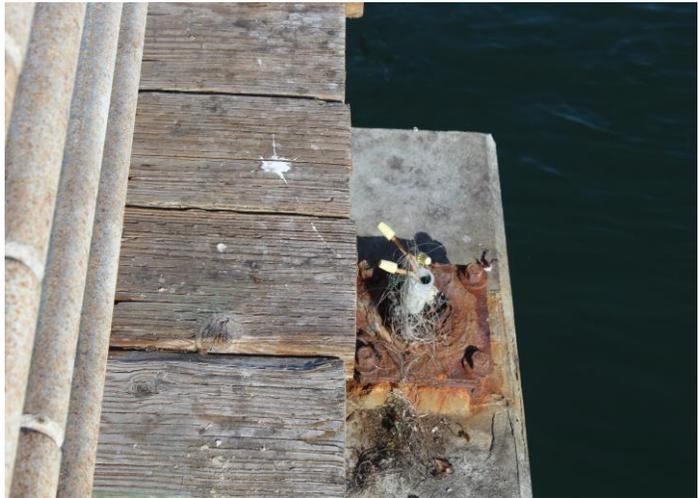
Light poles are missing and damaged, and missing ones are left with the wires exposed.
(photos 7248, 7252, 7265, 7289, 7310)

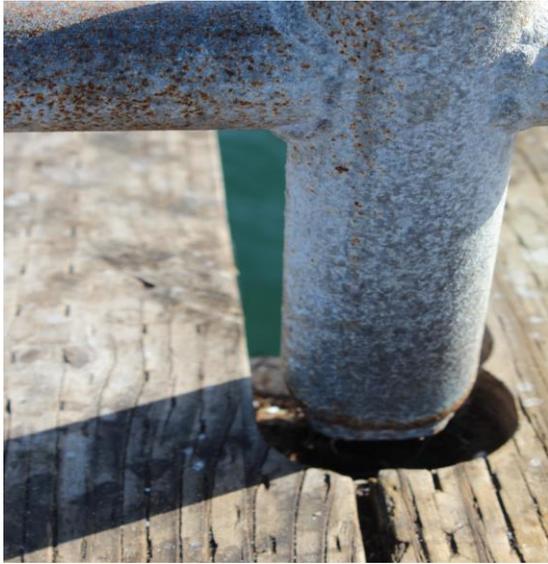
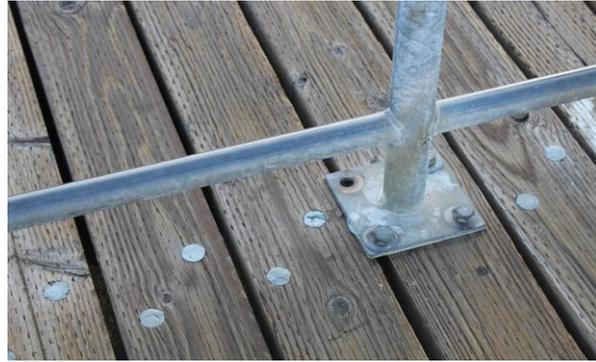
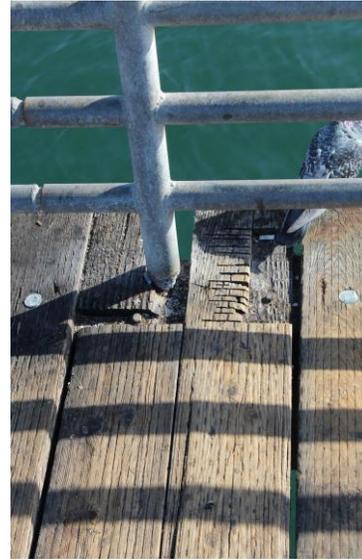
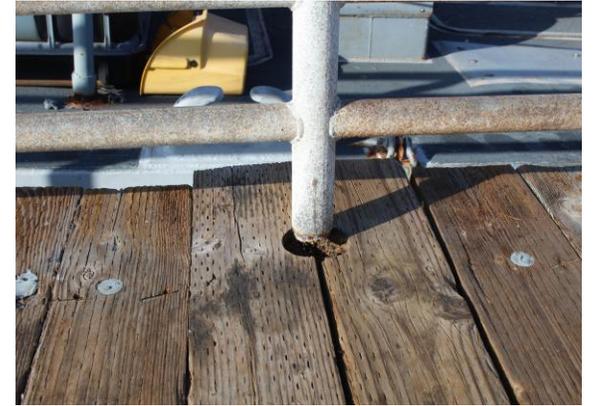
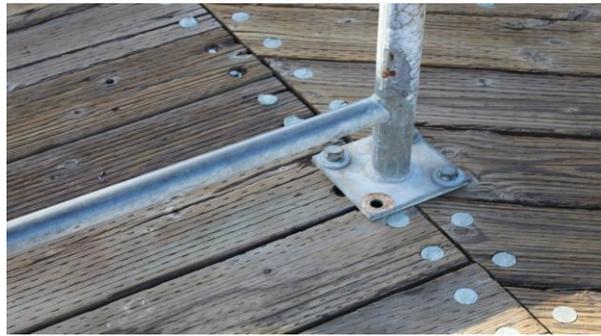
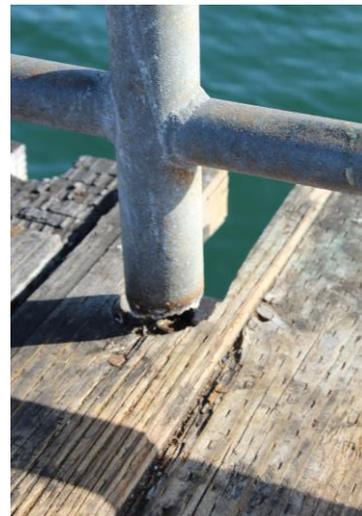
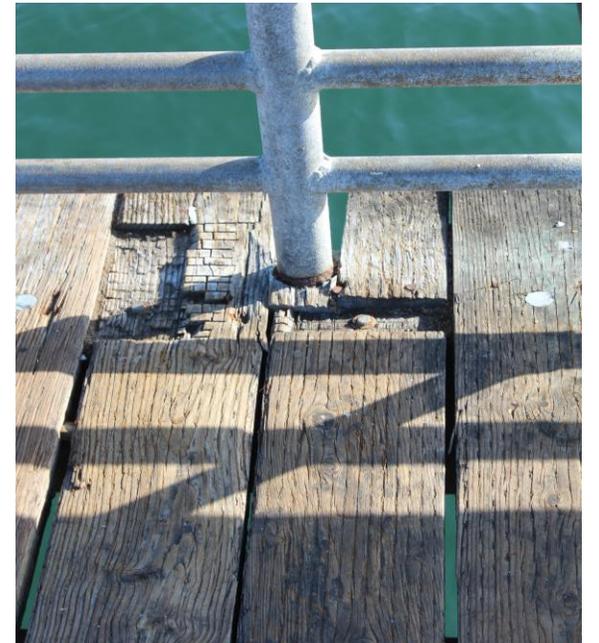
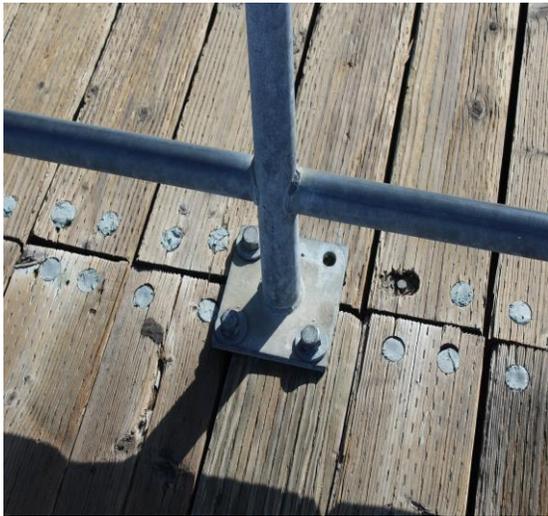
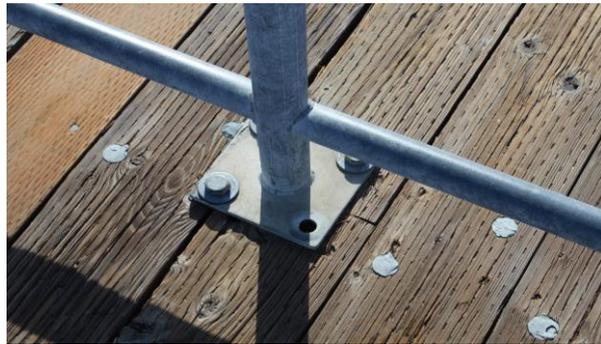
Handrails in multiple spots, missing bolts, or have rusted completely off at the bases.
(Photos 7255, 7256, 7257, 7258, 7305, 7308, 7309, 7311, 7312, 7322, 7323, 7324,
7330, 7331, 7332, 7333, 7335)

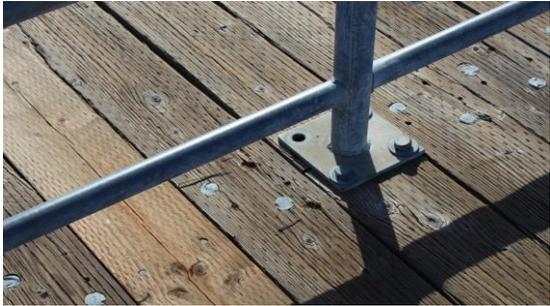
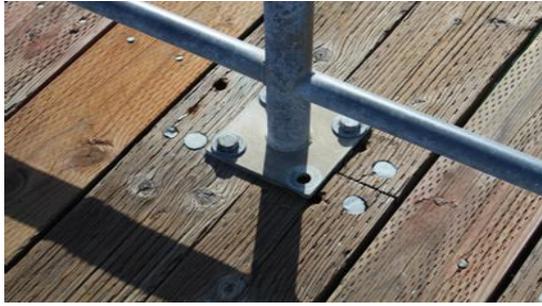
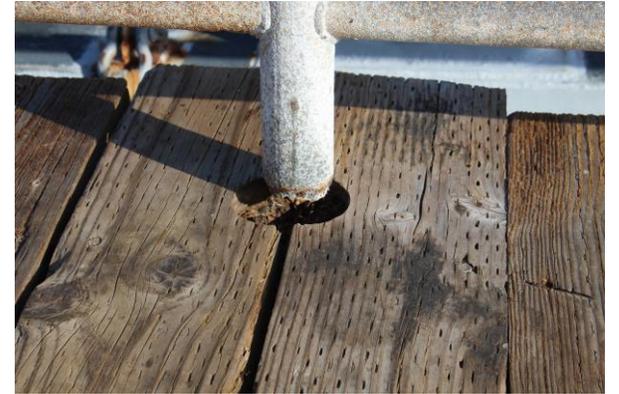
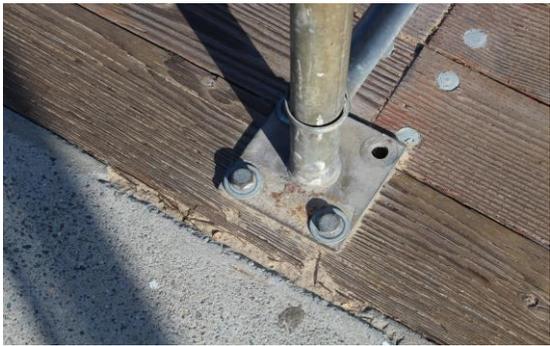
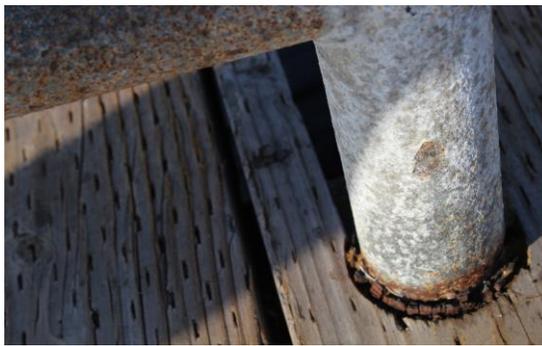
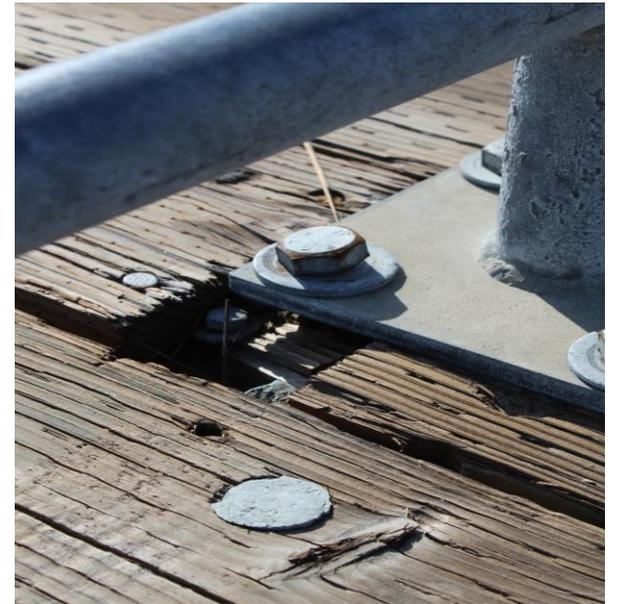
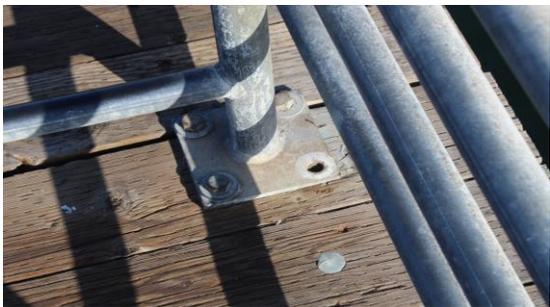
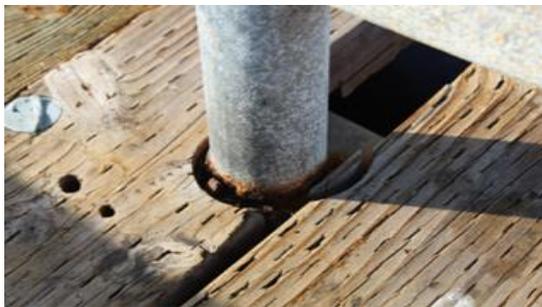
Handrails in multiple spots are missing bolts or have rusted completely off at the bases. (CONT.)

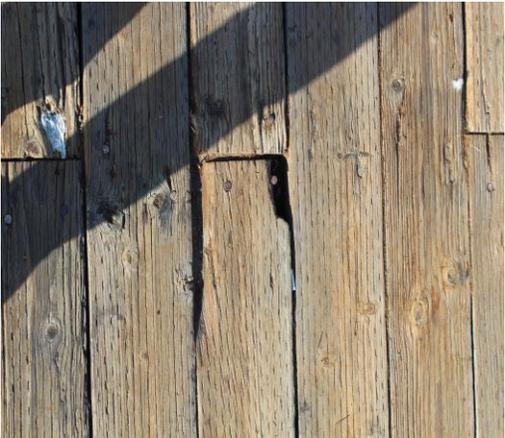
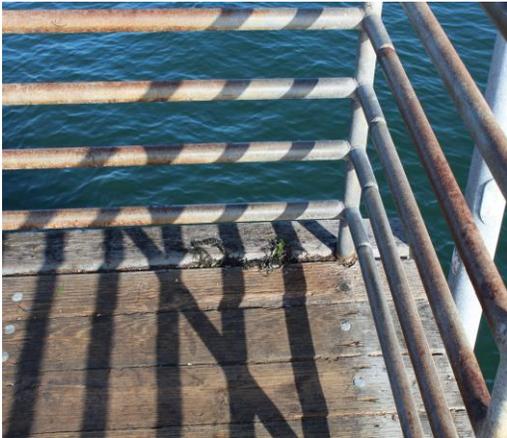
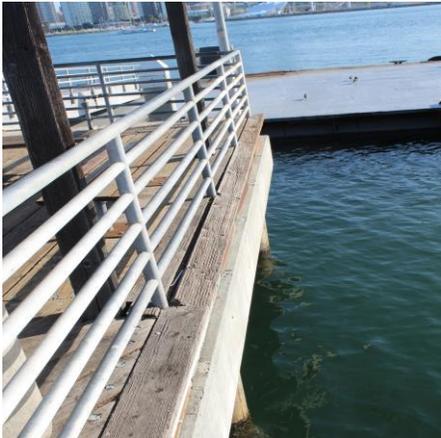
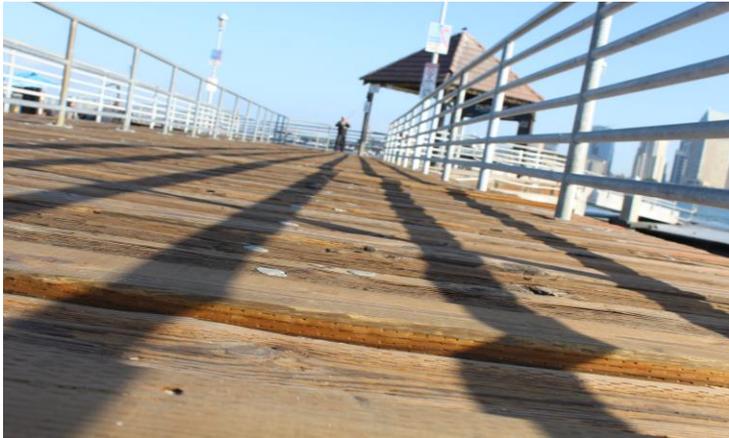
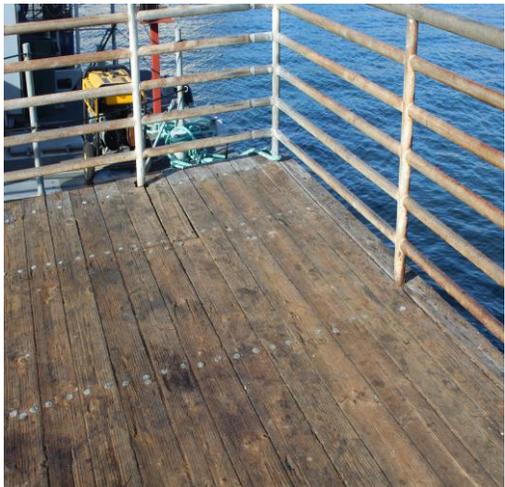
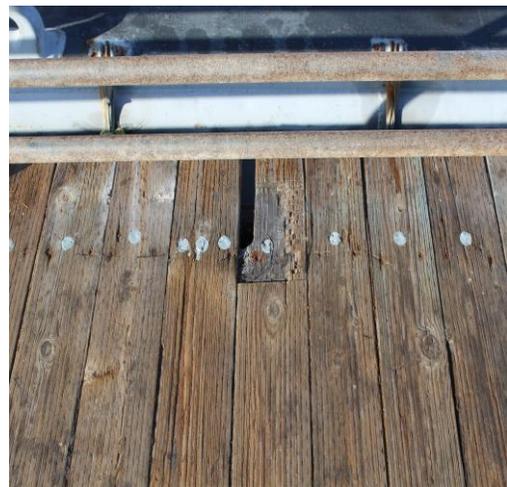
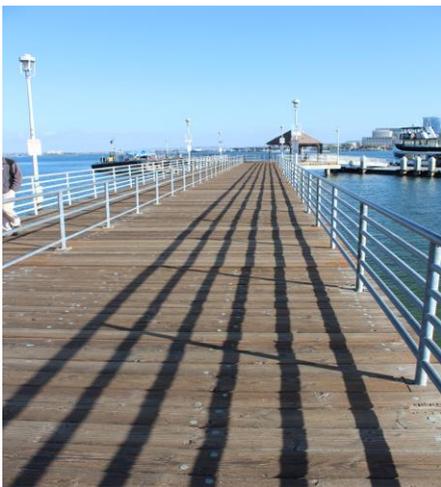
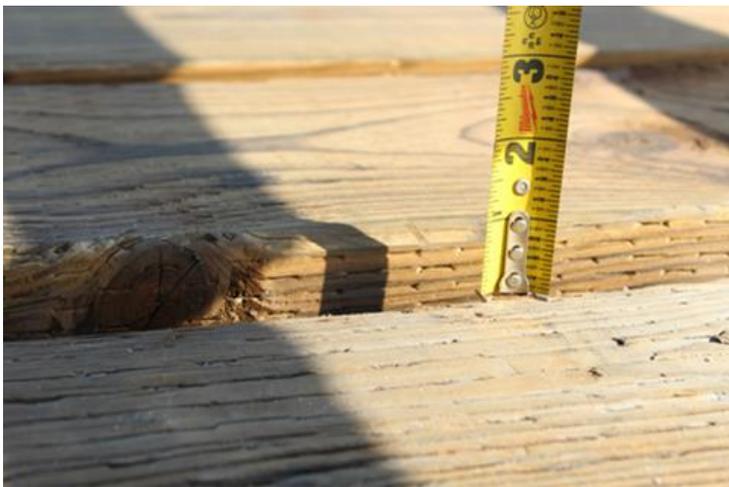
(Photos 7249, 7250, 7254, 7261, 7263, 7264, 7267, 7272, 7274, 7275, 7284, 7285, 7286, 7293, 7294, 7306, 7308, 7314, 7315, 7316, 7317, 7320, 7321, 7327, 7337, 7338)

Dock decking is worn and uneven, has loose boards, and some areas are rotting. It is also very dry and brittle. Some areas are almost a full inch higher than all the other boards around.

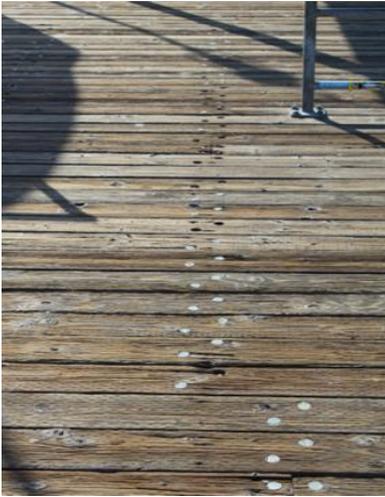
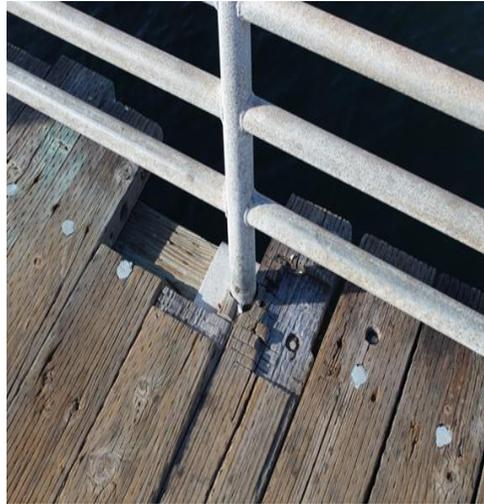
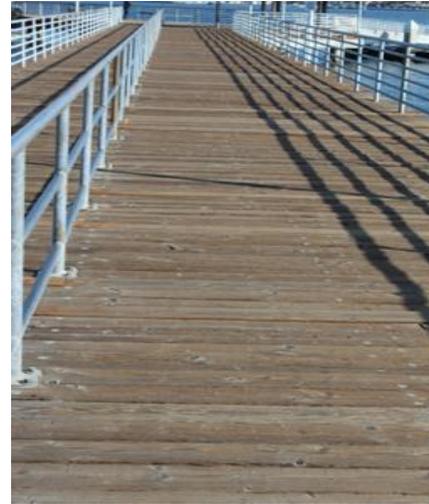
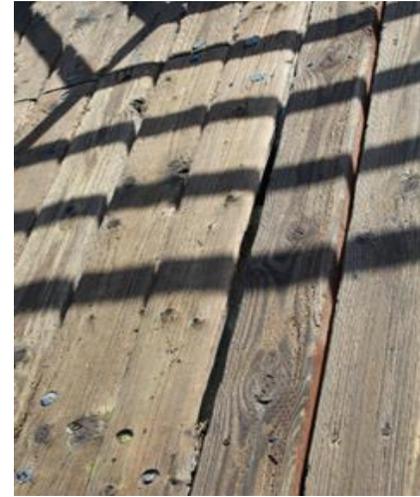
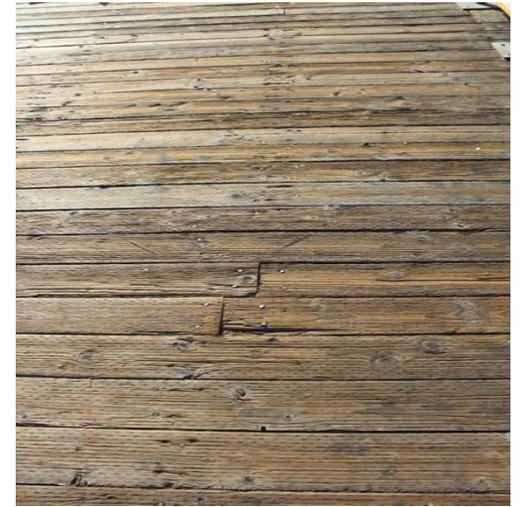
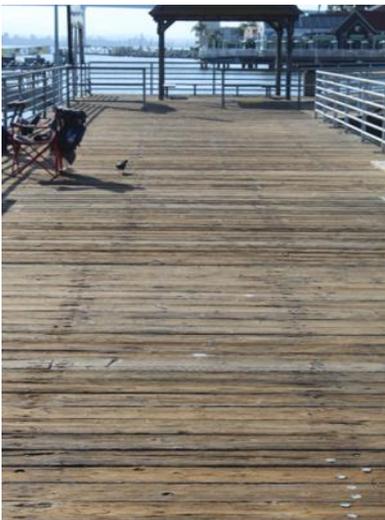
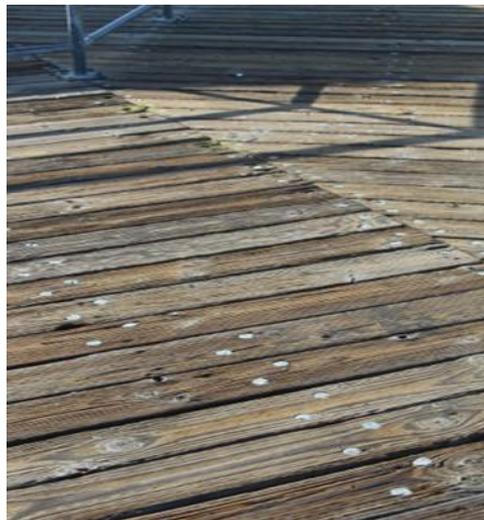
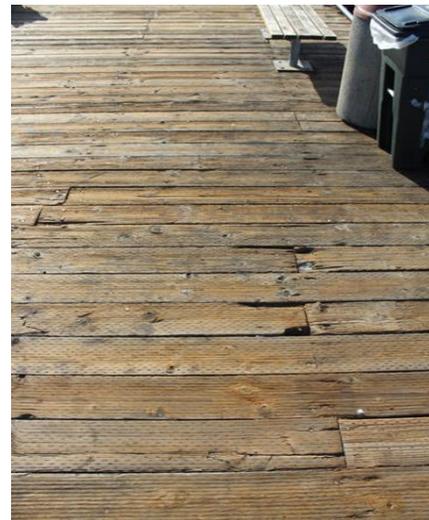
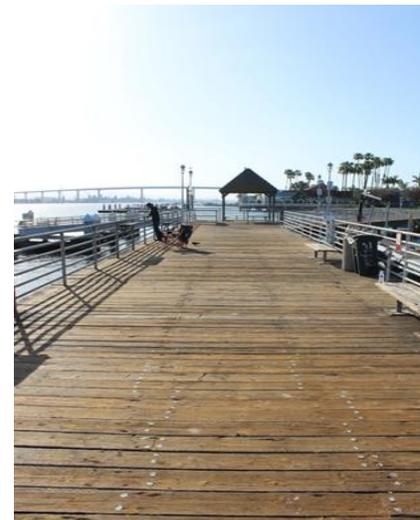
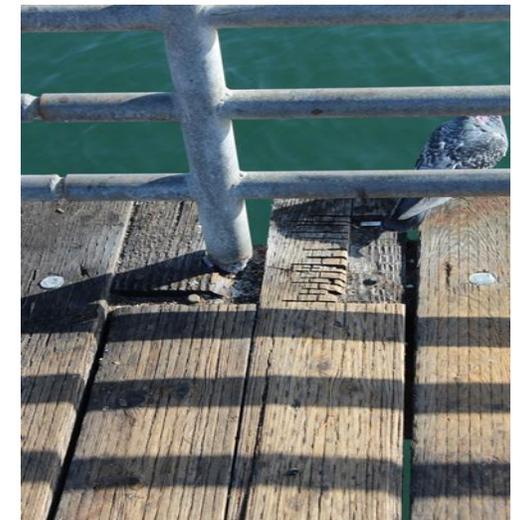
Cont.

Dock decking is worn and uneven, has loose boards, and some areas are rotting. It is also very dry and brittle. Some areas are almost a full inch higher than all the other boards around.

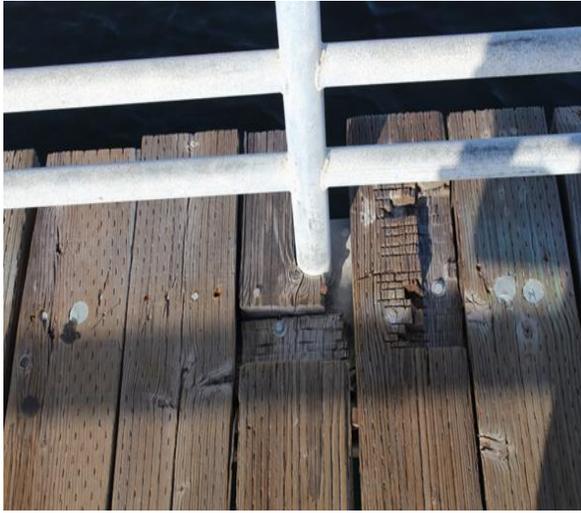
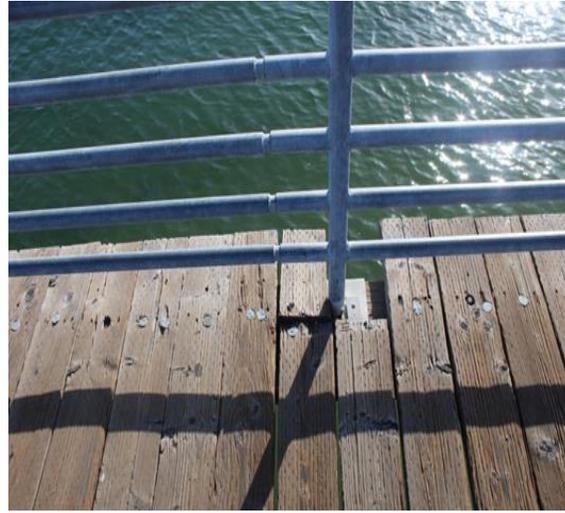
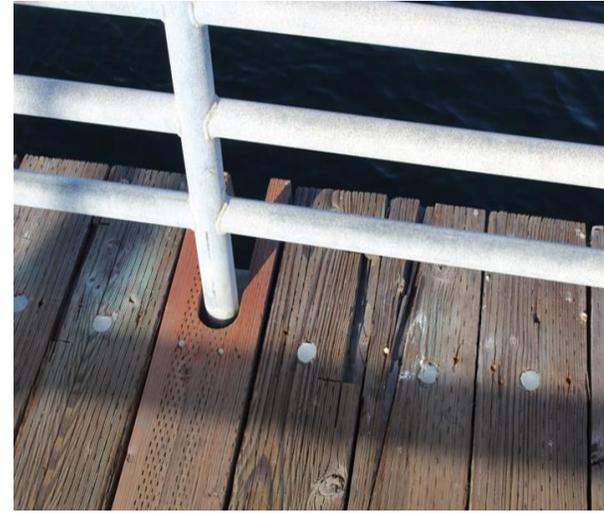
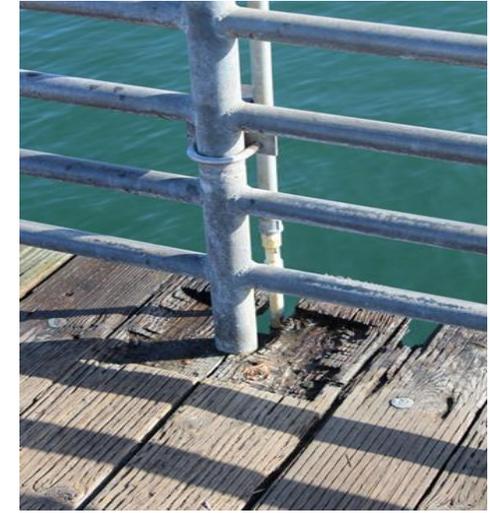
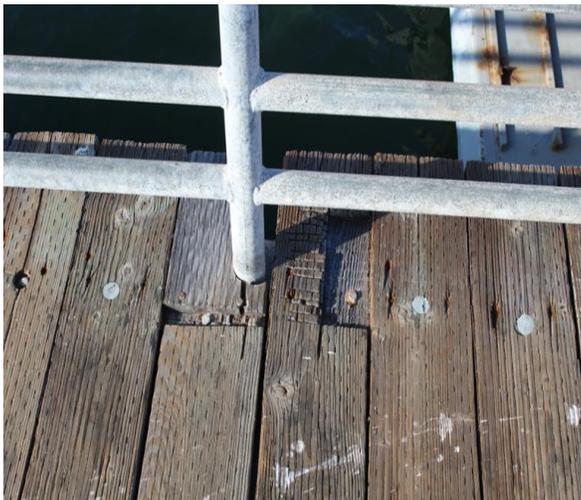
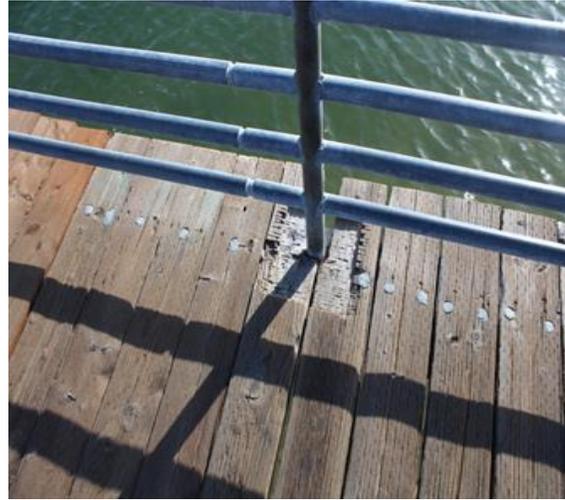
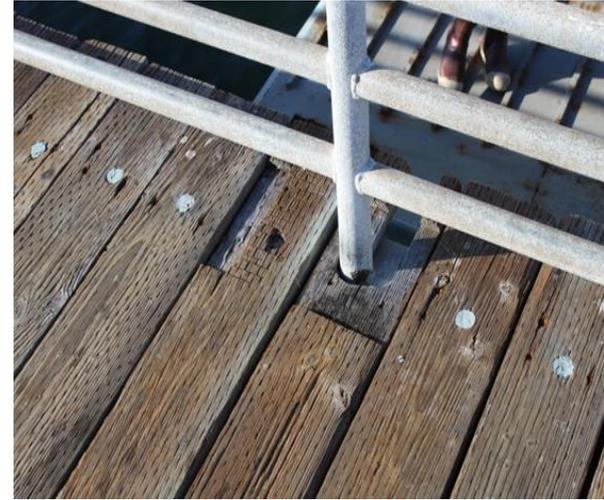
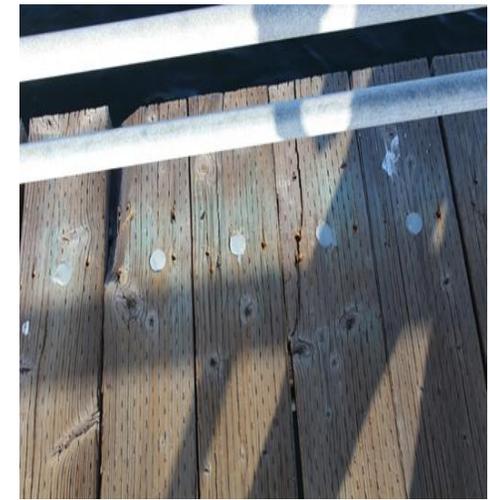
Cont.

Dock decking is worn and uneven, has loose boards, and some areas are rotting. It is also scorched and brittle. Some areas are almost a full inch higher than all the other boards.

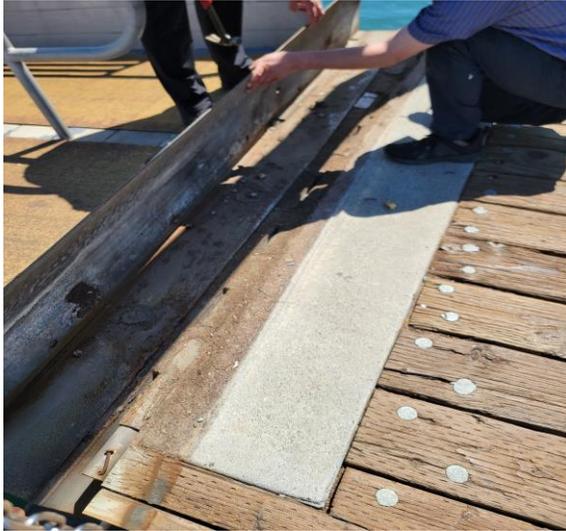
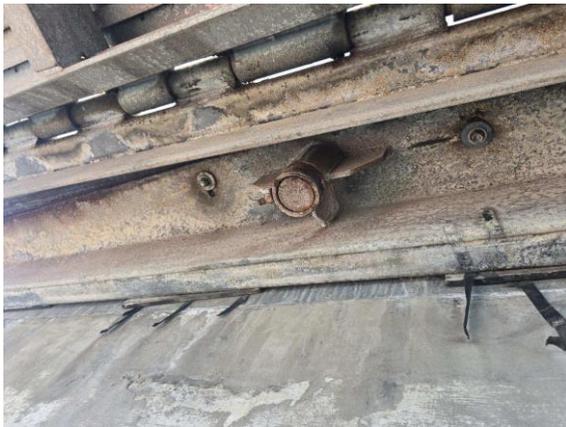
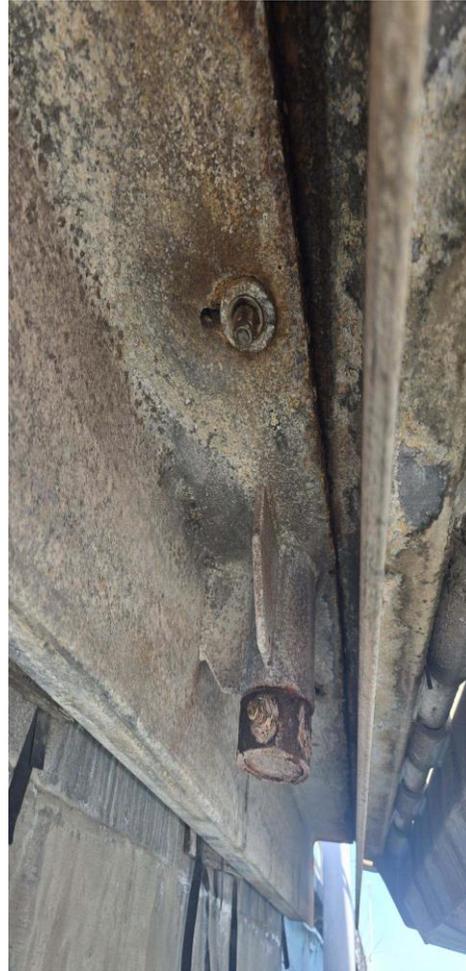
The floating dock ramp has an unfamiliar designed connection that is not on any of the plan sets. (photos 1000007044, 7045, 7046, 7047, 7048)

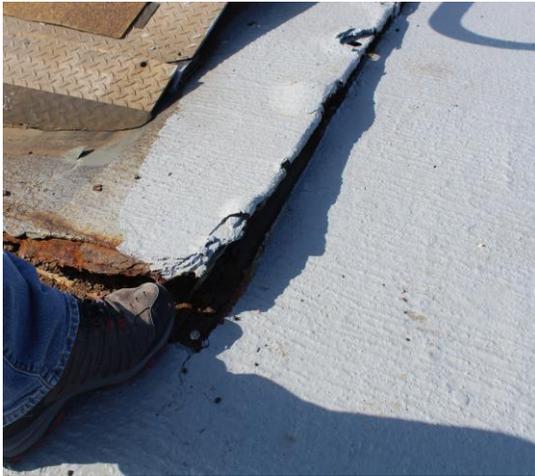
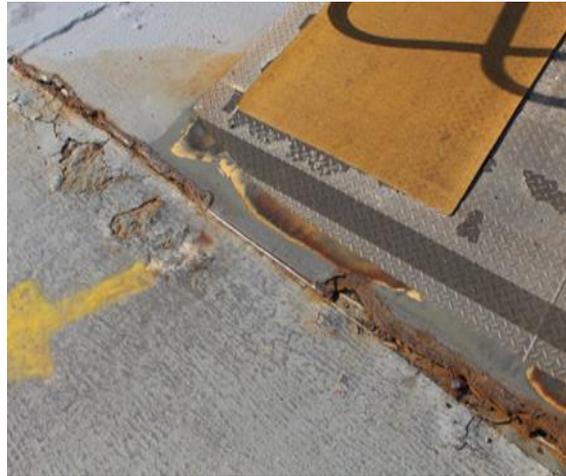
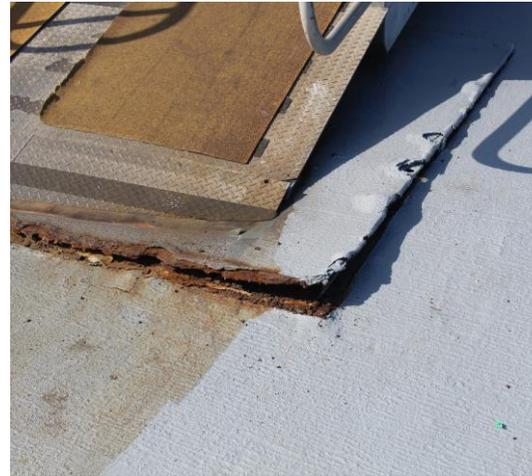
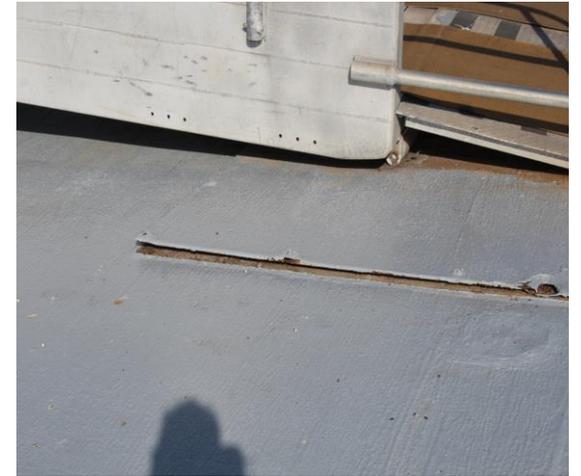
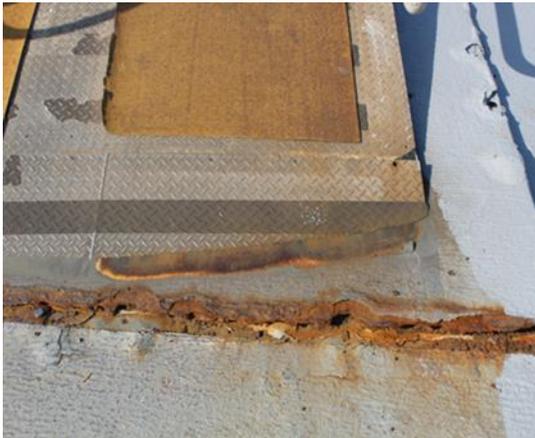
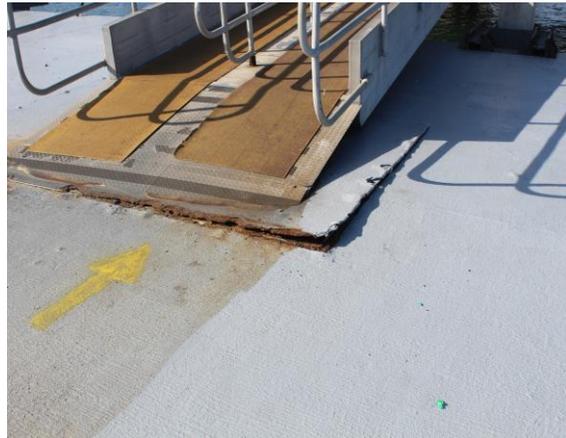
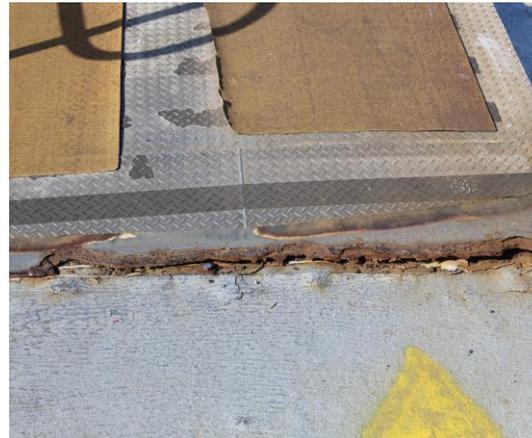
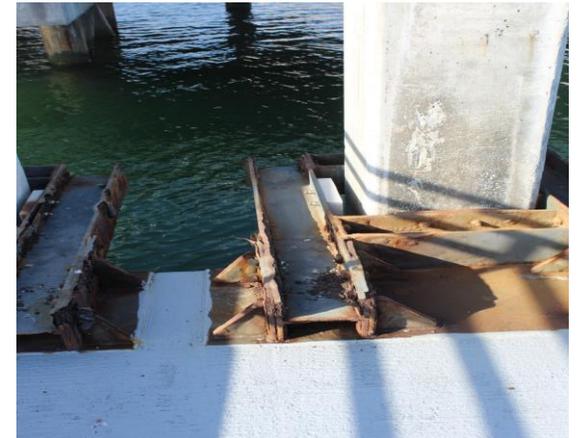
The floating dock ramp landing pad is delaminating from the deck of the dock, pile pocket brackets are in poor condition and are delaminating, bumper attachments to the deck are delaminating, and holes are rusting through on bumpers; the landing pad for the gangway ramp is delaminating and rusting through, end of ramp worn to a razor-sharp edge and pile cap missing. (Photos 7288, 7343, 7344, 7345, 7346, 7347, 7350, 7351, 7352, 7353, 7356, 7359, 7361, 7363, 7364, 7365, 7366)

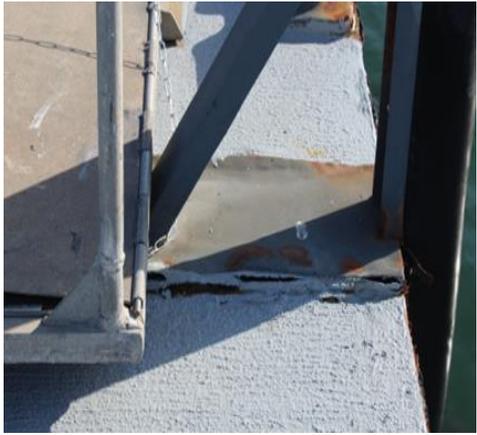
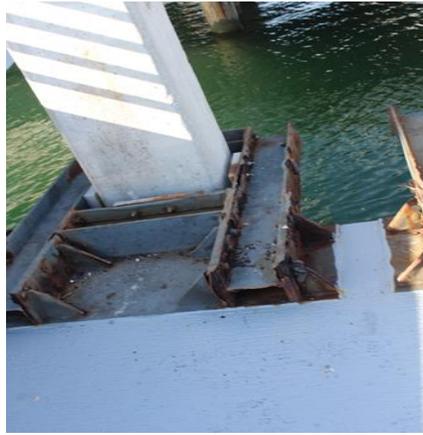
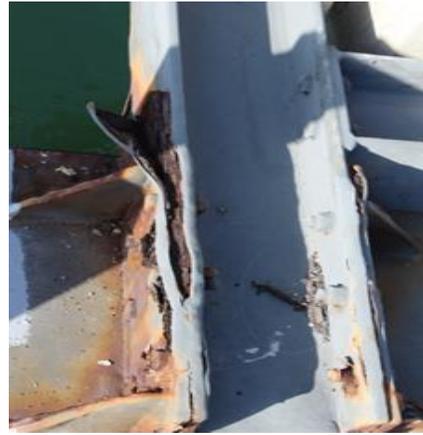
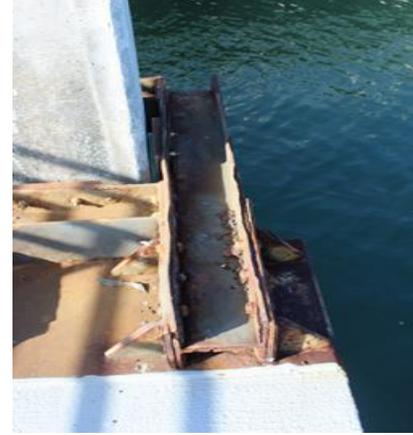
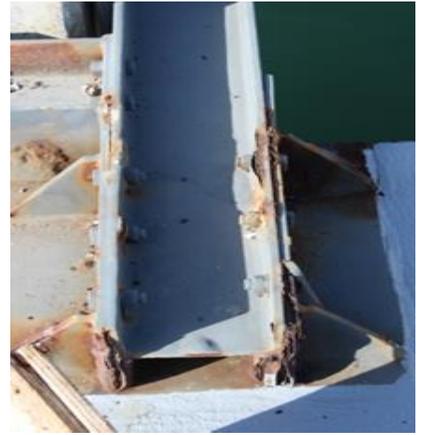
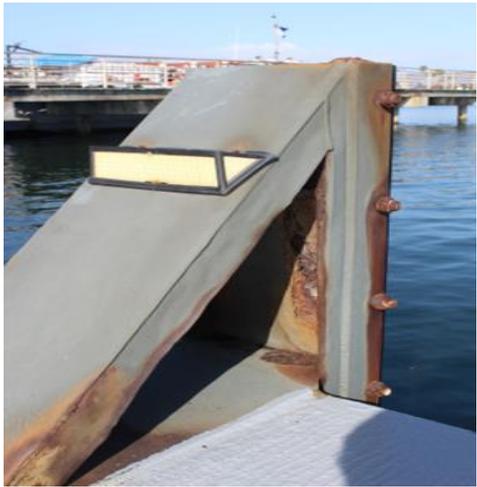
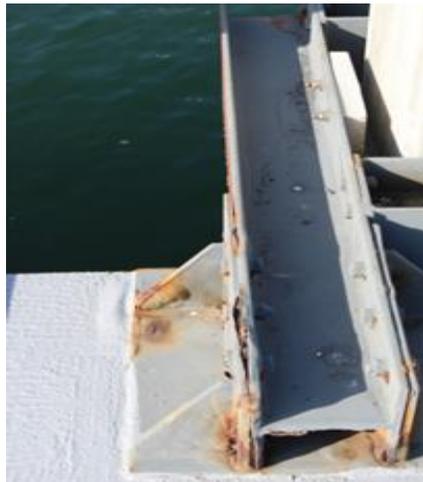
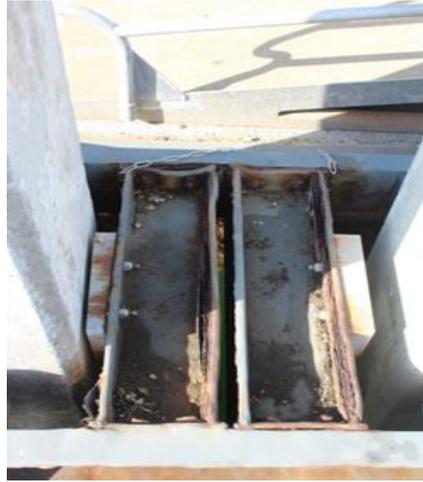
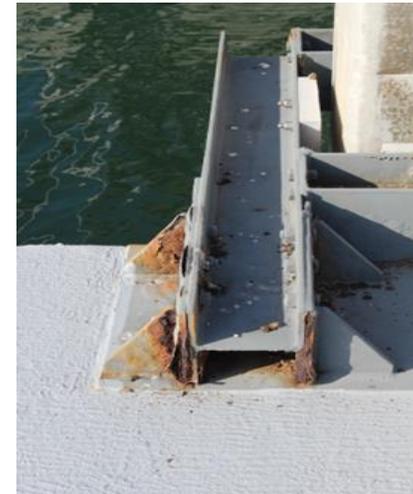
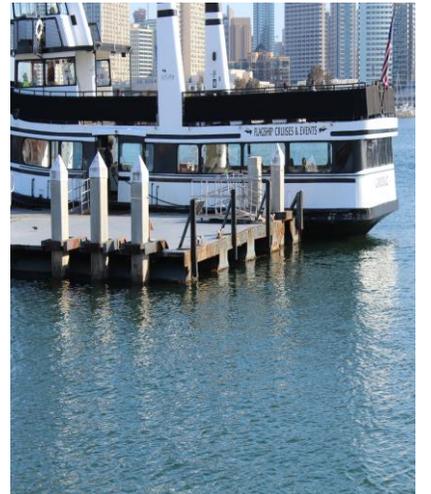
Additional photos of the floating dock damage. (Photos 7288, 7343, 7344, 7345, 7346, 7347, 7350, 7351, 7352, 7353, 7356, 7359, 7361, 7363, 7364, 7365, 7366)

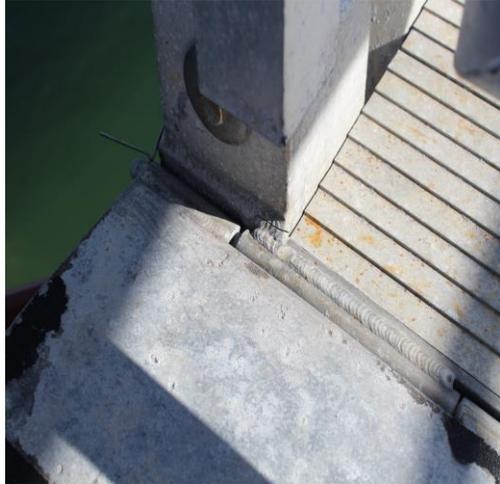
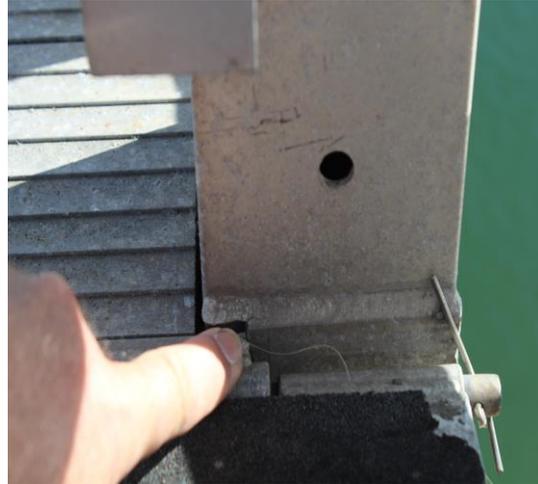
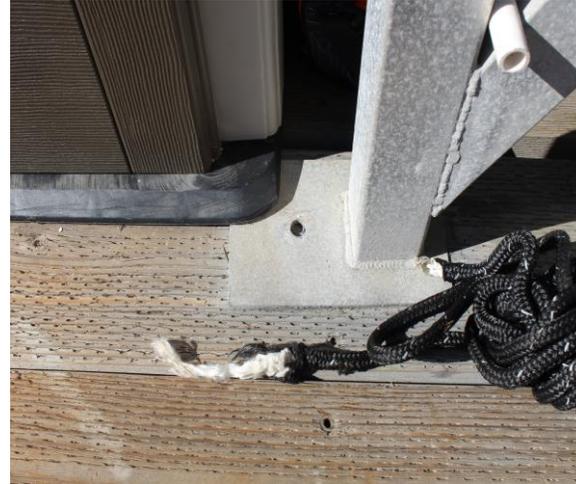
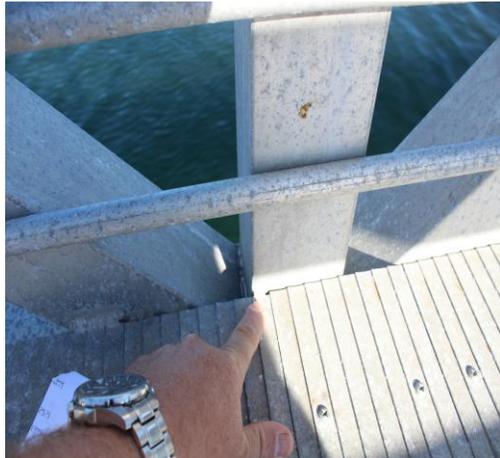
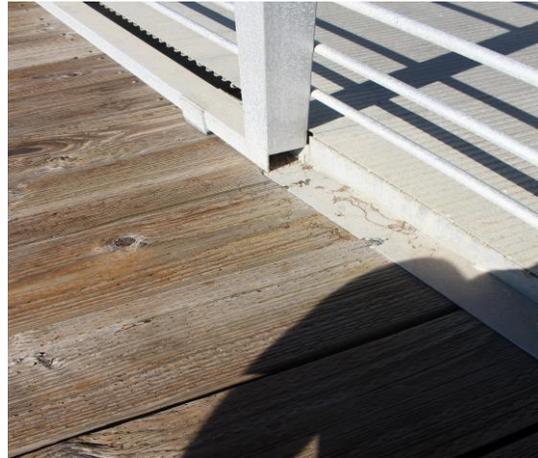
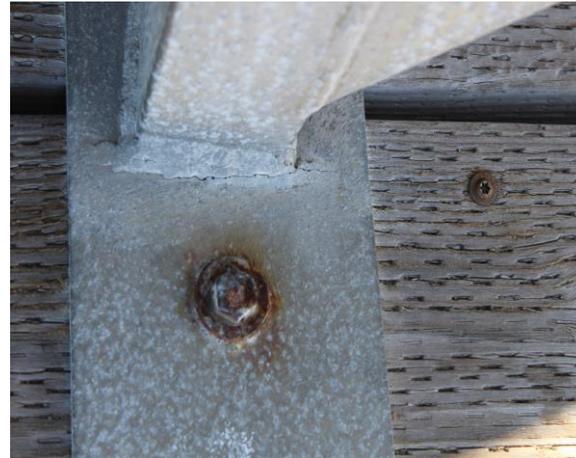
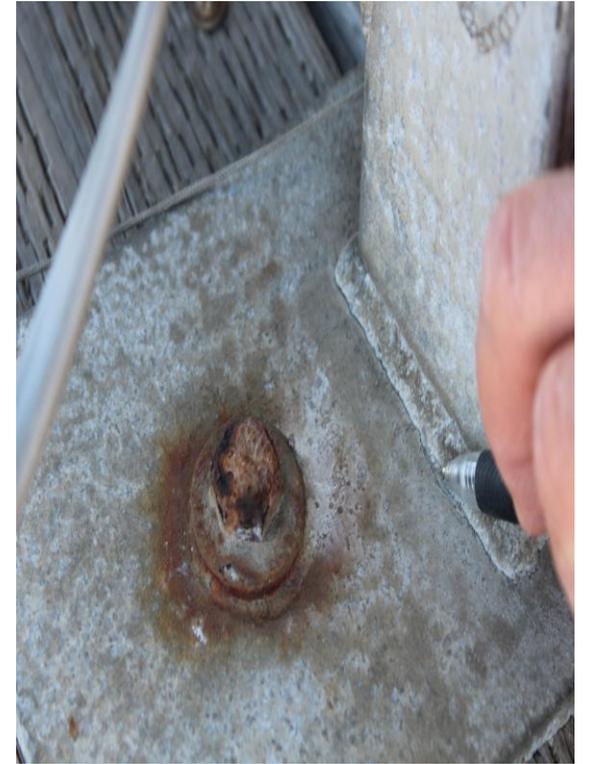
There are cracked welds on the handrail bases at the start of the ramp, feet on the dock middle landing legs are cracked, a bolt is missing from the leg base, and bolts in the ramp landing pad are pulled through.

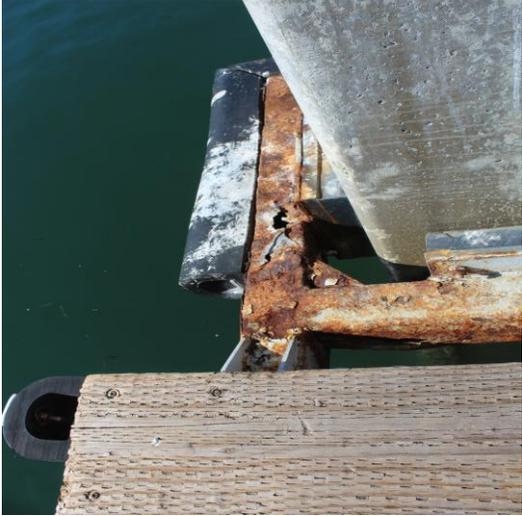
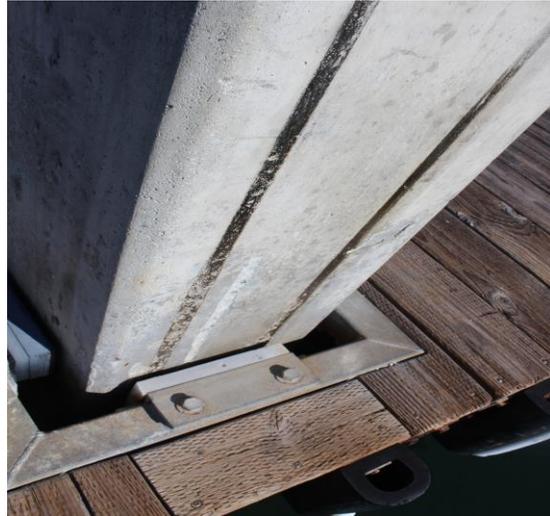
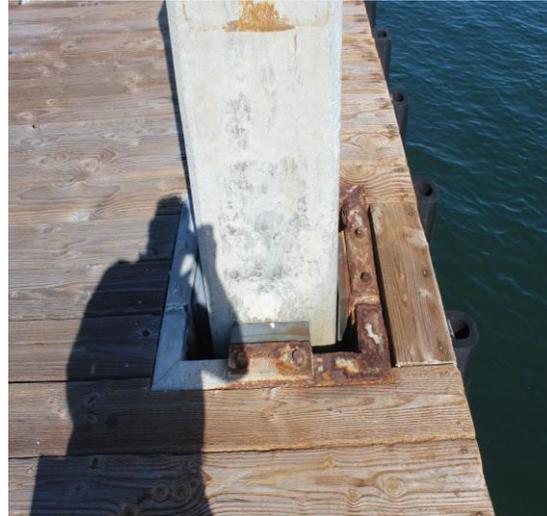
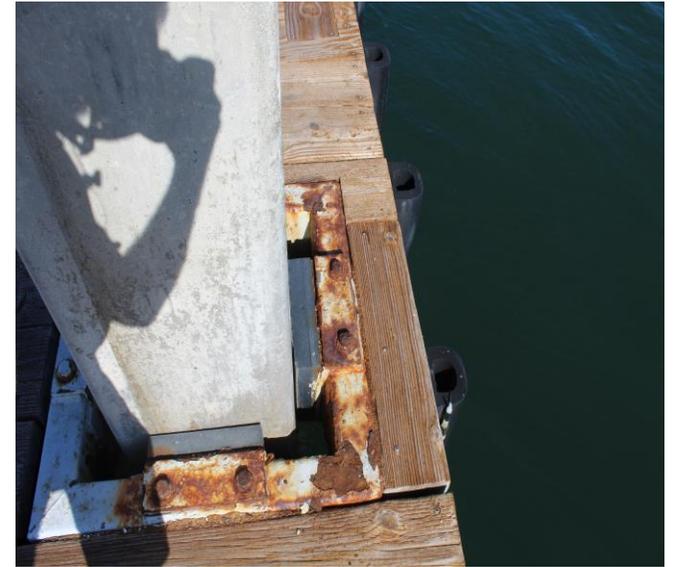
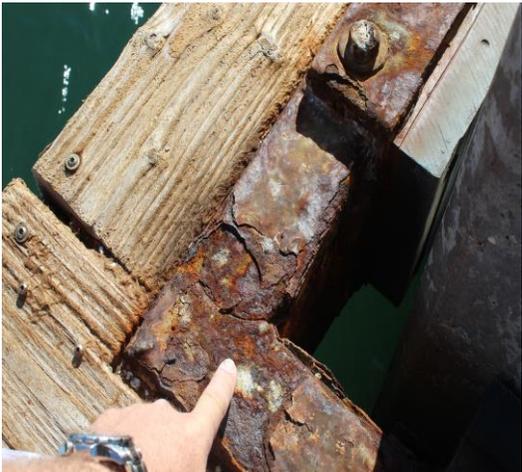
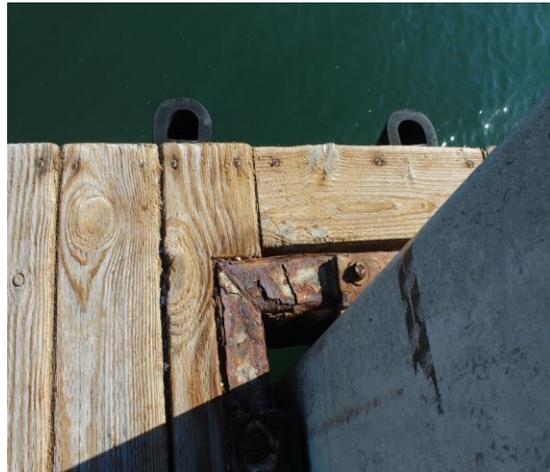
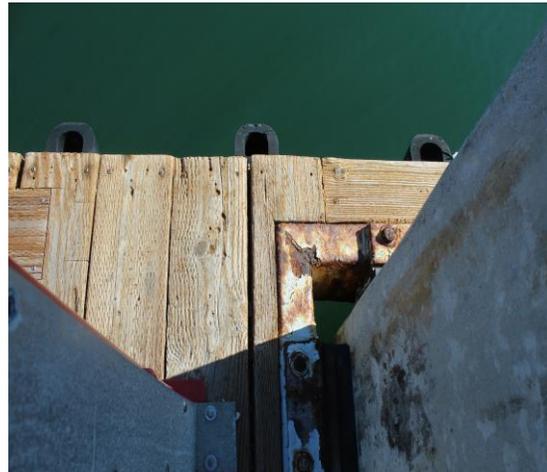
One pile pocket is completely broken in half, and the others are almost rusted through in multiple places. Pile guide pads are worn, causing grooves in one pile.
