Inspection Report

From: Jason P. Ball, PE, SE
Ball Maritime Group, LLC

Date: May 14, 2024

Project: PN 23-1035: Coronado Ferry Landing Level 1 Inspection
Coronado, California

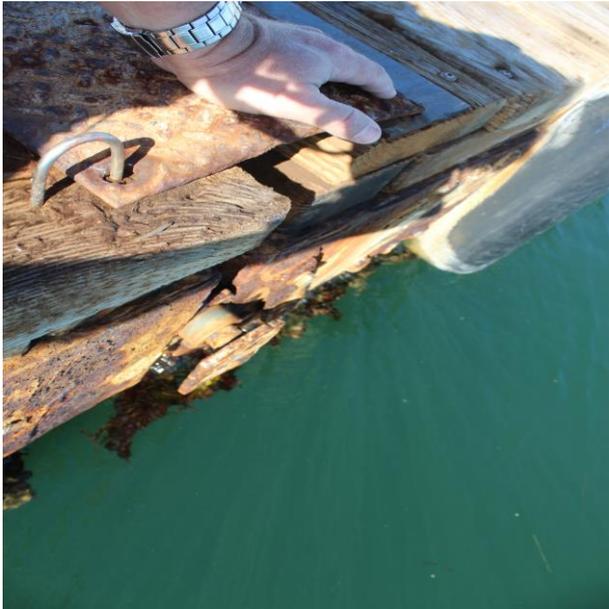
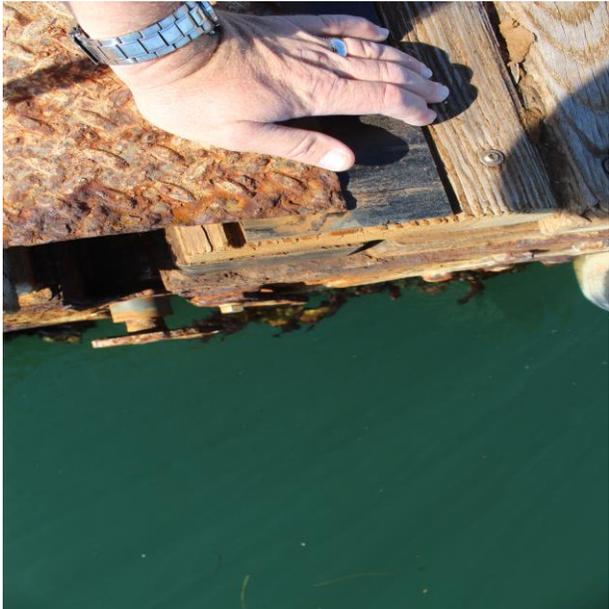
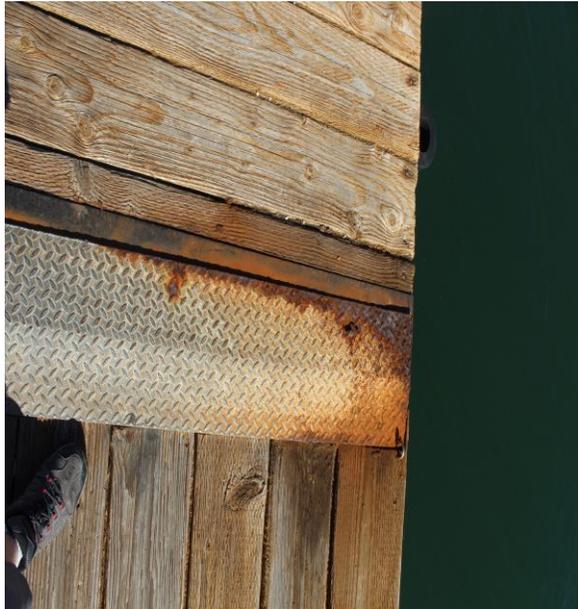
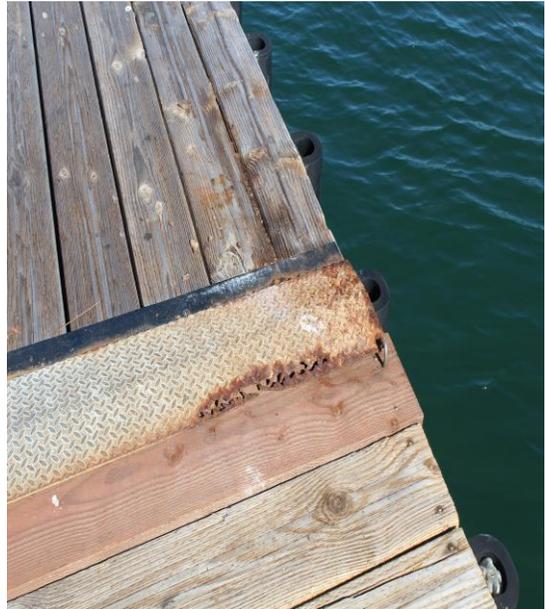
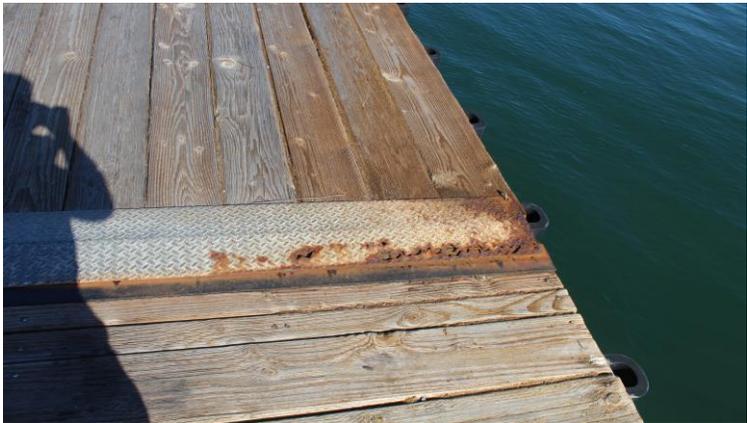
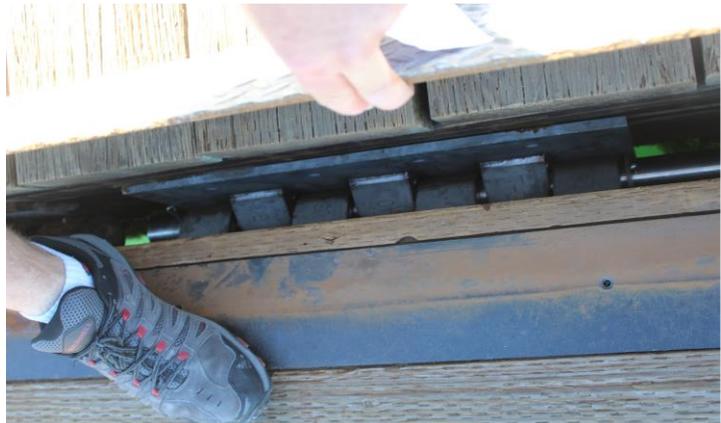
The hinge pin is not secured in its retainer; Hinge pin plates have jagged edges from rusting through, and a new hinge is installed but not connected on one side.

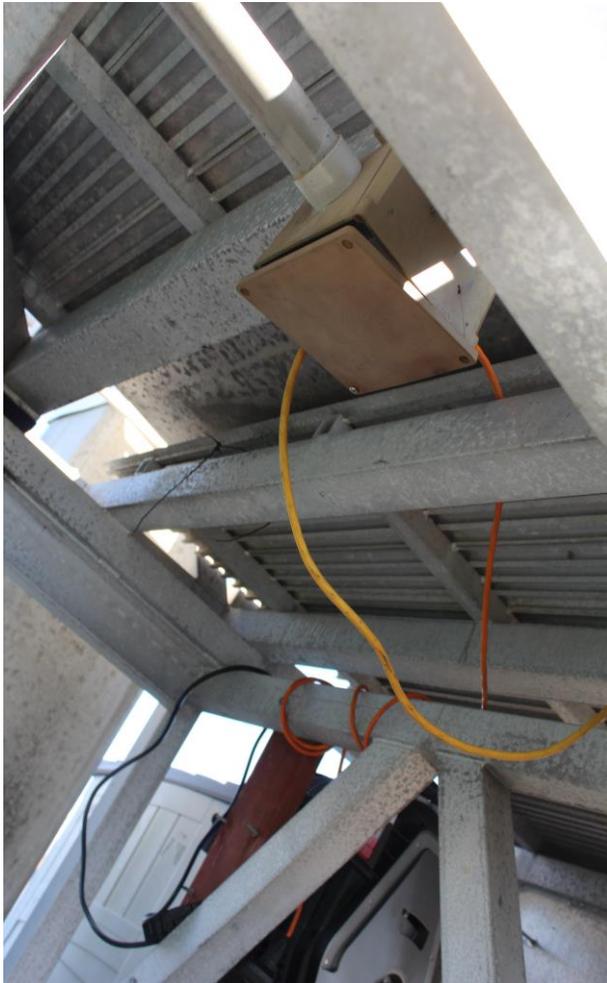
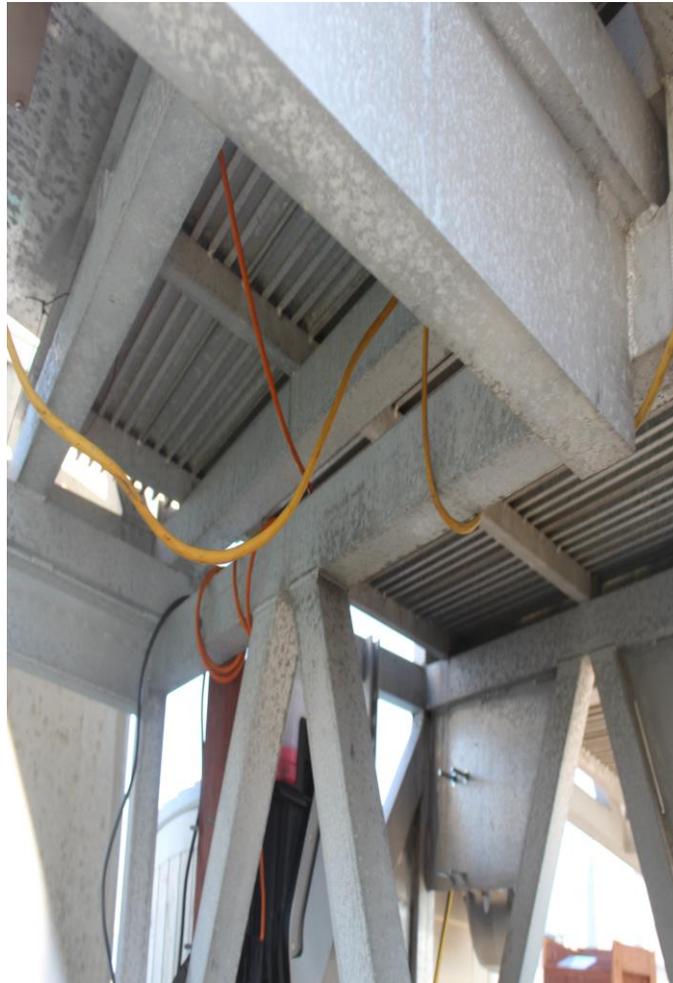
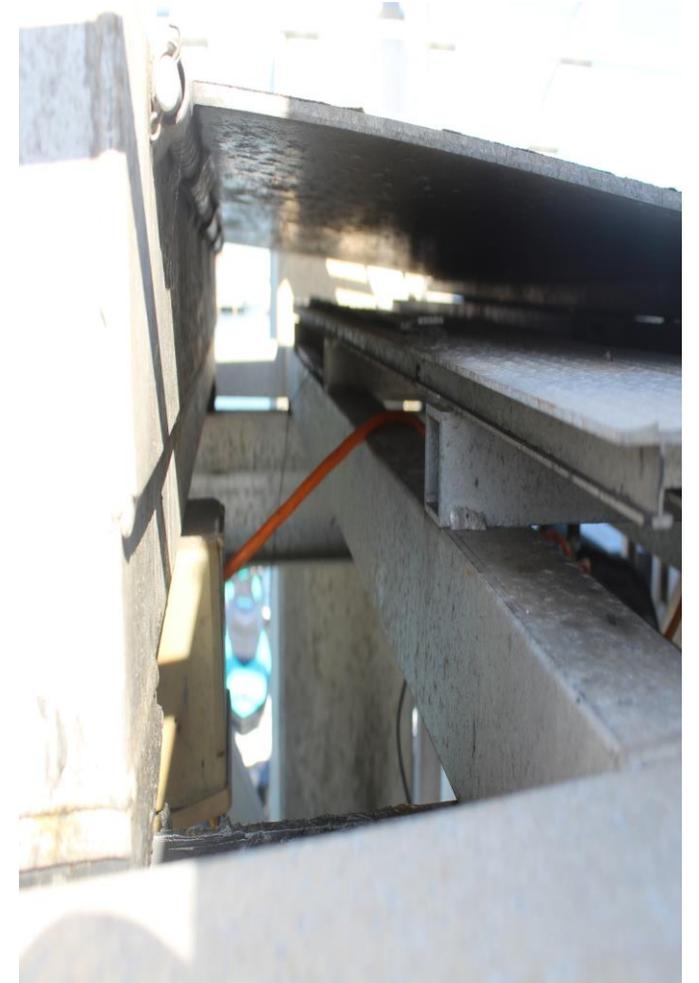
The extension cord ran through the floating dock ramp(around and through moving parts) to a junction box with an unsecured lid.

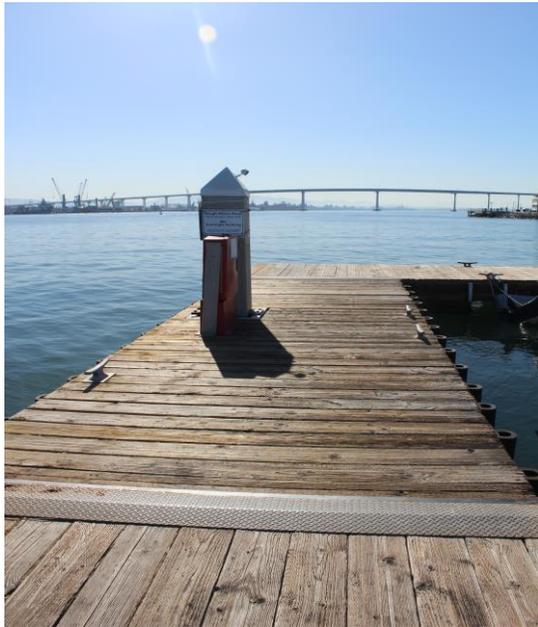
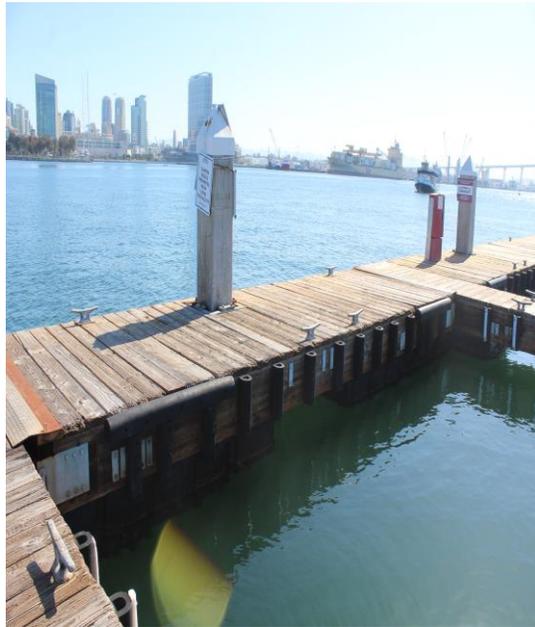
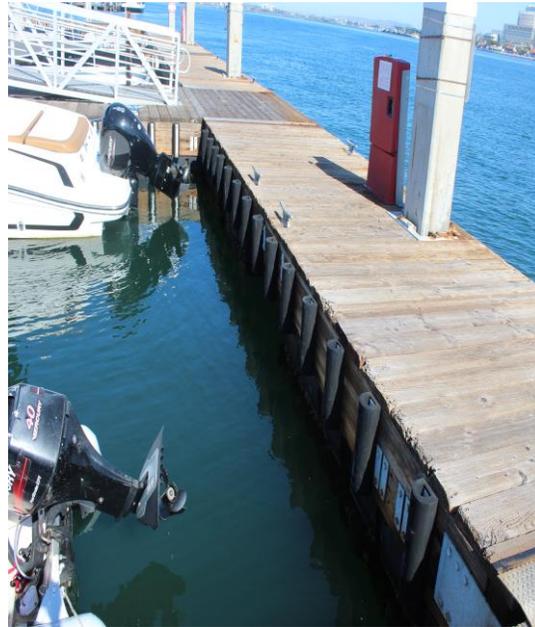
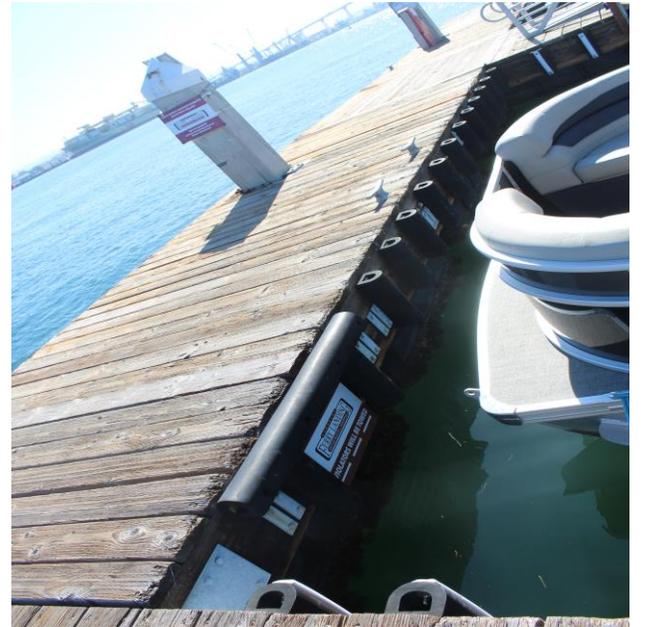
Decking is nearing the end of its service life. The wood has become very dry and brittle.

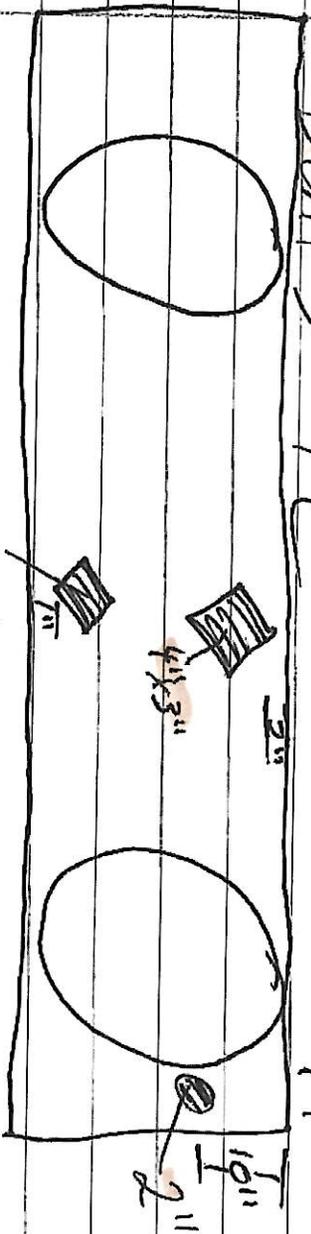
Bent 3 PC

Bravo: appears to be in good condition.
Charlie: bleed through on west face.
Bent cap: has a 2" circle of bleed through that is located east of pile Charlie. Location is 2" from east face of Charlie and 10" from the north face of pile cap.

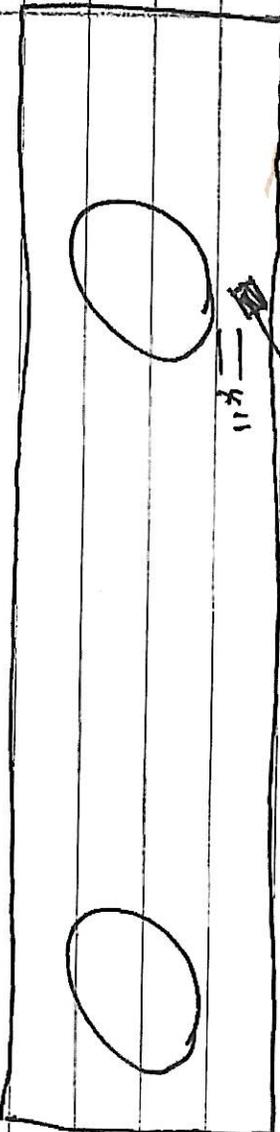
Bent 4 4'' x 3''

Bravo: pile appears to be in good condition.
Charlie: pile appears to be in good condition.
Bent cap: on bottom of pile cap, 4" north of pile bravo there is a 4" x 3" square of rust bleeding with the four corners having a corroding fastener located in the concrete.

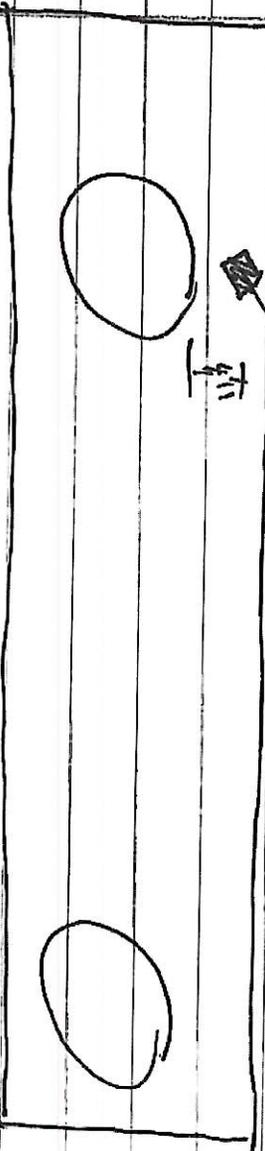
Bent 5 3'' x 4''

Bravo: has a spall located 18" below bent cap.
Charlie: has a horizontal crack starting on east face and travels north all the way around to center of south face. The beginning of crack on east face is $\frac{1}{2}$ " higher than where the crack terminates on the south face. There is also a spall on north face that's highest point is connected to the horizontal crack.
Bent cap: on bottom of bent cap centered between piles and centered north/south there is a 3" x 4" square of rust bleeding with rusting hardware located in the four corners. On the north side of bravo pile there is a 3" x 4" square of rust bleeding with rusting hardware located in the four corners.

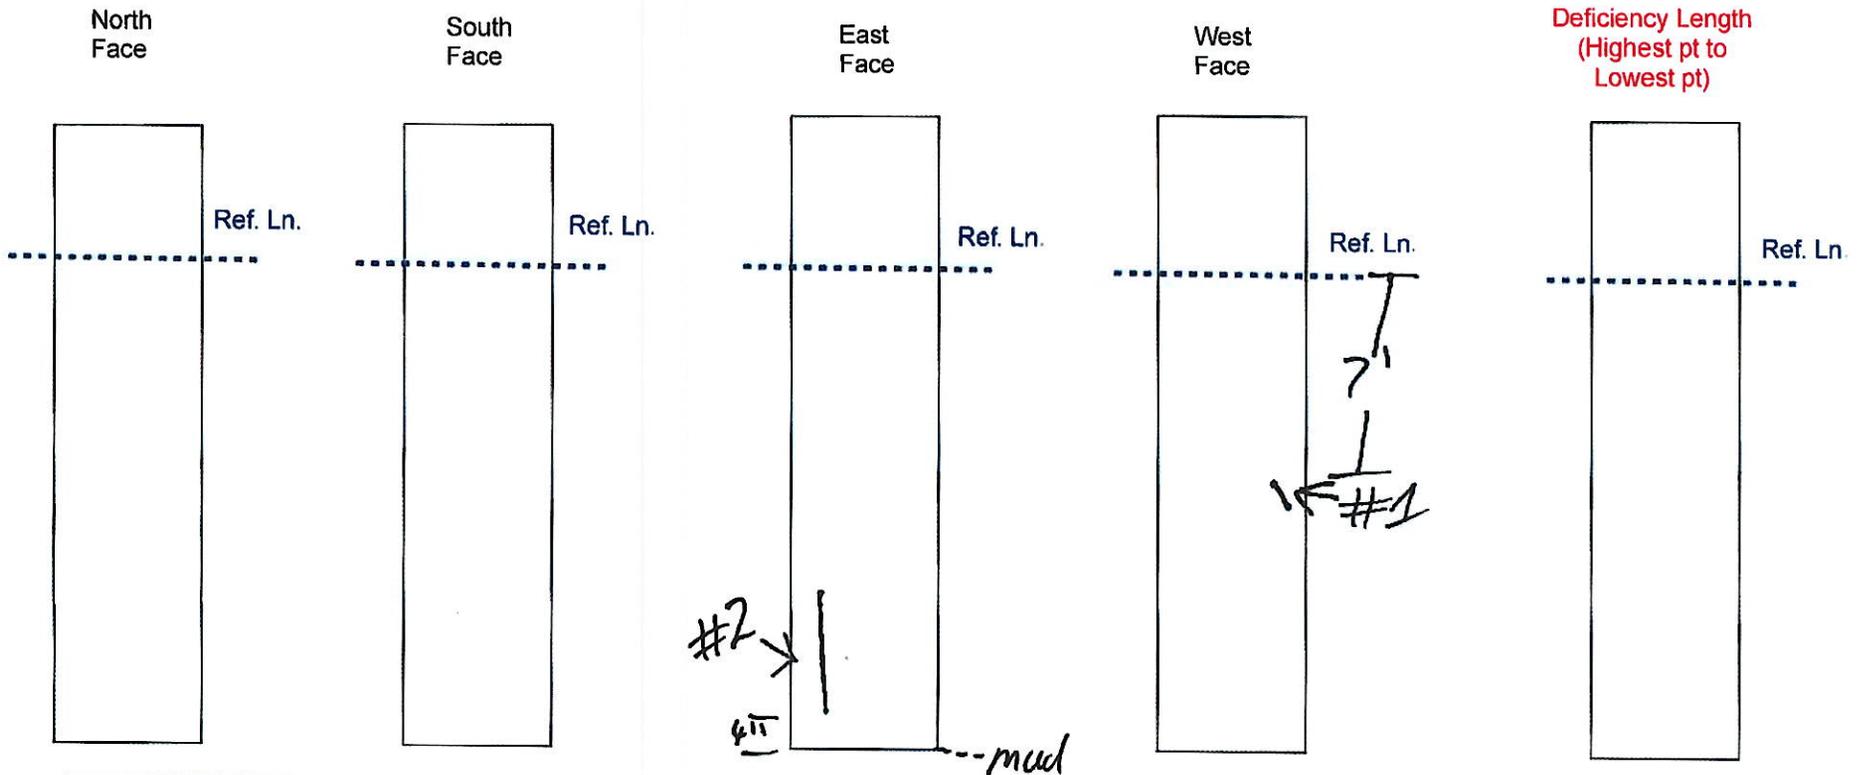
Bent #	2
Pile #	D

Spall & Crack - Dimensions and locations Table (all measurements in inches)					
Location #	Type	Distance from Ref. Line	Vert. Length	Width	Depth
1	Crack	84"	3"	1"	1/16" - 1/8"
2	Cracks		15"	1"	1/16" - 3/16"
3					< 3"
4					
5					
6					
7					
8					
9					
10

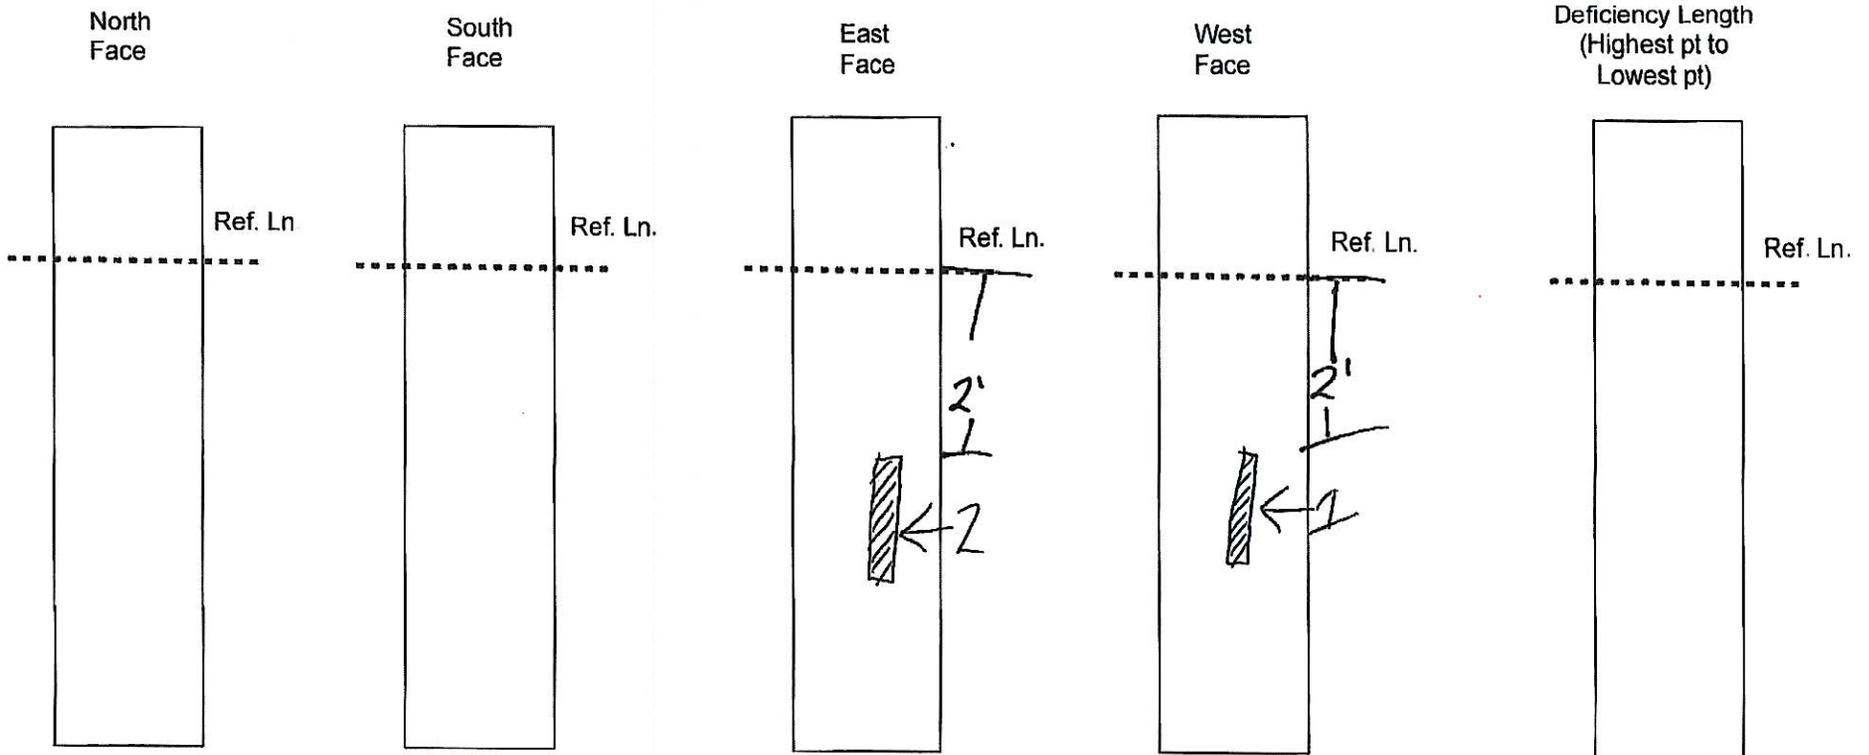
Bent #	15
Pile #	H

Location #	Type	Distance from Ref. Line	Vert. Length	Width	Depth
1	Bleeding	24"	12"	1"	N/A
2	Bleeding	24"	15"	1"	N/A
3					
4					
5					
6					
7					
8					
9					
10

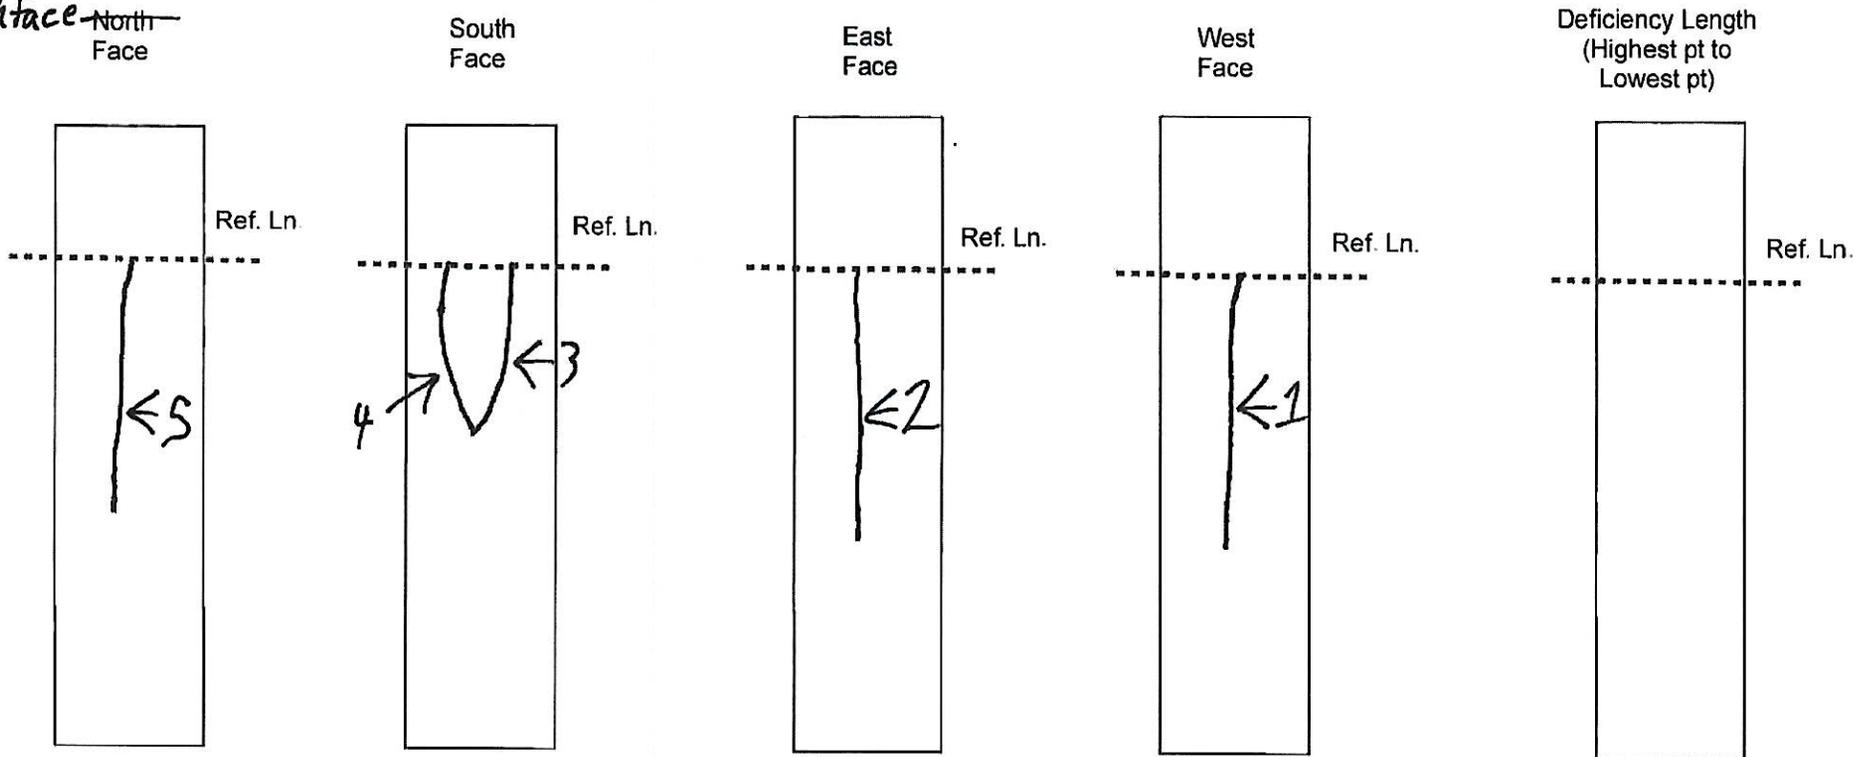
Location #	Type	Distance from Ref. Line	Vert. Length	Width	Depth
1	Crack	0"	42"	1/16" - 1/4"	3/8" - 3/4"
2	Crack	0"	42"	1/16" - 1/4"	3/8" - 1"
3	Crack	0"	24"	1/16" - 1/2"	1/16" - 5"
4	Crack	0"	24"	1/16" - 1/2"	1/16" - 5"
5	Crack	0"	36"	1/16" - 3/4"	1/16" - 4"
6					
7					
8					
9					
10
